LAKE COUNTY AIRPORT

This report describes how your Pavement Maintenance Management Program (PMMP) was developed. Your Program was developed as part of the Oregon Continuous Aviation System Plan sponsored in part by the Oregon Department of Aviation and the Federal Aviation Administration (FAA). The information and data contained in this report ensures you are in compliance with the requirements of FAA Grant Assurance Number 11 which states that any airport requesting federal funds for pavement improvement projects must have implemented a pavement maintenance management program.

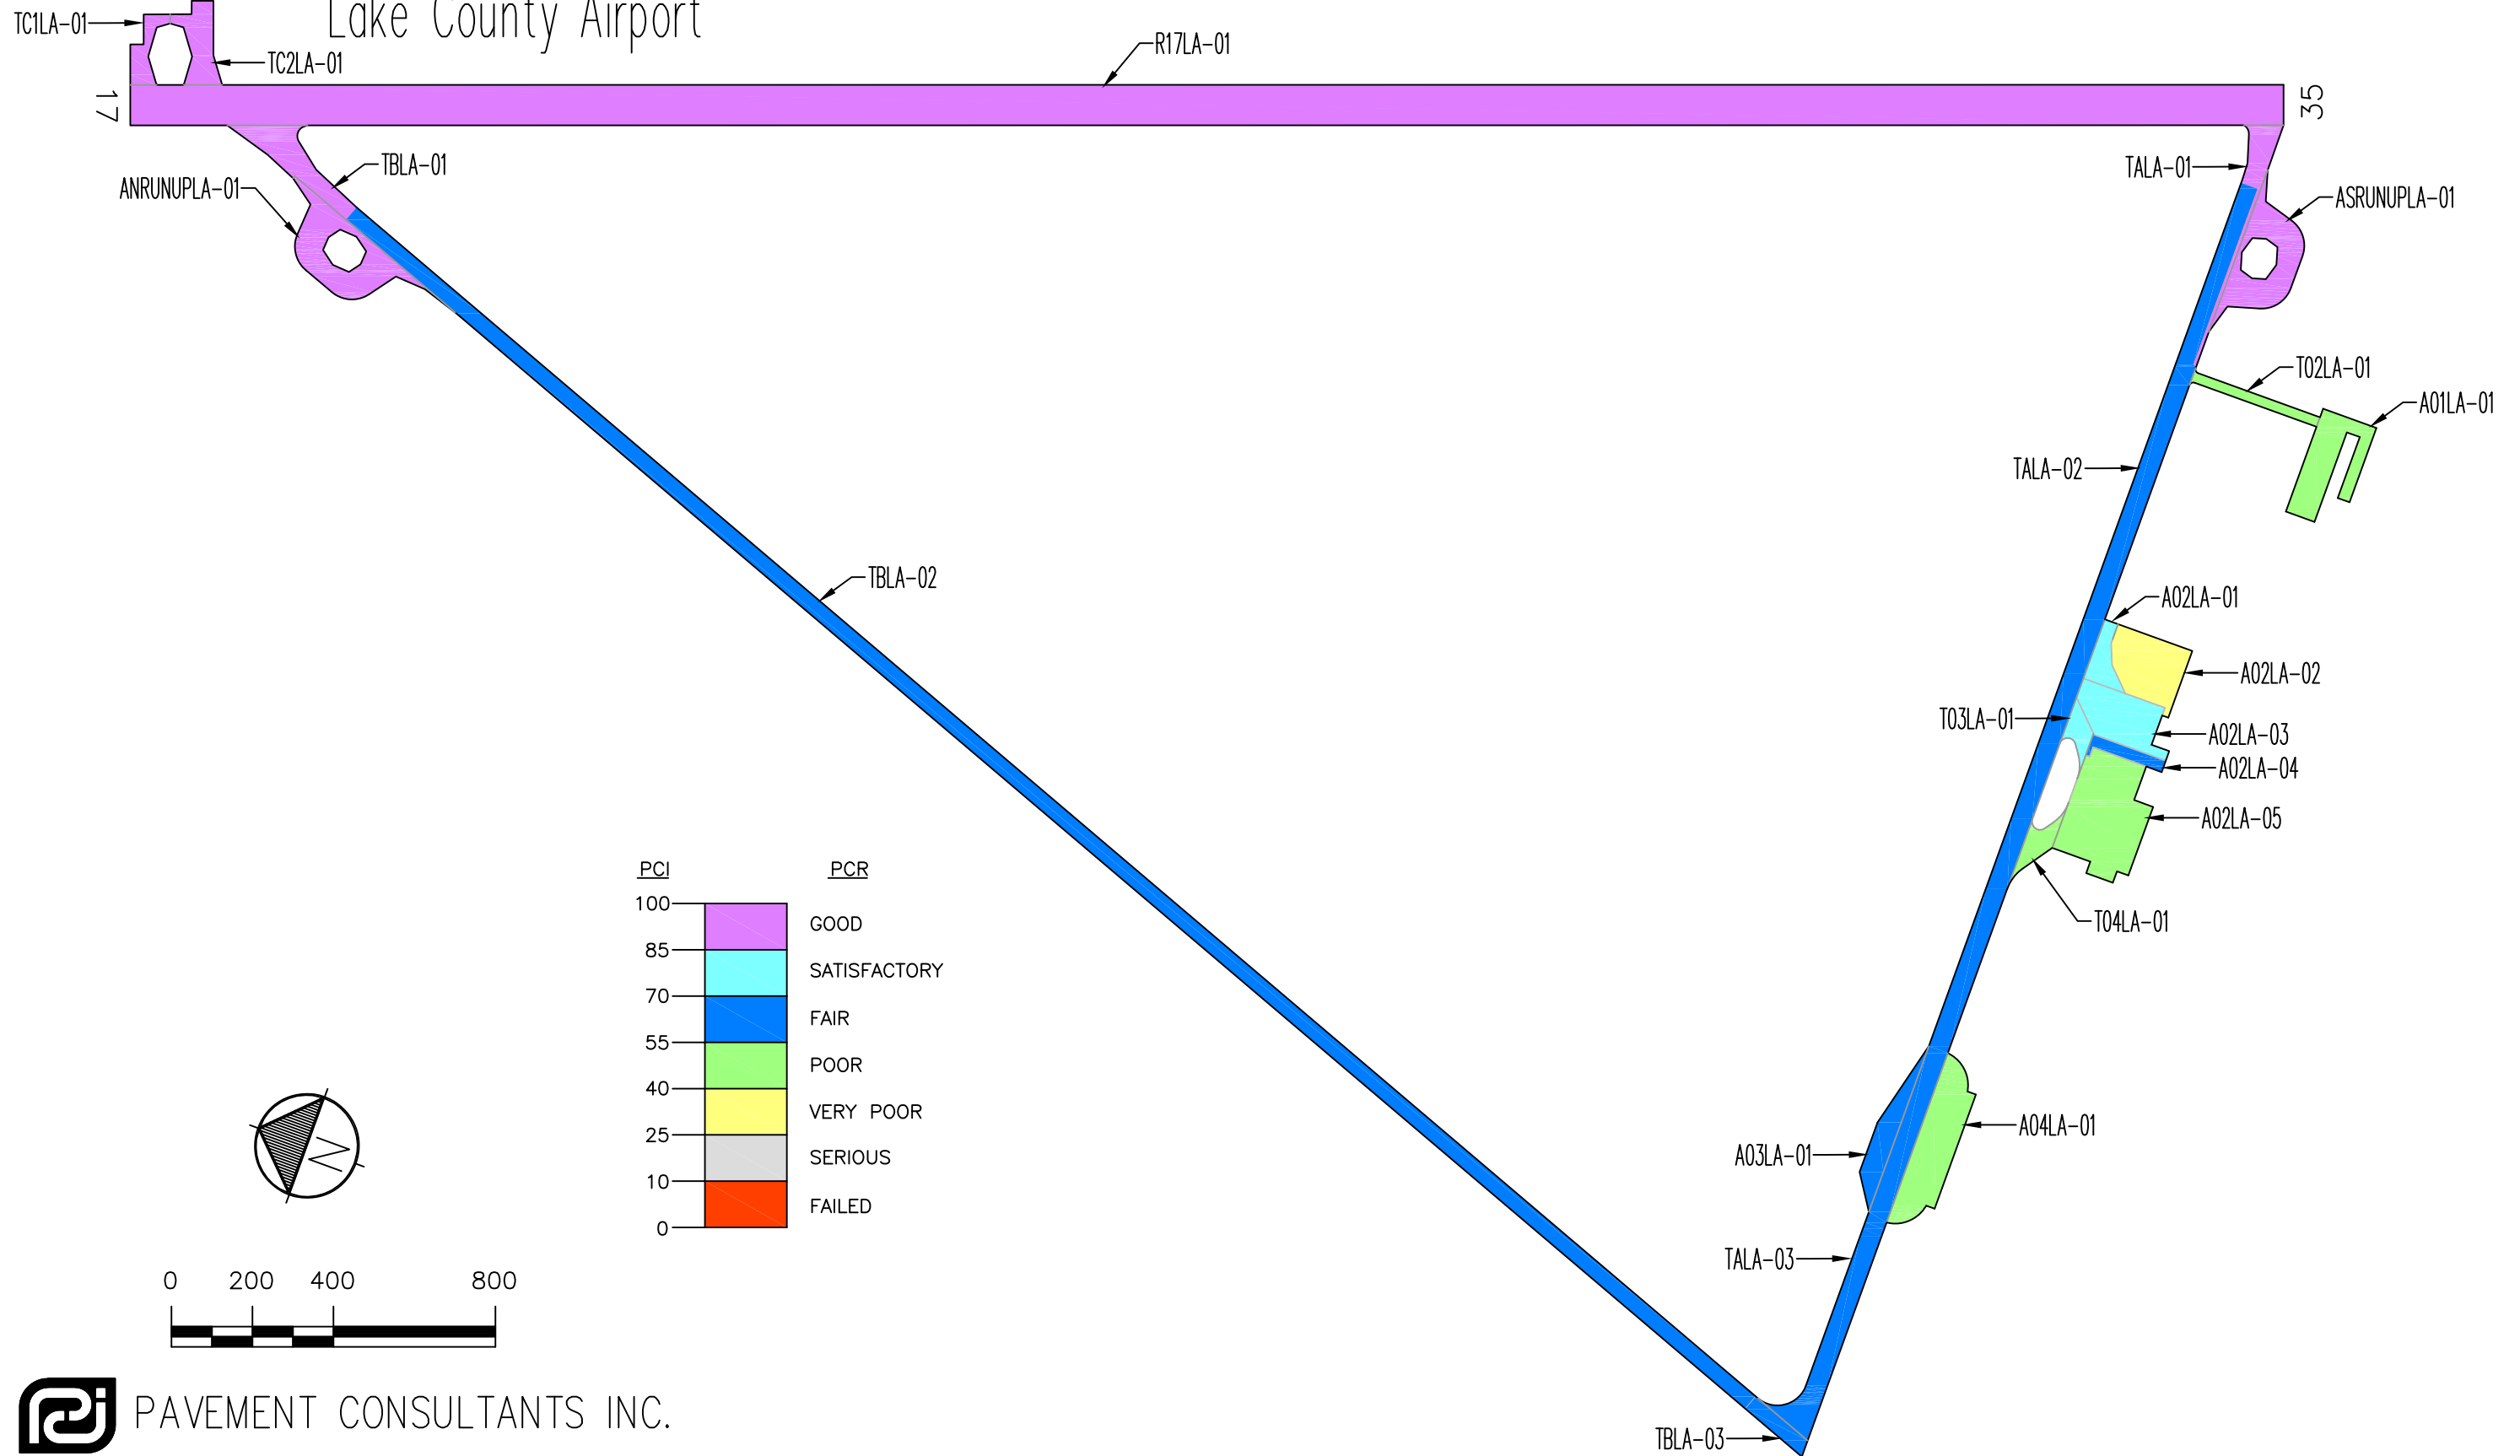
Figure LA-3. Pavement Condition in July 2016.

The Branch Condition Report in Appendix 1 summarizes current pavement condition by branch while the Section Condition Report in Appendix 2 lists pavement condition by section. The current Pavement Condition Rating (PCR) is shown graphically in Figure LA-3.

Section PCIs at Lake County Airport range from a low of 30 (a PCR of “Very Poor”) to a high of 100 (a PCR of “Good”). The area-weighted average PCI for all airport pavements is 80, corresponding to an overall PCR of “Satisfactory”. Figure LA-4 shows how much pavement area is associated with each Pavement Condition Rating category and also shows pavement condition distribution from the inspections conducted in 2009 and 2013.

The primary distresses observed during the inspection were: block cracking, depressions, longitudinal and transverse cracking, raveling, weathering, patching, alligator cracking, and joint reflection cracking.

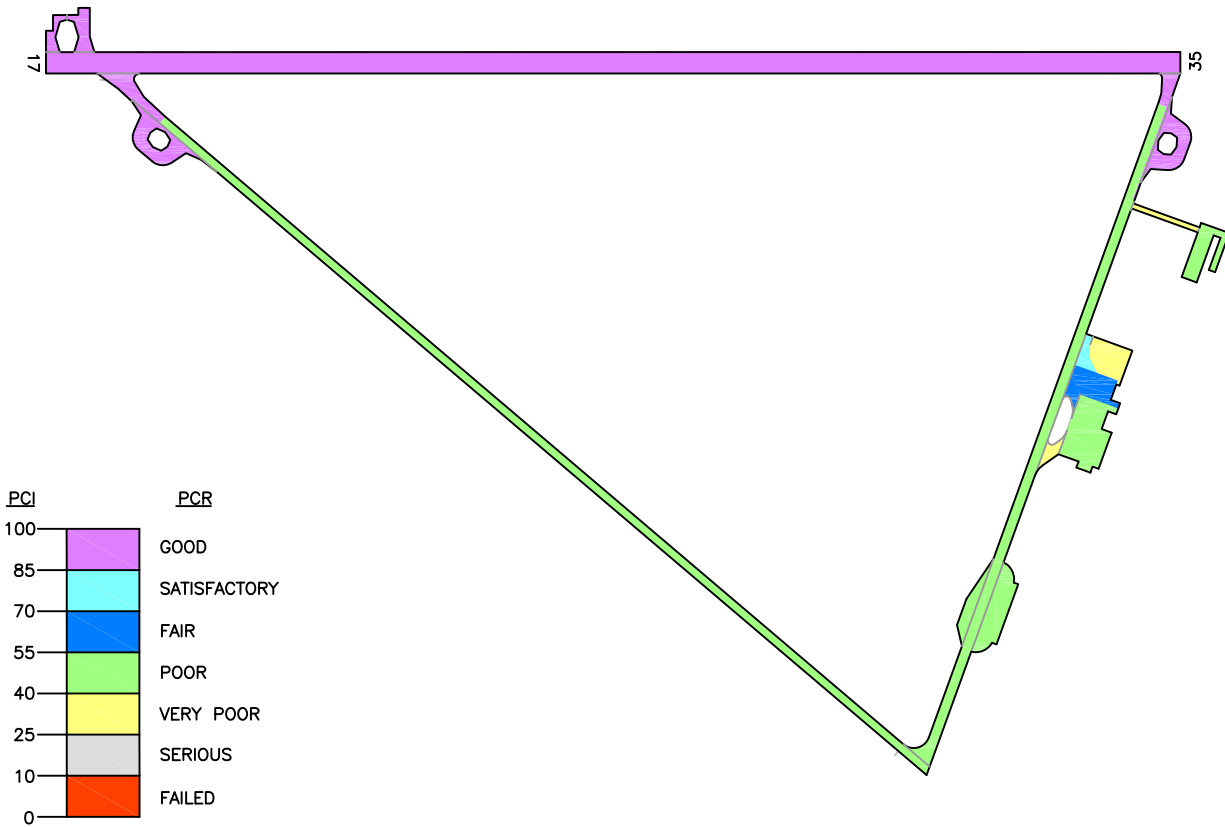
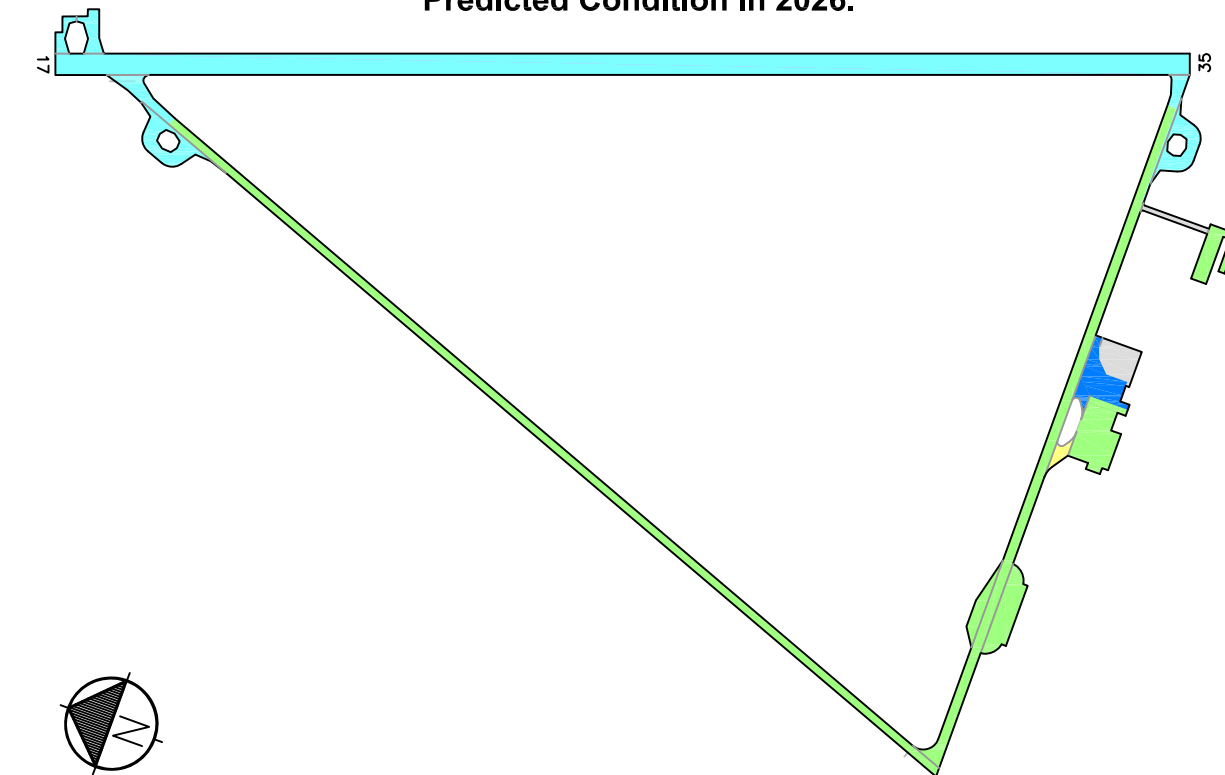
Figure LA-5. Future Pavement Condition.

A graphical representation of the projected PCIs listed in Table 1 is shown in Figure LA-5.
