MYRTLE CREEK MUNICIPAL AIRPORT

Figure MC-1. Airport Layout, Dimensions and Pavement Cross-Sections.
Myrtle Creek Municipal Airport

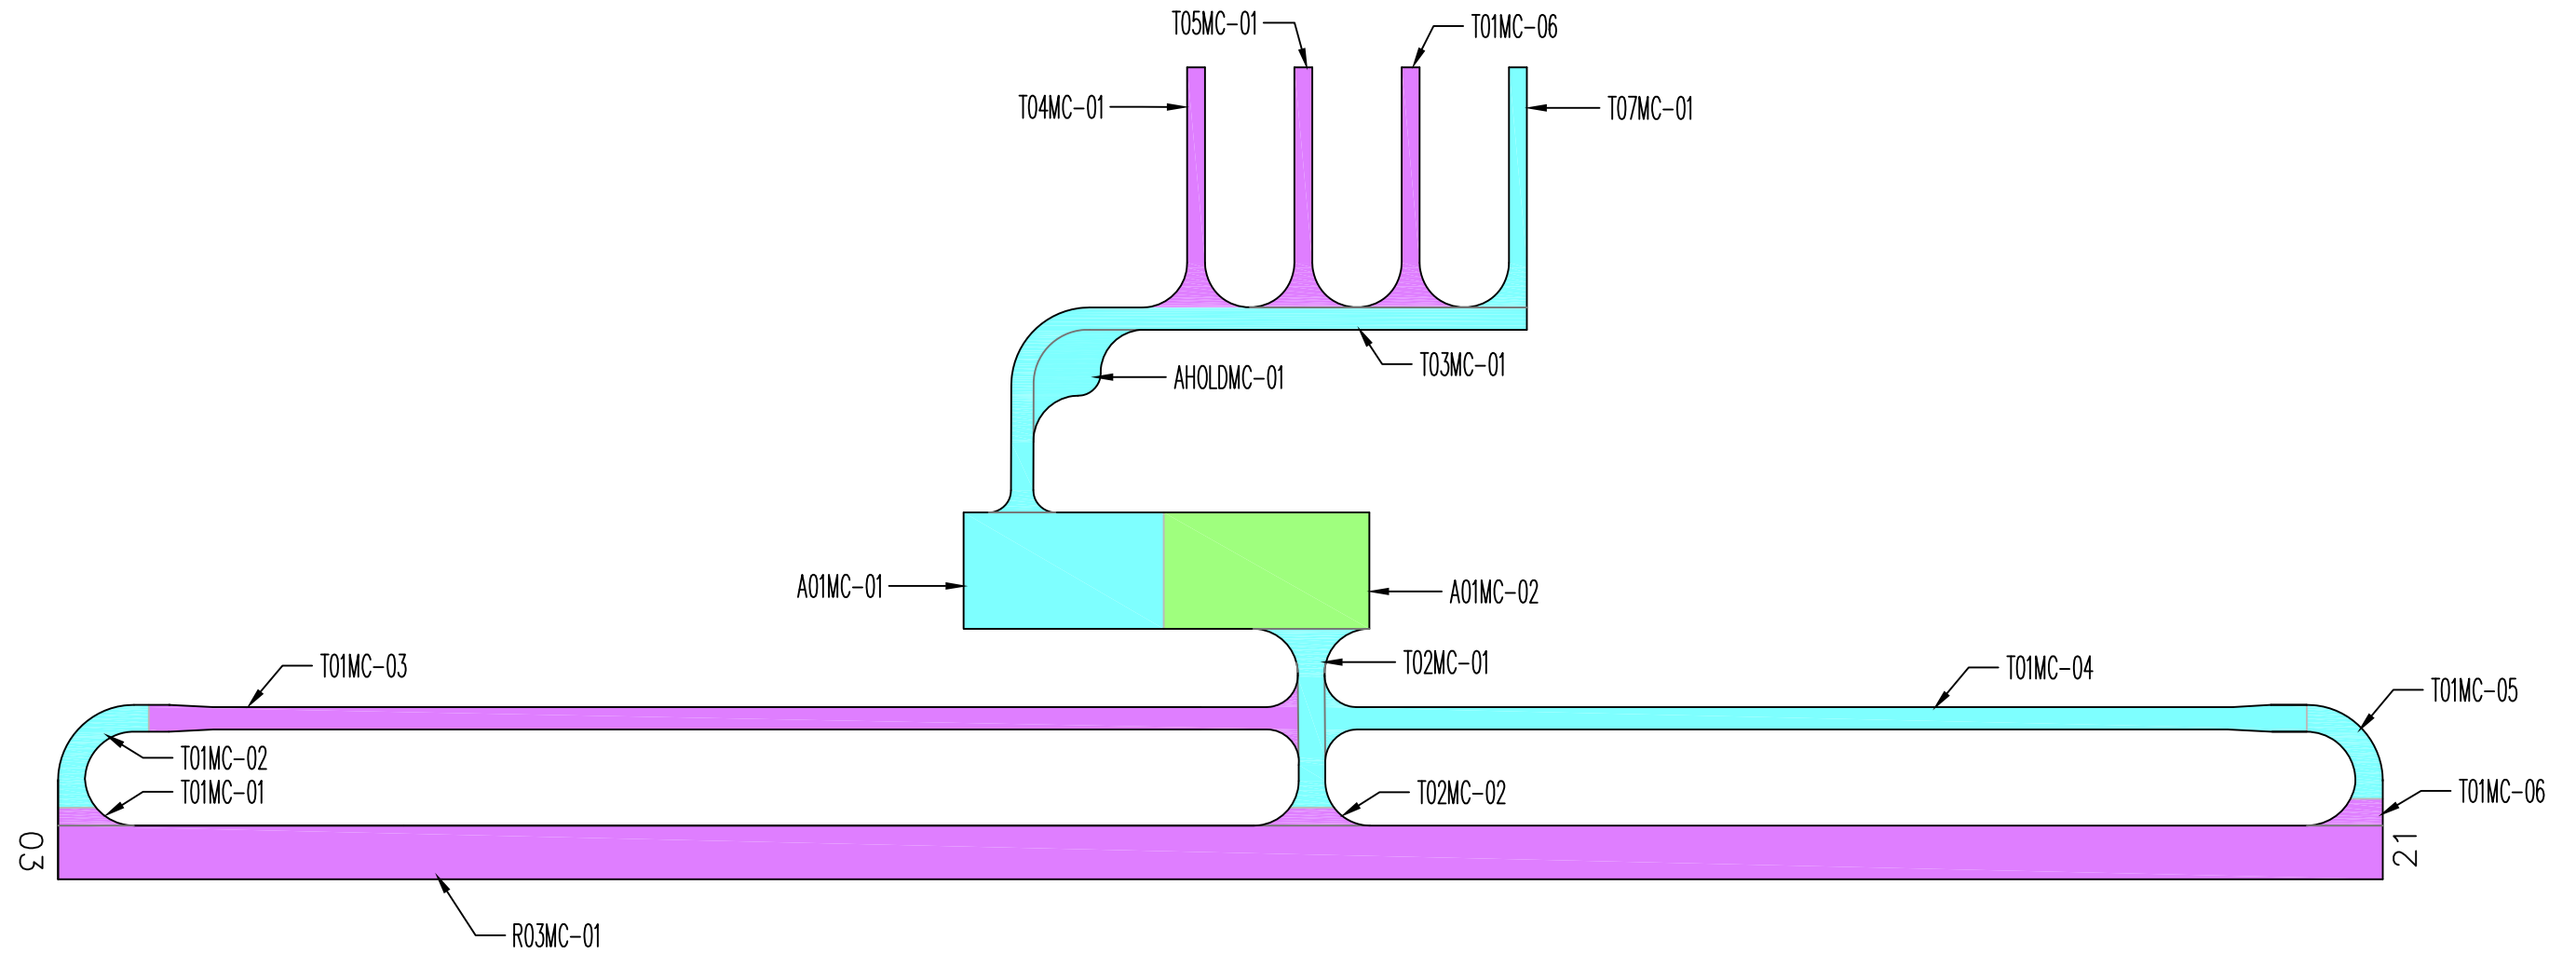
Figure MC-3. Pavement Condition in July 2016.
Myrtle Creek Municipal Airport

Section PCIs at Myrtle Creek Municipal Airport range from a low of 49 (a PCR of “Poor”) to a high of 100 (a PCR of “Good”). The area-weighted average PCI for all airport pavements is 87, corresponding to an overall PCR of “Good”. Figure MC-4 shows how much pavement area is associated with each Pavement Condition Rating category and also shows pavement condition distribution from the inspections conducted in 2009 and 2013.

The primary distresses observed during the inspection were: longitudinal and transverse cracking, weathering, and depressions, with isolated occurrences of block cracking and patching.

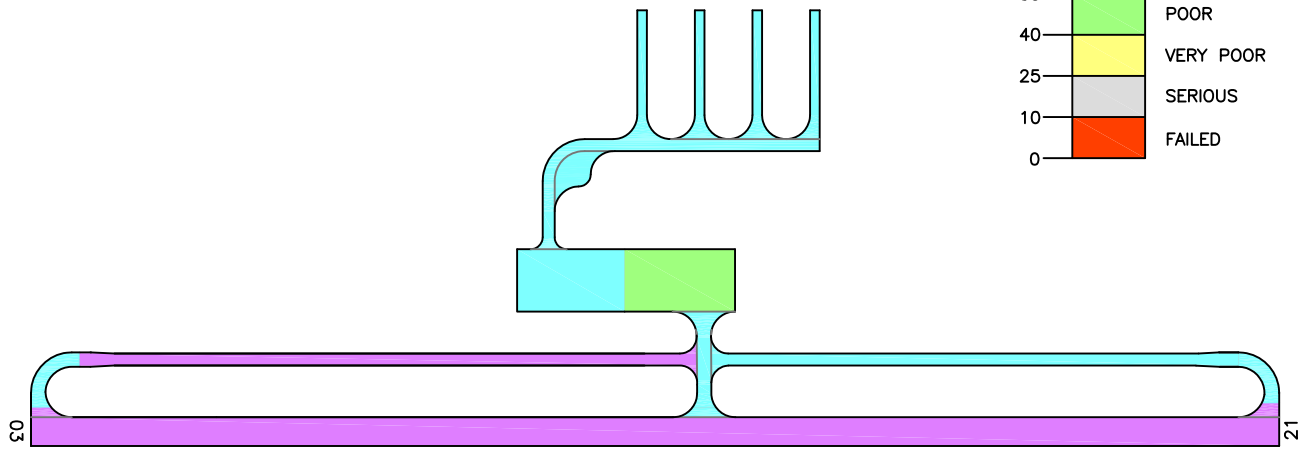
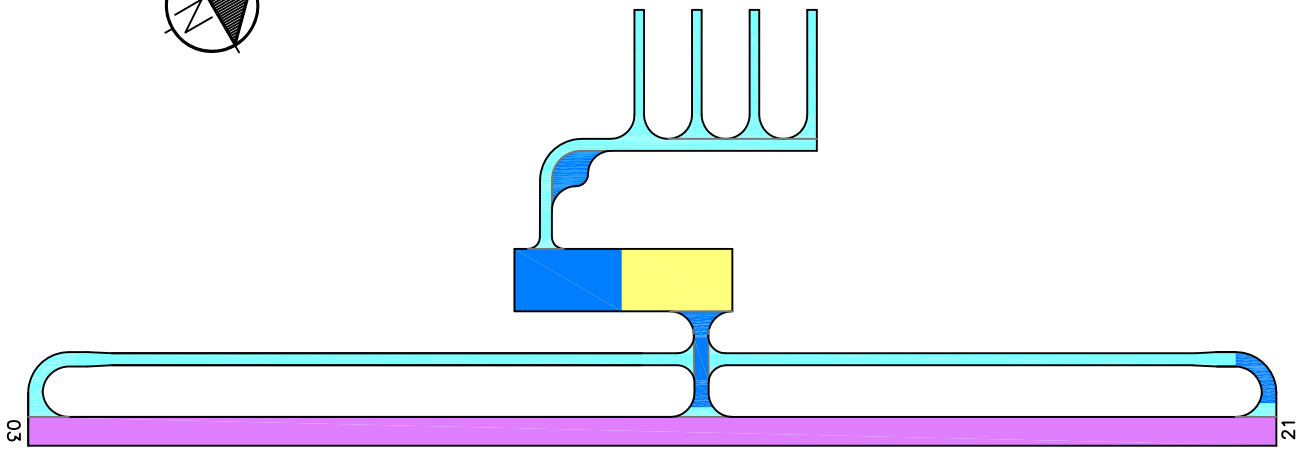
Figure MC-5. Future Pavement Condition.

A graphical representation of the projected PCIs listed in Table 1 is shown in Figure MC-5.
