# OAKRIDGE STATE AIRPORT

This report describes how your Pavement Maintenance Management Program (PMMP) was developed. Your Program was developed as part of the Oregon Continuous Aviation System Plan sponsored in part by the Oregon Department of Aviation and the Federal Aviation Administration (FAA). The information and data contained in this report ensures you are in compliance with the requirements of FAA Grant Assurance Number 11 which states that any airport requesting federal funds for pavement improvement projects must have implemented a pavement maintenance management program.

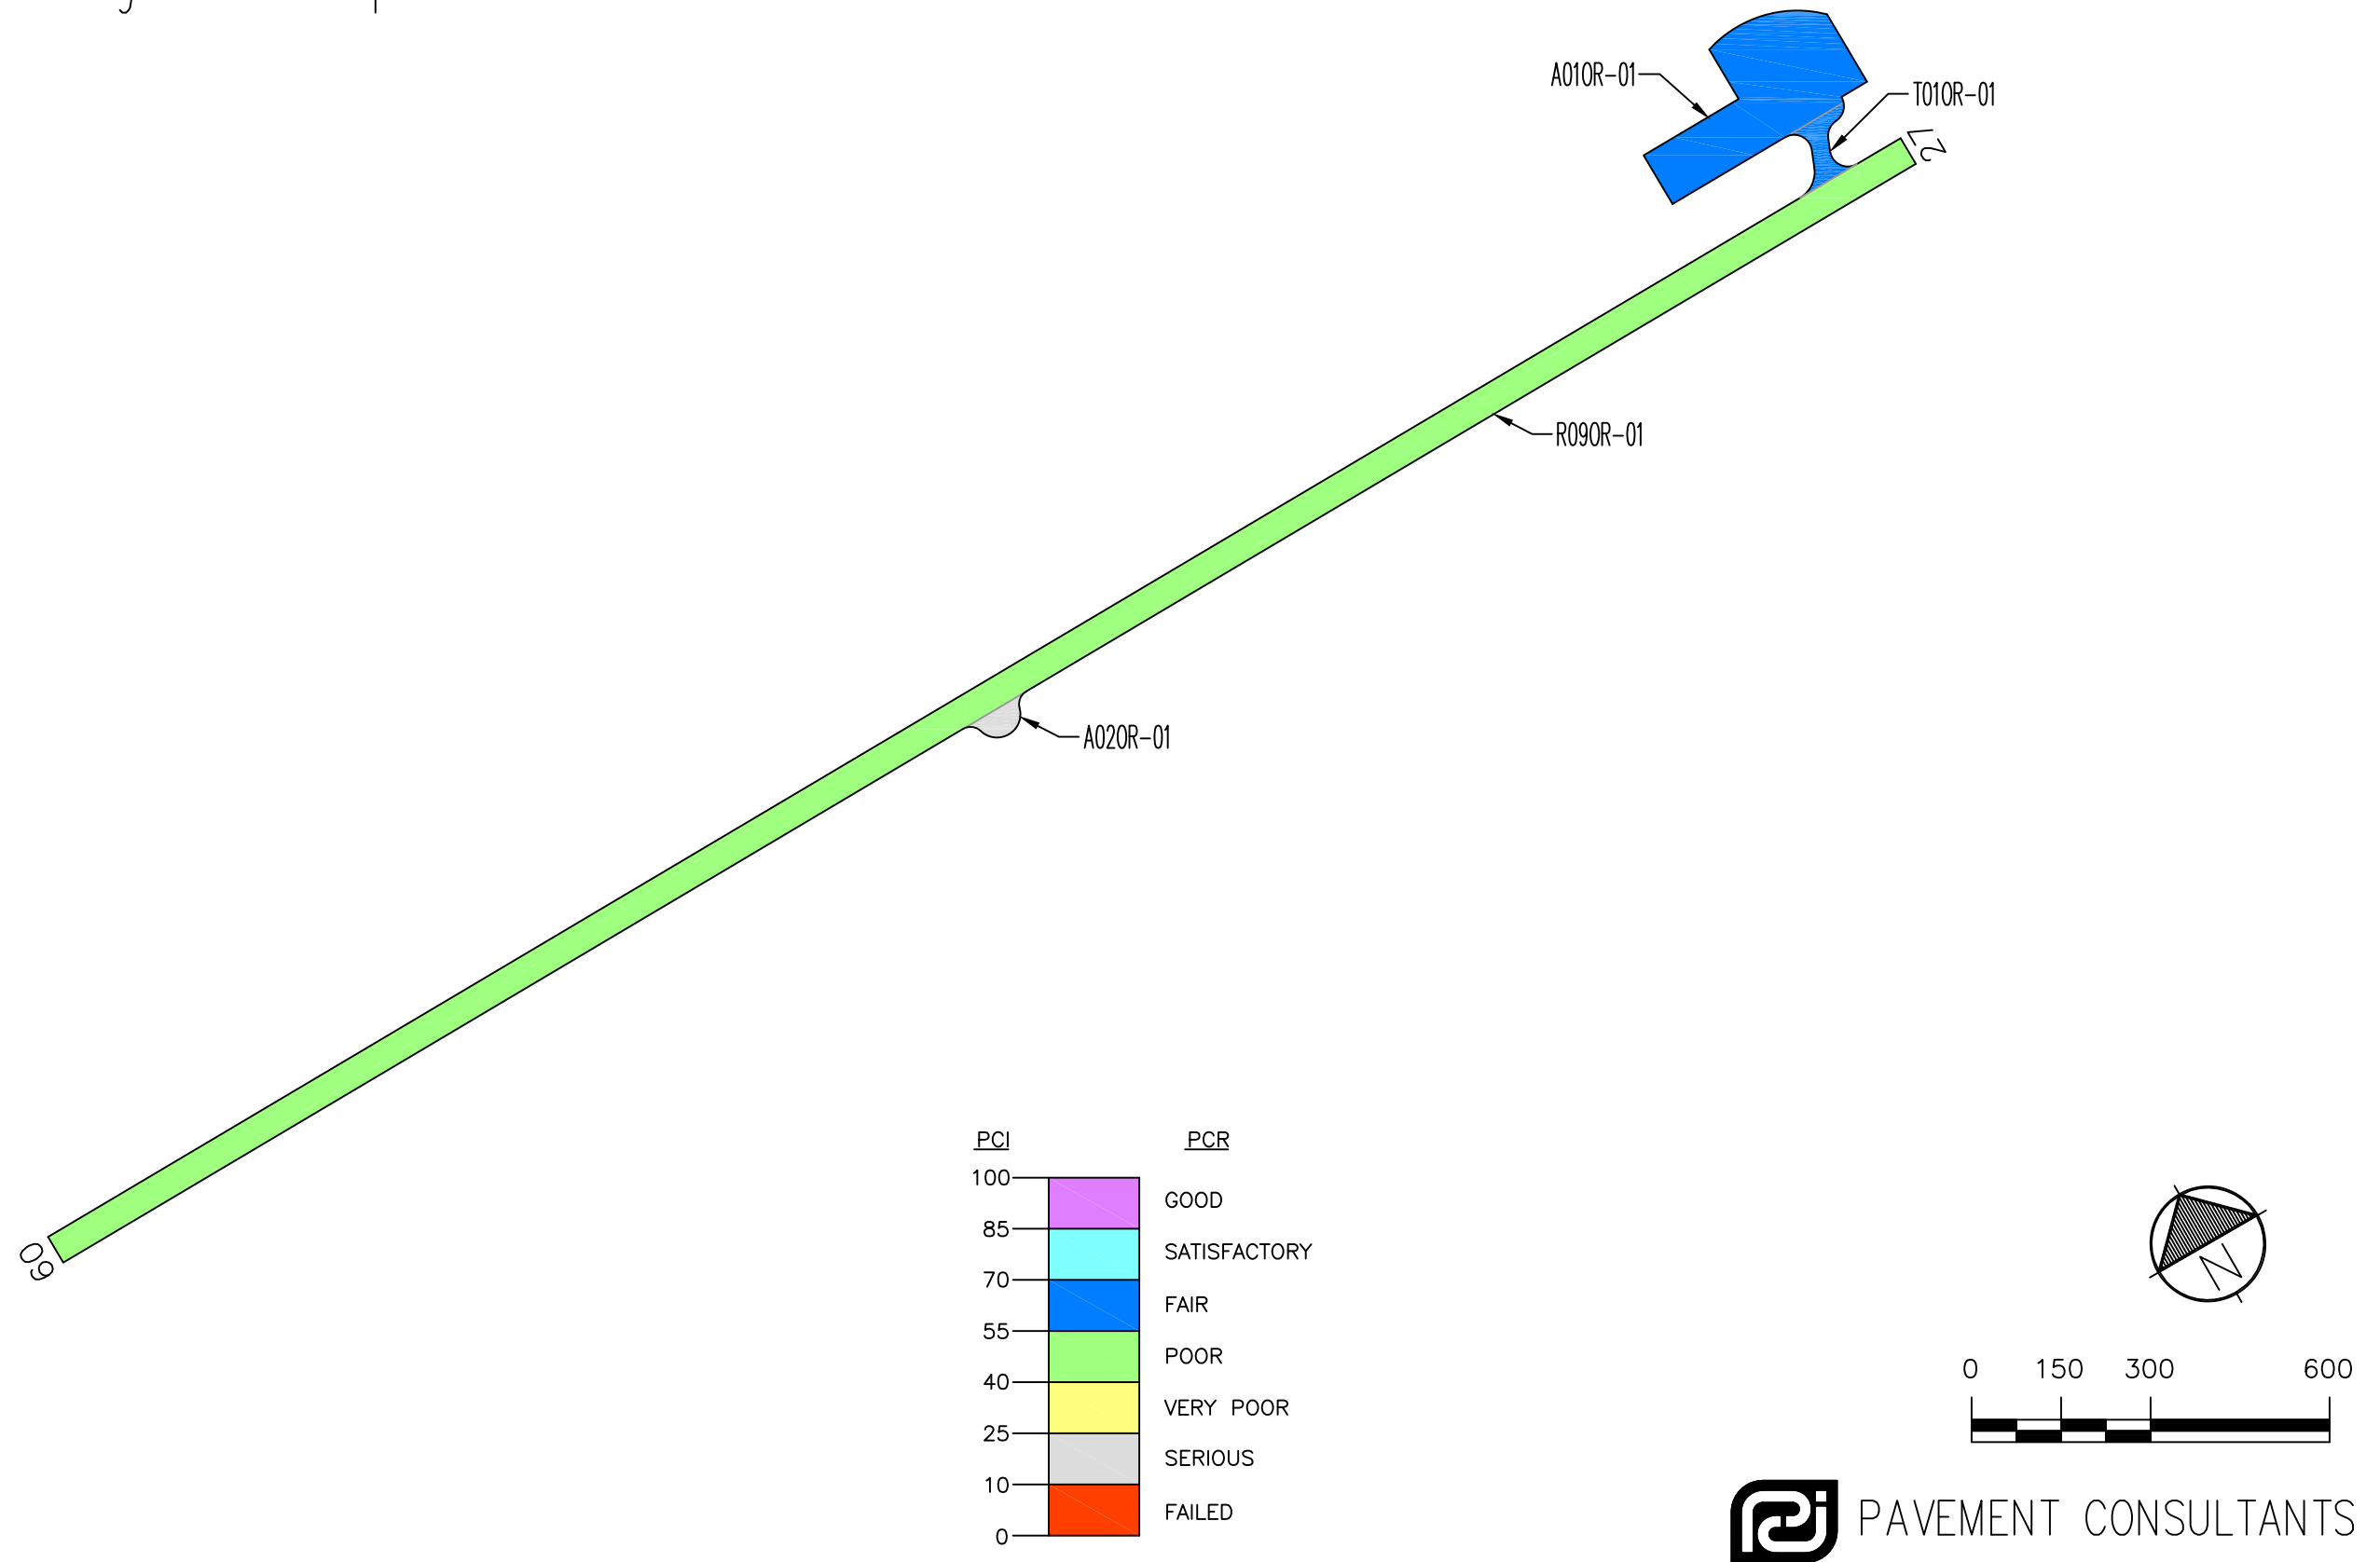
Figure OR-3. Pavement Condition in July 2016.  
Oakridge State Airport

The Branch Condition Report in Appendix 1 summarizes current pavement condition by branch while the Section Condition Report in Appendix 2 lists pavement condition by section. The current Pavement Condition Rating (PCR) is shown graphically in Figure OR-3.

Section PCIs at Oakridge State Airport range from a low of 19 (a PCR of "Serious") to a high of 57 (a PCR of "Fair"). The area-weighted average PCI for all airport pavements is 51, corresponding to an overall PCR of "Poor". Figure OR-4 shows how much pavement area is associated with each Pavement Condition Rating category and also shows pavement condition distribution from the inspections conducted in 2009 and 2013.

The primary distresses observed during the inspection were: block cracking, with isolated occurrences of alligator cracking, longitudinal and transverse cracking, and raveling.

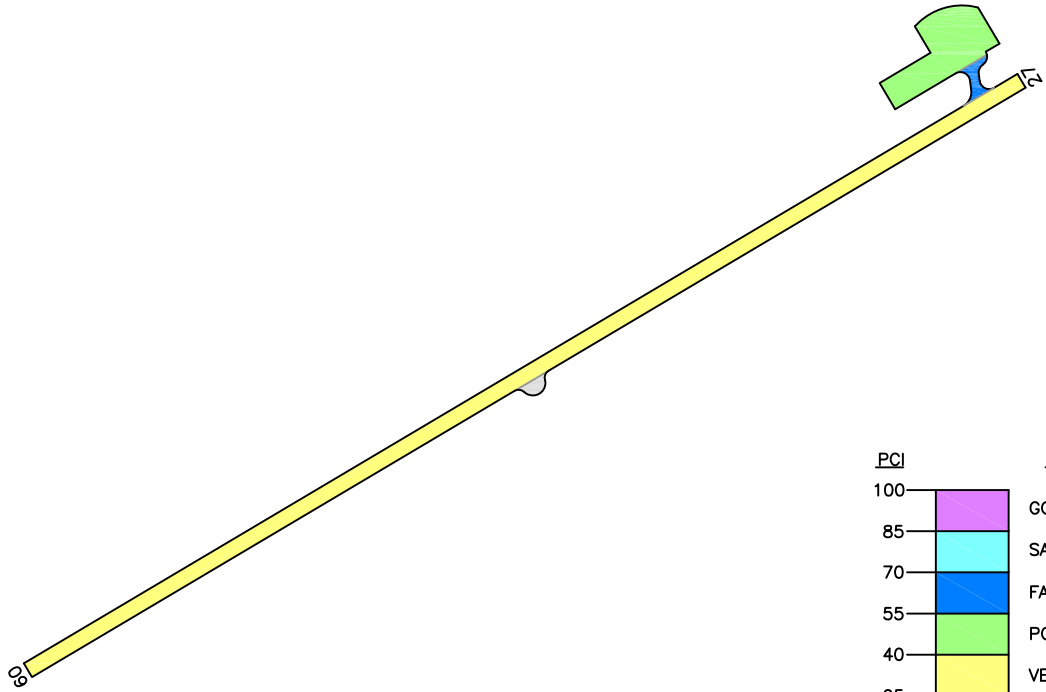
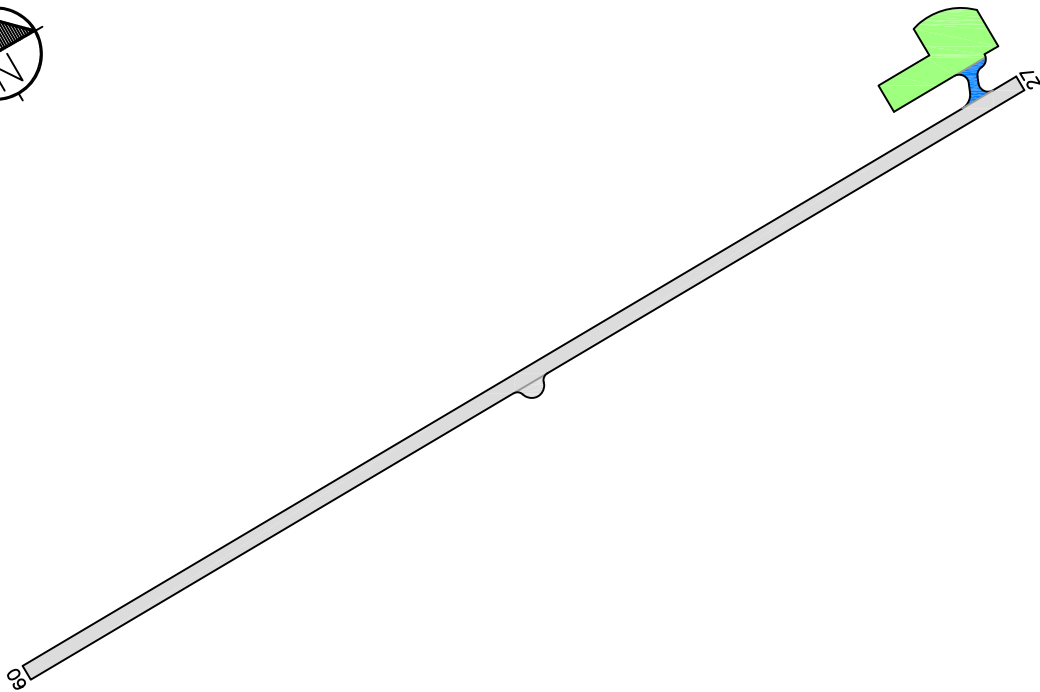
Figure OR-5. Future Pavement Condition.

Branch	Section	Inspections			Forecast	
		2009	2013	2016	2021	2026
A01OR	1	57	64	57	54	51
A02OR	1	11	25	19	17	15
R09OR	1	58	49	49	35	22
T01OR	1	70	67	70	62	59

A graphical representation of the projected PCIs listed in Table 1 is shown in Figure OR-5.
