PINEHURST STATE AIRPORT

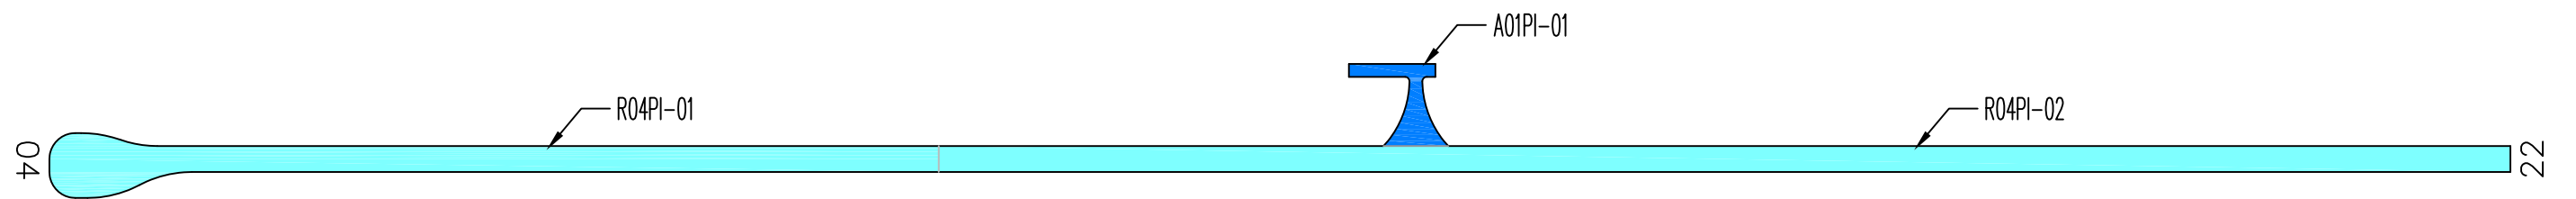
Figure PI-3. Pavement Condition in July 2016.
Pinehurst State Airport

Section PCIs at Pinehurst State Airport range from a low of 59 (a PCR of "Fair") to a high of 82 (a PCR of "Satisfactory"). The area-weighted average PCI for all airport pavements is 80, corresponding to an overall PCR of "Satisfactory". Figure PI-4 shows how much pavement area is associated with each Pavement Condition Rating category and also shows pavement condition distribution from the inspections conducted in 2009 and 2013.

The primary distresses observed during the inspection were: longitudinal and transverse cracking, patching and raveling, with an isolated occurrence of alligator cracking.

Data collected during the visual condition survey were used by the Micro PAVER software to generate the Network Maintenance Report contained in Appendix 3. This report identifies, for each pavement section, the recommended localized maintenance activities (i.e.-crack sealing, patching) that should be completed to repair the defects observed during the visual inspection. The repair quantities identified in the report were extrapolated to cover the entire pavement section, based on the distresses measured in the inspected sample units. If the repair activities identified are completed, the pavement deterioration rate will be slowed.

- 1,109 linear feet of asphalt concrete crack sealing.
