PROSPECT STATE AIRPORT

This report describes how your Pavement Maintenance Management Program (PMMP) was developed. Your Program was developed as part of the Oregon Continuous Aviation System Plan sponsored in part by the Oregon Department of Aviation and the Federal Aviation Administration (FAA). The information and data contained in this report ensures you are in compliance with the requirements of FAA Grant Assurance Number 11 which states that any airport requesting federal funds for pavement improvement projects must have implemented a pavement maintenance management program.

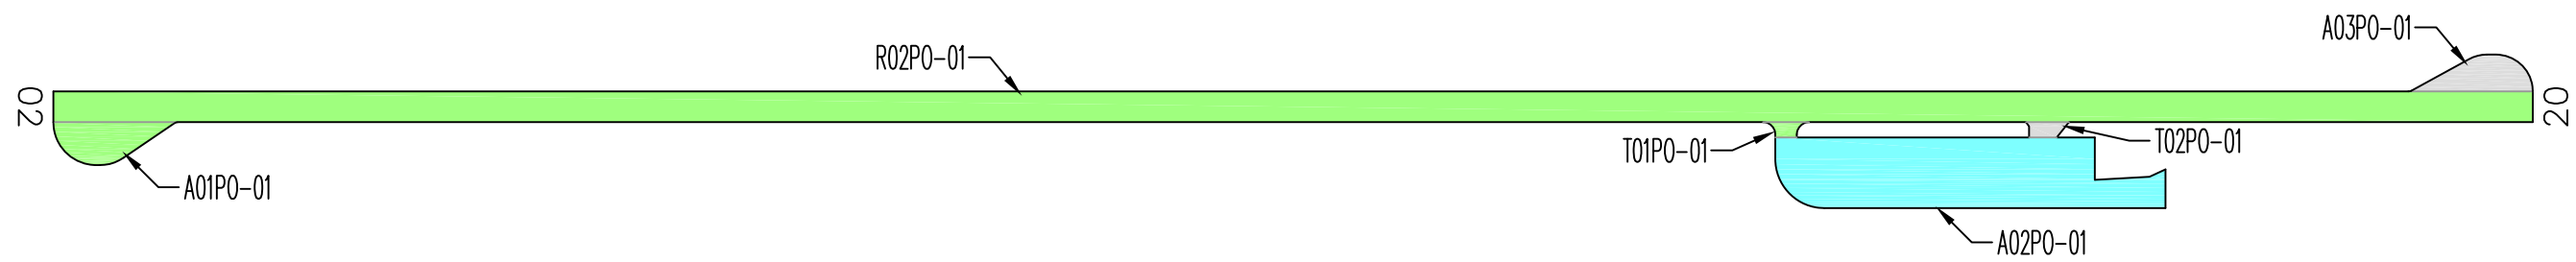
Figure PO-3. Pavement Condition in July 2016.
Prospect State Airport

The Branch Condition Report in Appendix 1 summarizes current pavement condition by branch while the Section Condition Report in Appendix 2 lists pavement condition by section. The current Pavement Condition Rating (PCR) is shown graphically in Figure PO-3.

Section PCIs at Prospect State Airport range from a low of 20 (a PCR of “Serious”) to a high of 78 (a PCR of “Satisfactory”). The area-weighted average PCI for all airport pavements is 49, corresponding to an overall PCR of “Poor”. Figure PO-4 shows how much pavement area is associated with each Pavement Condition Rating category and also shows pavement condition distribution from the inspections conducted in 2009 and 2013.

The primary distresses observed during the inspection were: longitudinal and transverse cracking, block cracking, alligator cracking and an isolated occurrence of depression.
