ROSEBURG REGIONAL AIRPORT

This report describes how your Pavement Maintenance Management Program (PMMP) was developed. Your Program was developed as part of the Oregon Continuous Aviation System Plan sponsored in part by the Oregon Department of Aviation and the Federal Aviation Administration (FAA). The information and data contained in this report ensures you are in compliance with the requirements of FAA Grant Assurance Number 11 which states that any airport requesting federal funds for pavement improvement projects must have implemented a pavement maintenance management program.

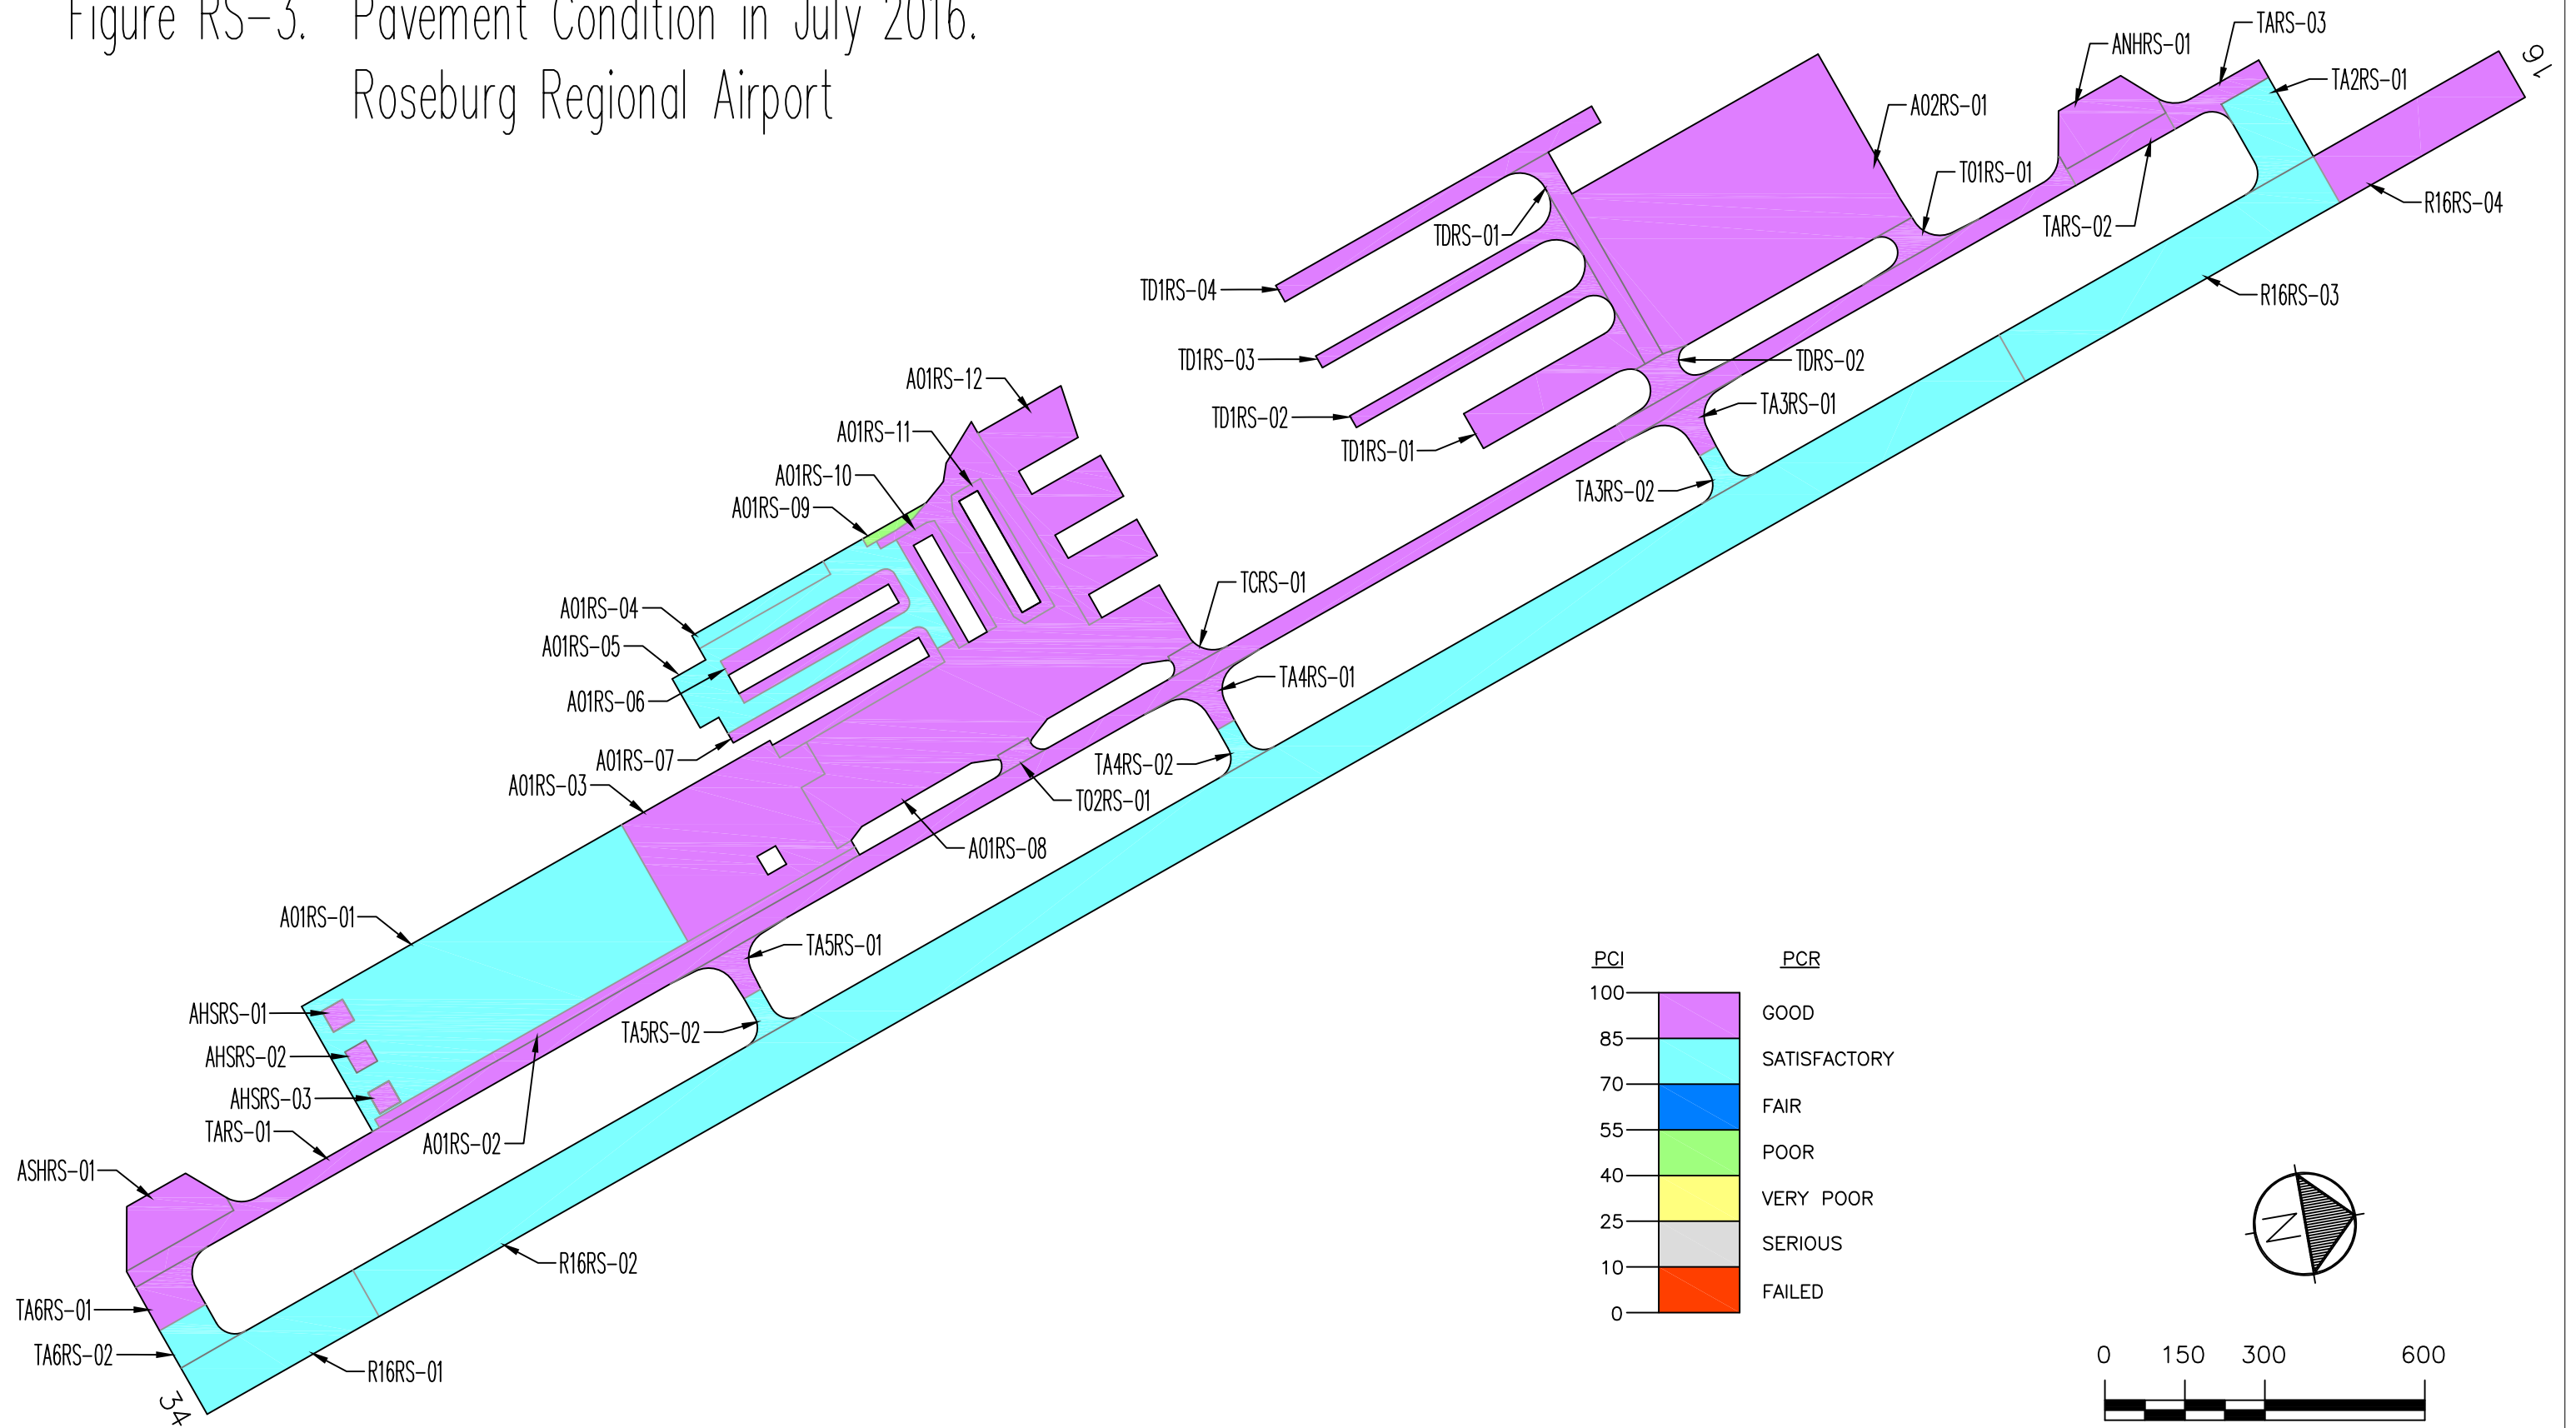
Figure RS-3. Pavement Condition in July 2016.
Roseburg Regional Airport

Section PCIs at Roseburg Regional Airport range from a low of 44 (a PCR of “Serious”) to a high of 100 (a PCR of “Good”). The area-weighted average PCI for all airport pavements is 90, corresponding to an overall PCR of “Good”. Figure RS-4 shows how much pavement area is associated with each Pavement Condition Rating category and also shows pavement condition distribution from the inspections conducted in 2009 and 2013.

The primary distresses observed during the inspection were: longitudinal and transverse cracking, weathering, block cracking, patching, raveling, and joint and corner spalls.

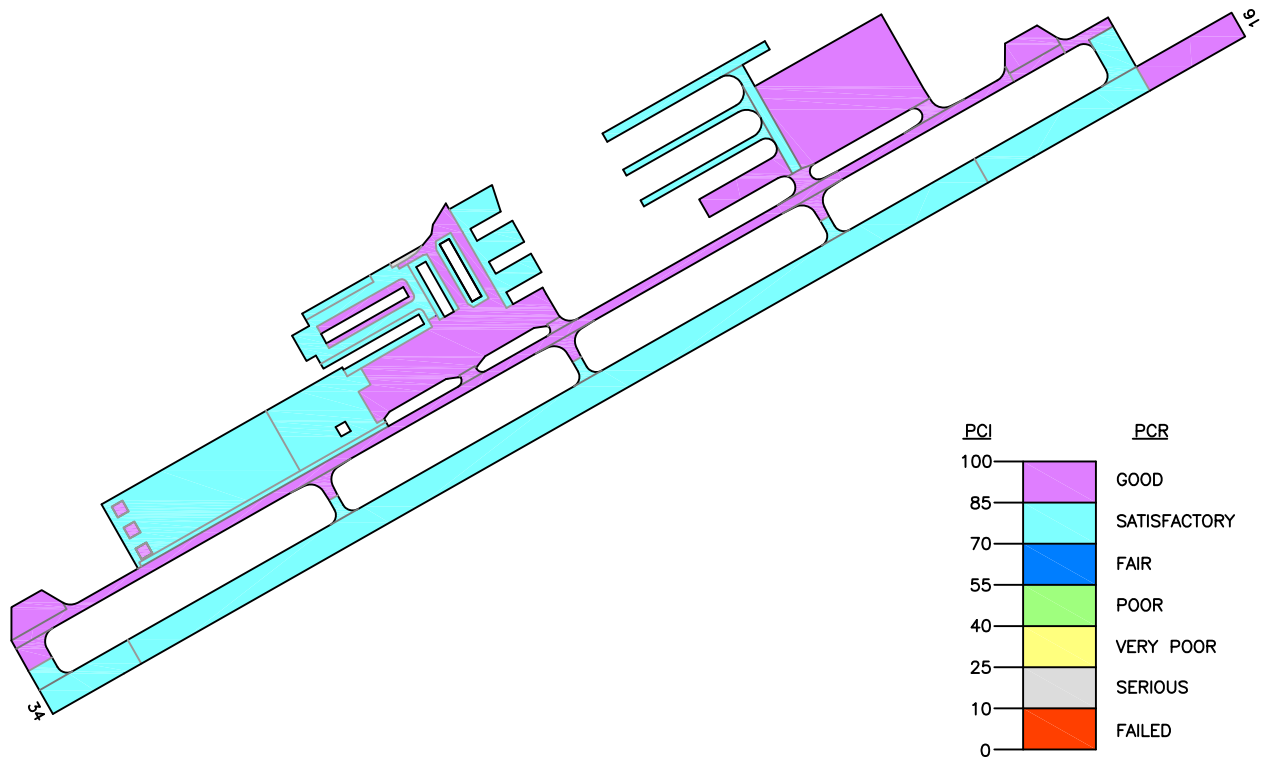
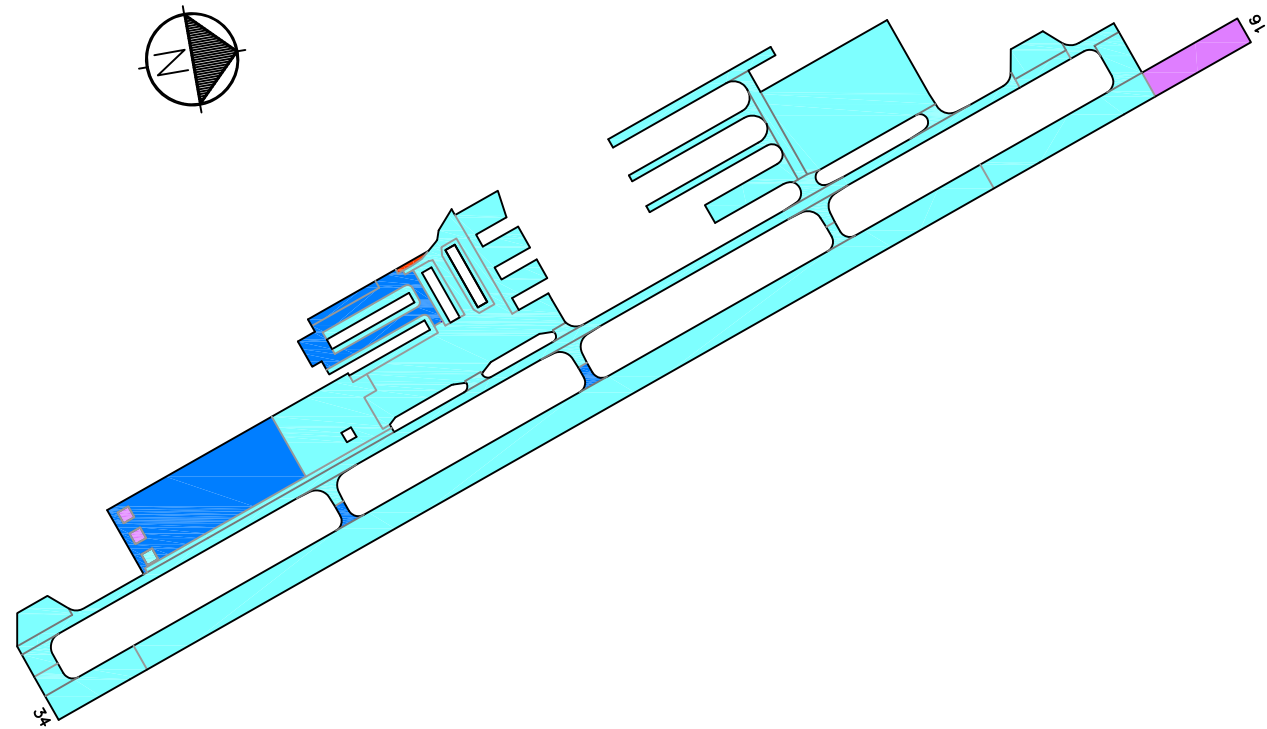
Figure RS-5. Future Pavement Condition.

A graphical representation of the projected PCIs listed in Table 1 is shown in Figure RS-5.
