# BAKER CITY MUNICIPAL AIRPORT

This report describes how your Pavement Maintenance Management Program (PMMP) was developed. Your Program was developed as part of the Oregon Continuous Aviation System Plan sponsored in part by the Oregon Department of Aviation and the Federal Aviation Administration (FAA). The information and data contained in this report ensures you comply with the requirements of FAA Grant Assurance Number 11 which states that any airport requesting federal funds for pavement improvement projects must have implemented a pavement maintenance management program.

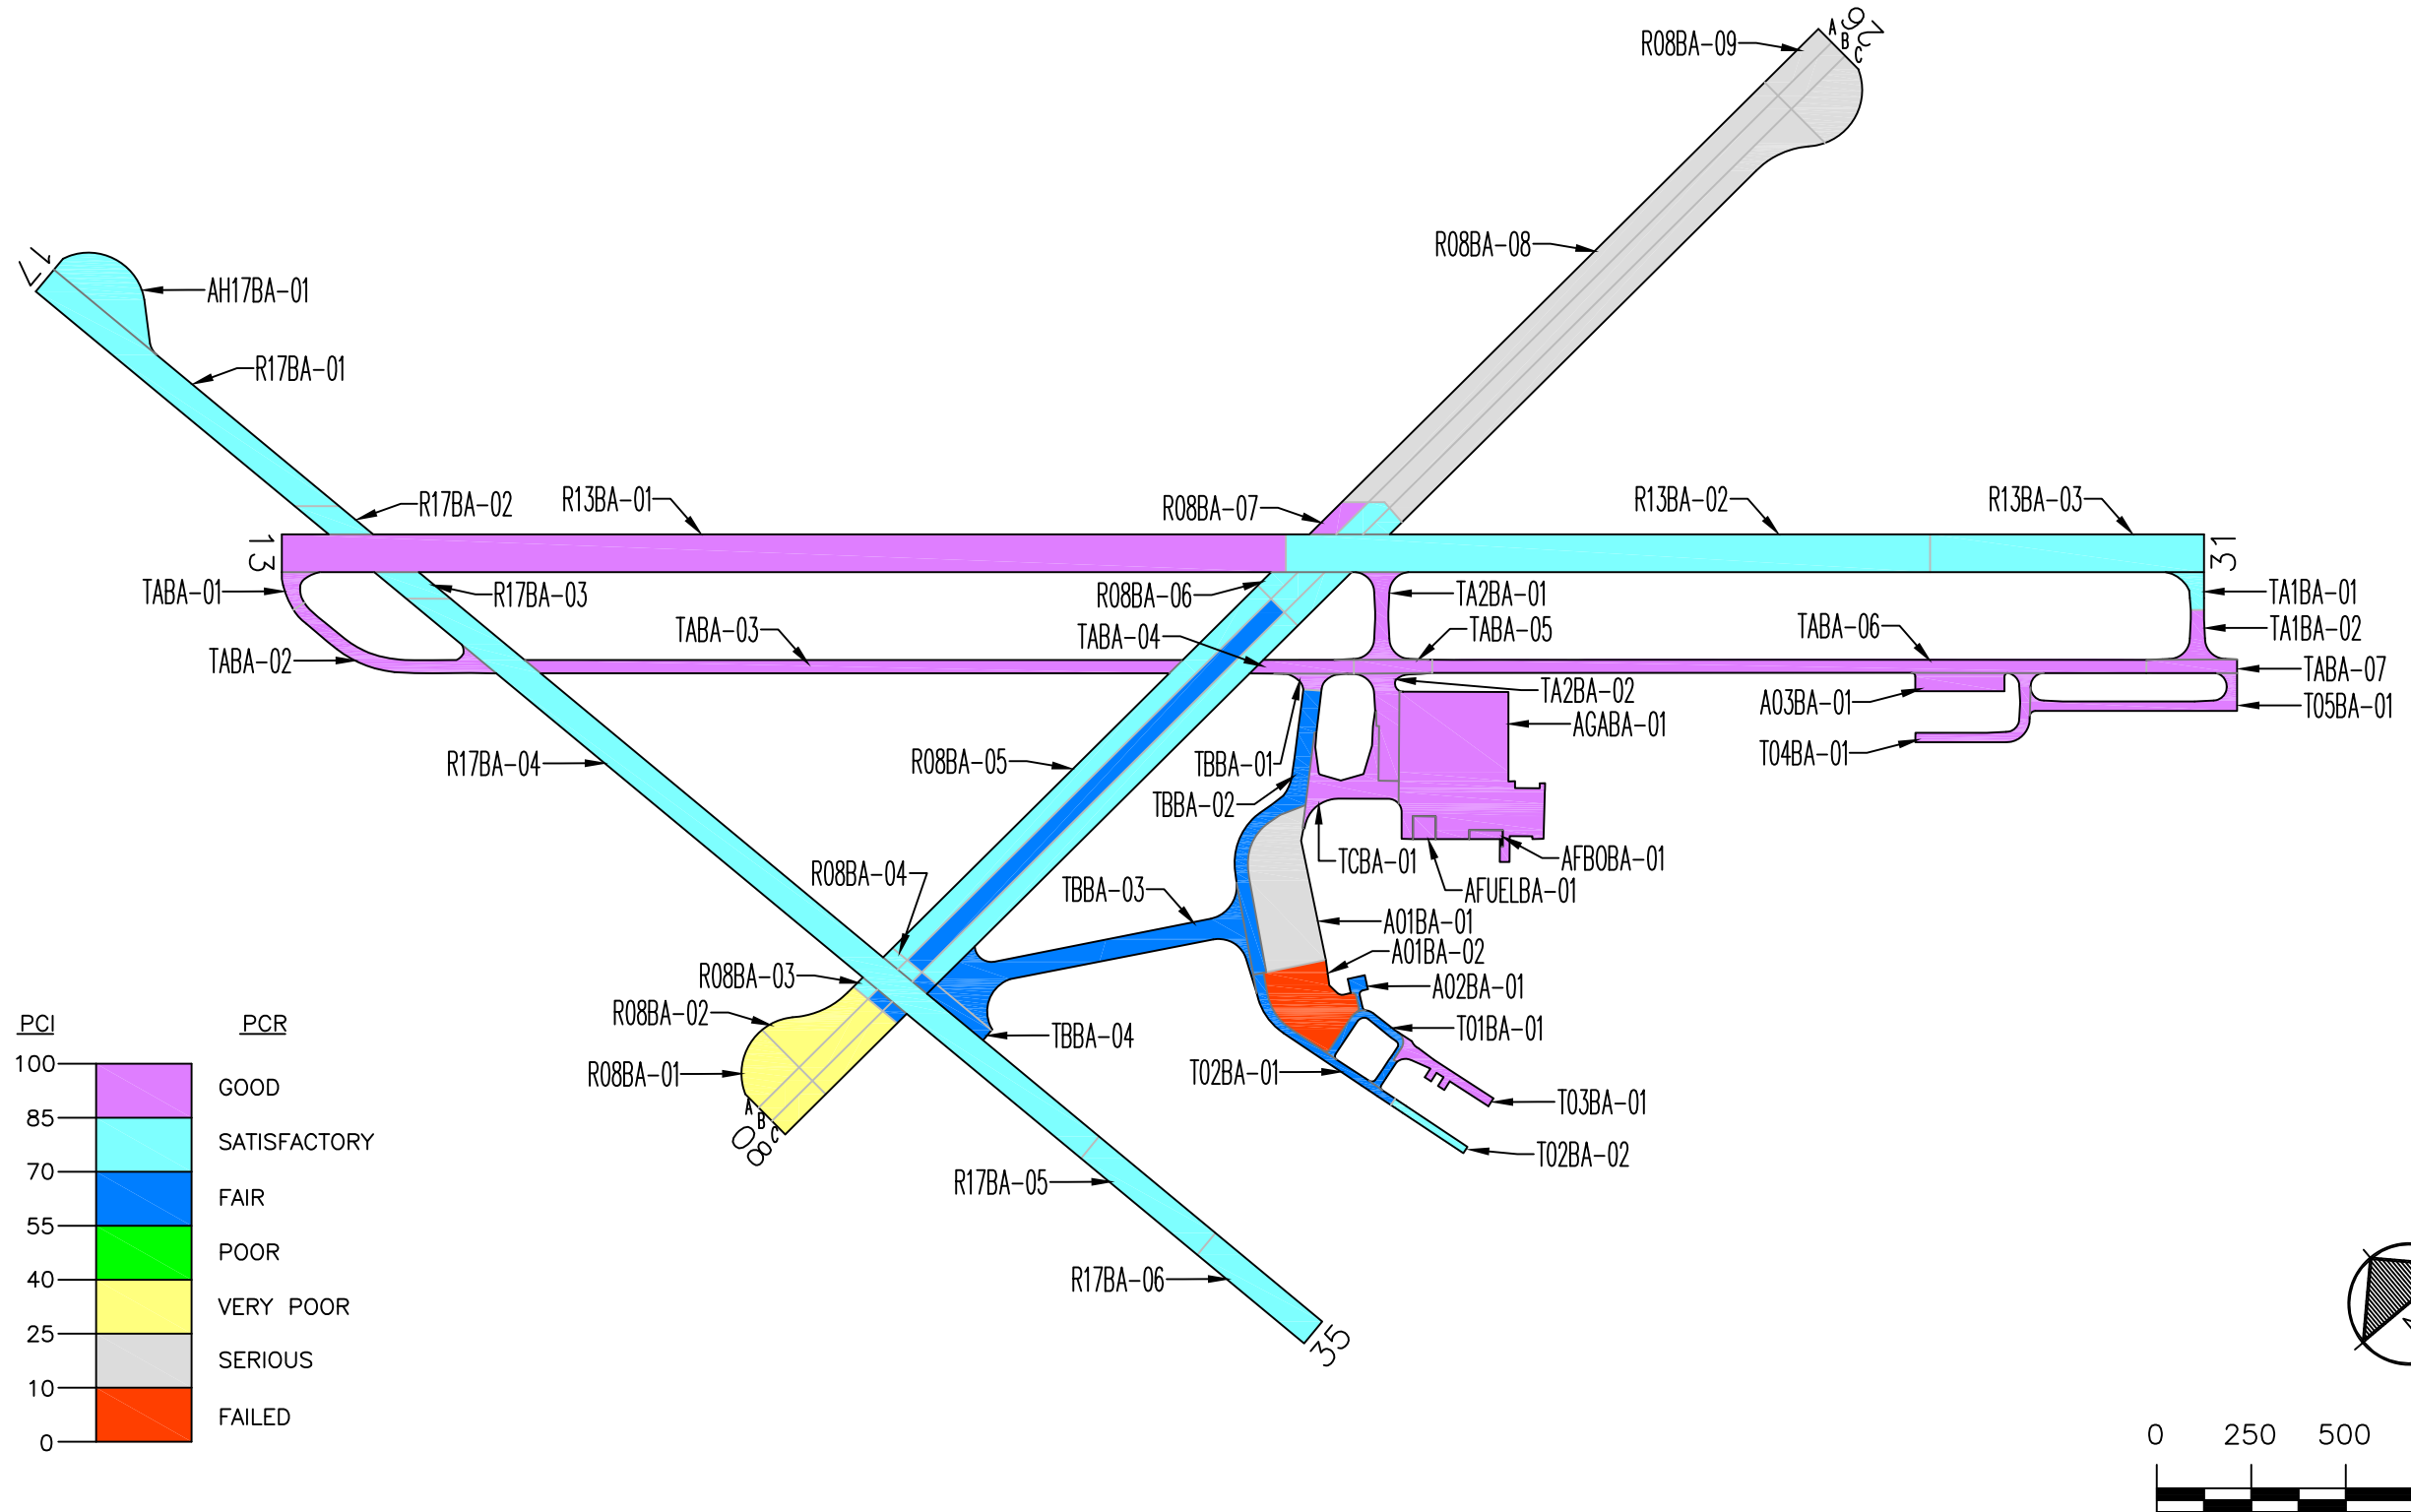
Figure BA-3. Pavement Condition in June 2017.  
Baker City Municipal Airport

Section PCIs at Baker City Municipal Airport range from a low of 6 (a PCR of “Failed”) to a high of 100 (a PCR of “Good”). The area-weighted average PCI for all airport pavements is 71, corresponding to an overall PCR of “Satisfactory”. Figure BA-4 shows how much pavement area is associated with each Pavement Condition Rating category and also shows pavement condition distribution from the inspections conducted in 2011 and 2014.

The primary distresses observed during the inspection of asphalt concrete pavements were: weathering, longitudinal and transverse cracking, block cracking, patching, and alligator cracking with isolated occurrences of bleeding and raveling. The concrete pavements are new and showed no distress.
