# BOARDMAN AIRPORT

Figure B0-1. Airport Layout, Dimensions and Pavement Cross-Sections.  
Boardman Airport

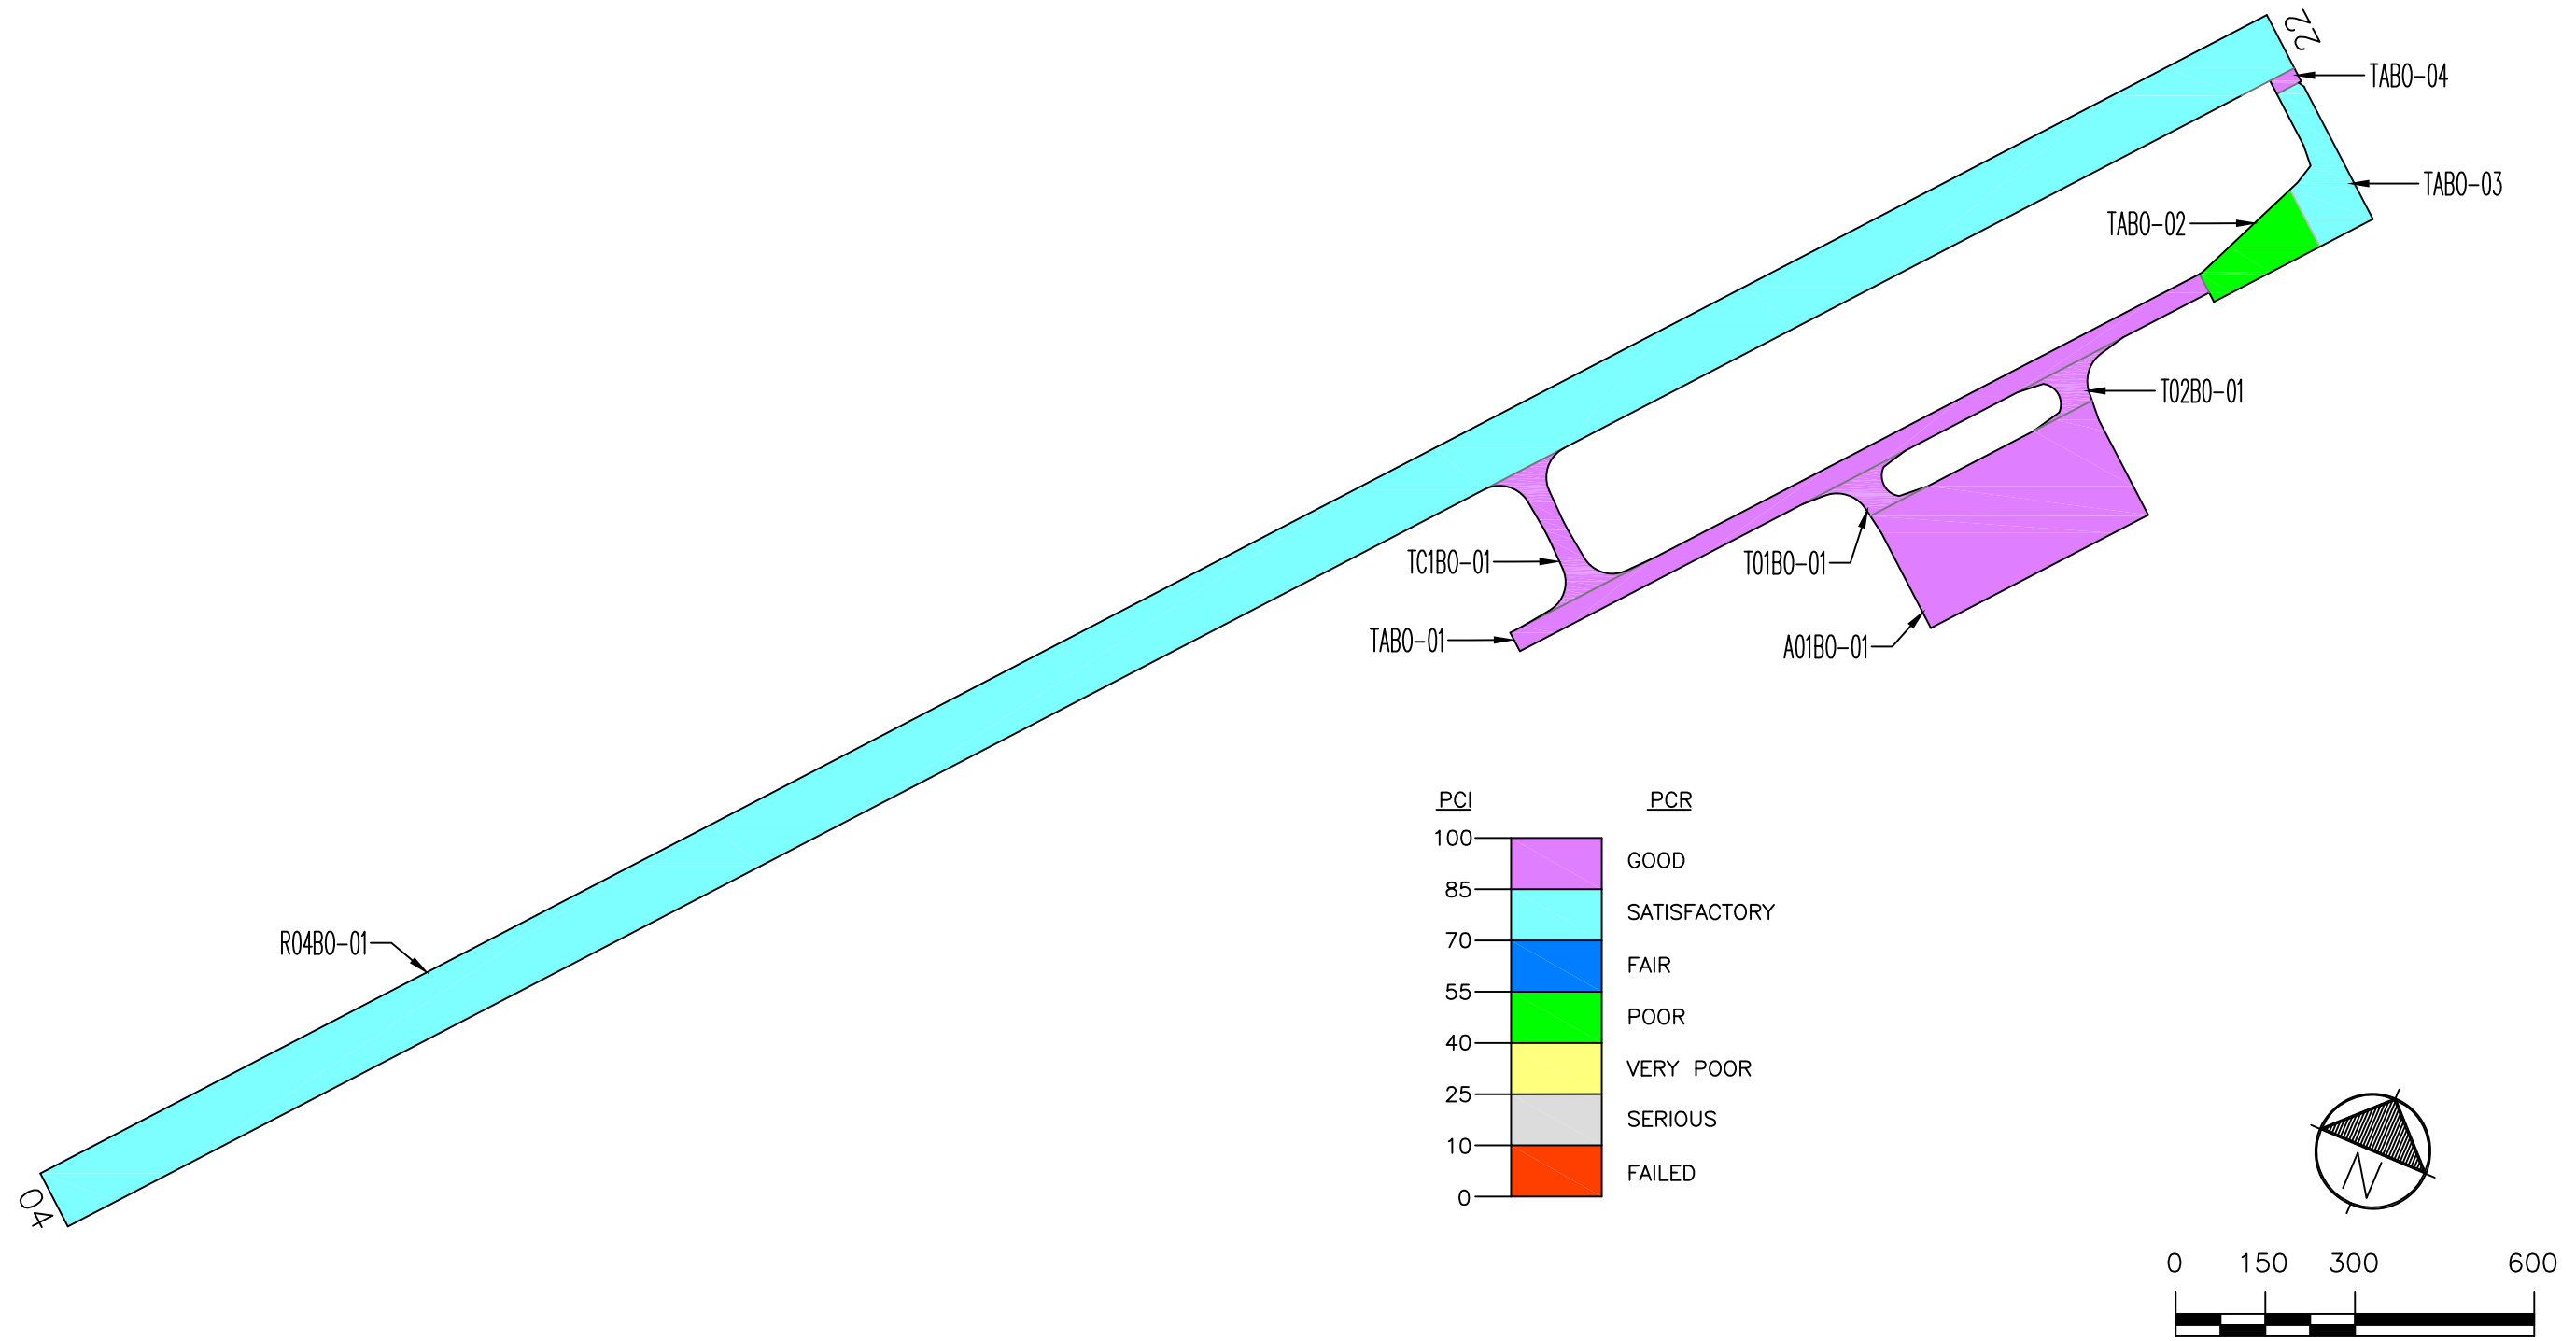
Figure B0-3. Pavement Condition in June 2017.  
Boardman Airport

The Branch Condition Report in Appendix 1 summarizes current pavement condition by branch while the Section Condition Report in Appendix 2 lists pavement condition by section. The current Pavement Condition Rating (PCR) is shown graphically in Figure BO-3.

Section PCIs at Boardman Airport range from a low of 47 (a PCR of “Poor”) to a high of 100 (a PCR of “Good”). The area-weighted average PCI for all airport pavements is 87, corresponding to an overall PCR of “Good”. Figure BO-4 shows how much pavement area is associated with each Pavement Condition Rating category and also shows pavement condition distribution from the inspections conducted in 2011 and 2014.

The primary distresses observed during the inspection were: longitudinal and transverse cracking, and weathering, with isolated occurrences of block cracking, raveling, patching and alligator cracking.

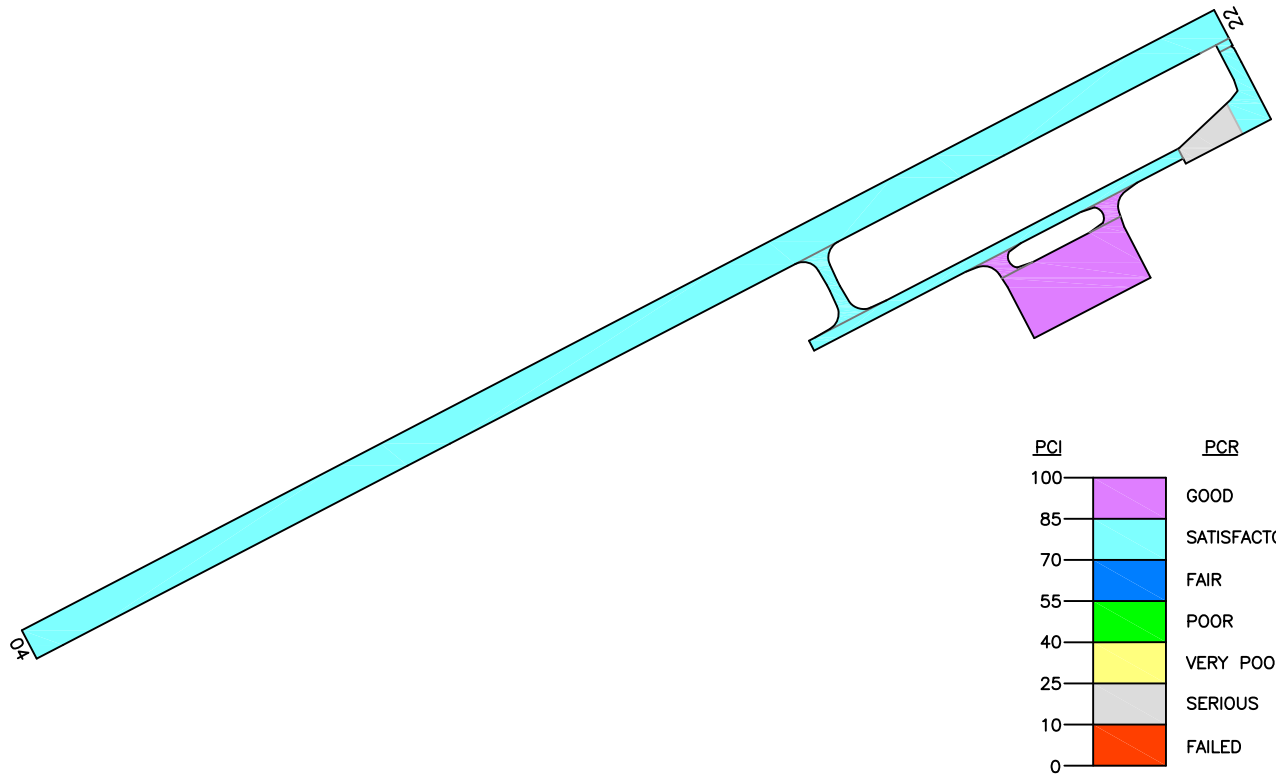
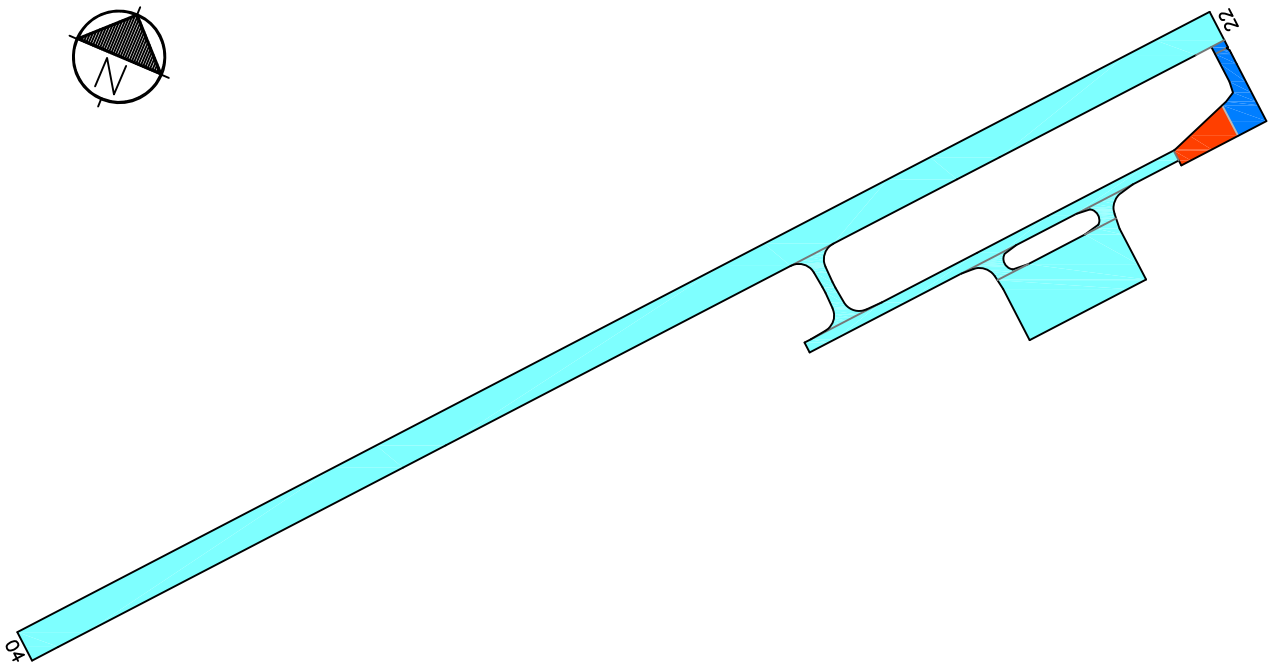
Figure BO-5. Future Pavement Condition.

A graphical representation of the projected PCIs listed in Table 1 is shown in Figure BO-5.
