# BURNS MUNICIPAL AIRPORT

## DATA COLLECTION

Using the branch, section and sample unit divisions established, a visual condition survey was conducted at Burns Municipal Airport in June 2017. During the inspection, pavement defects were identified and measured in accordance with the methodology outlined in ASTM D5430. This inspection ensures your airport complies with the “detailed inspection” requirement of FAA’s PMMP guidelines. After collection, the data were entered into the PAVER software for analysis. These data are reproduced in the Re-Inspection Report attached as Appendix 4.

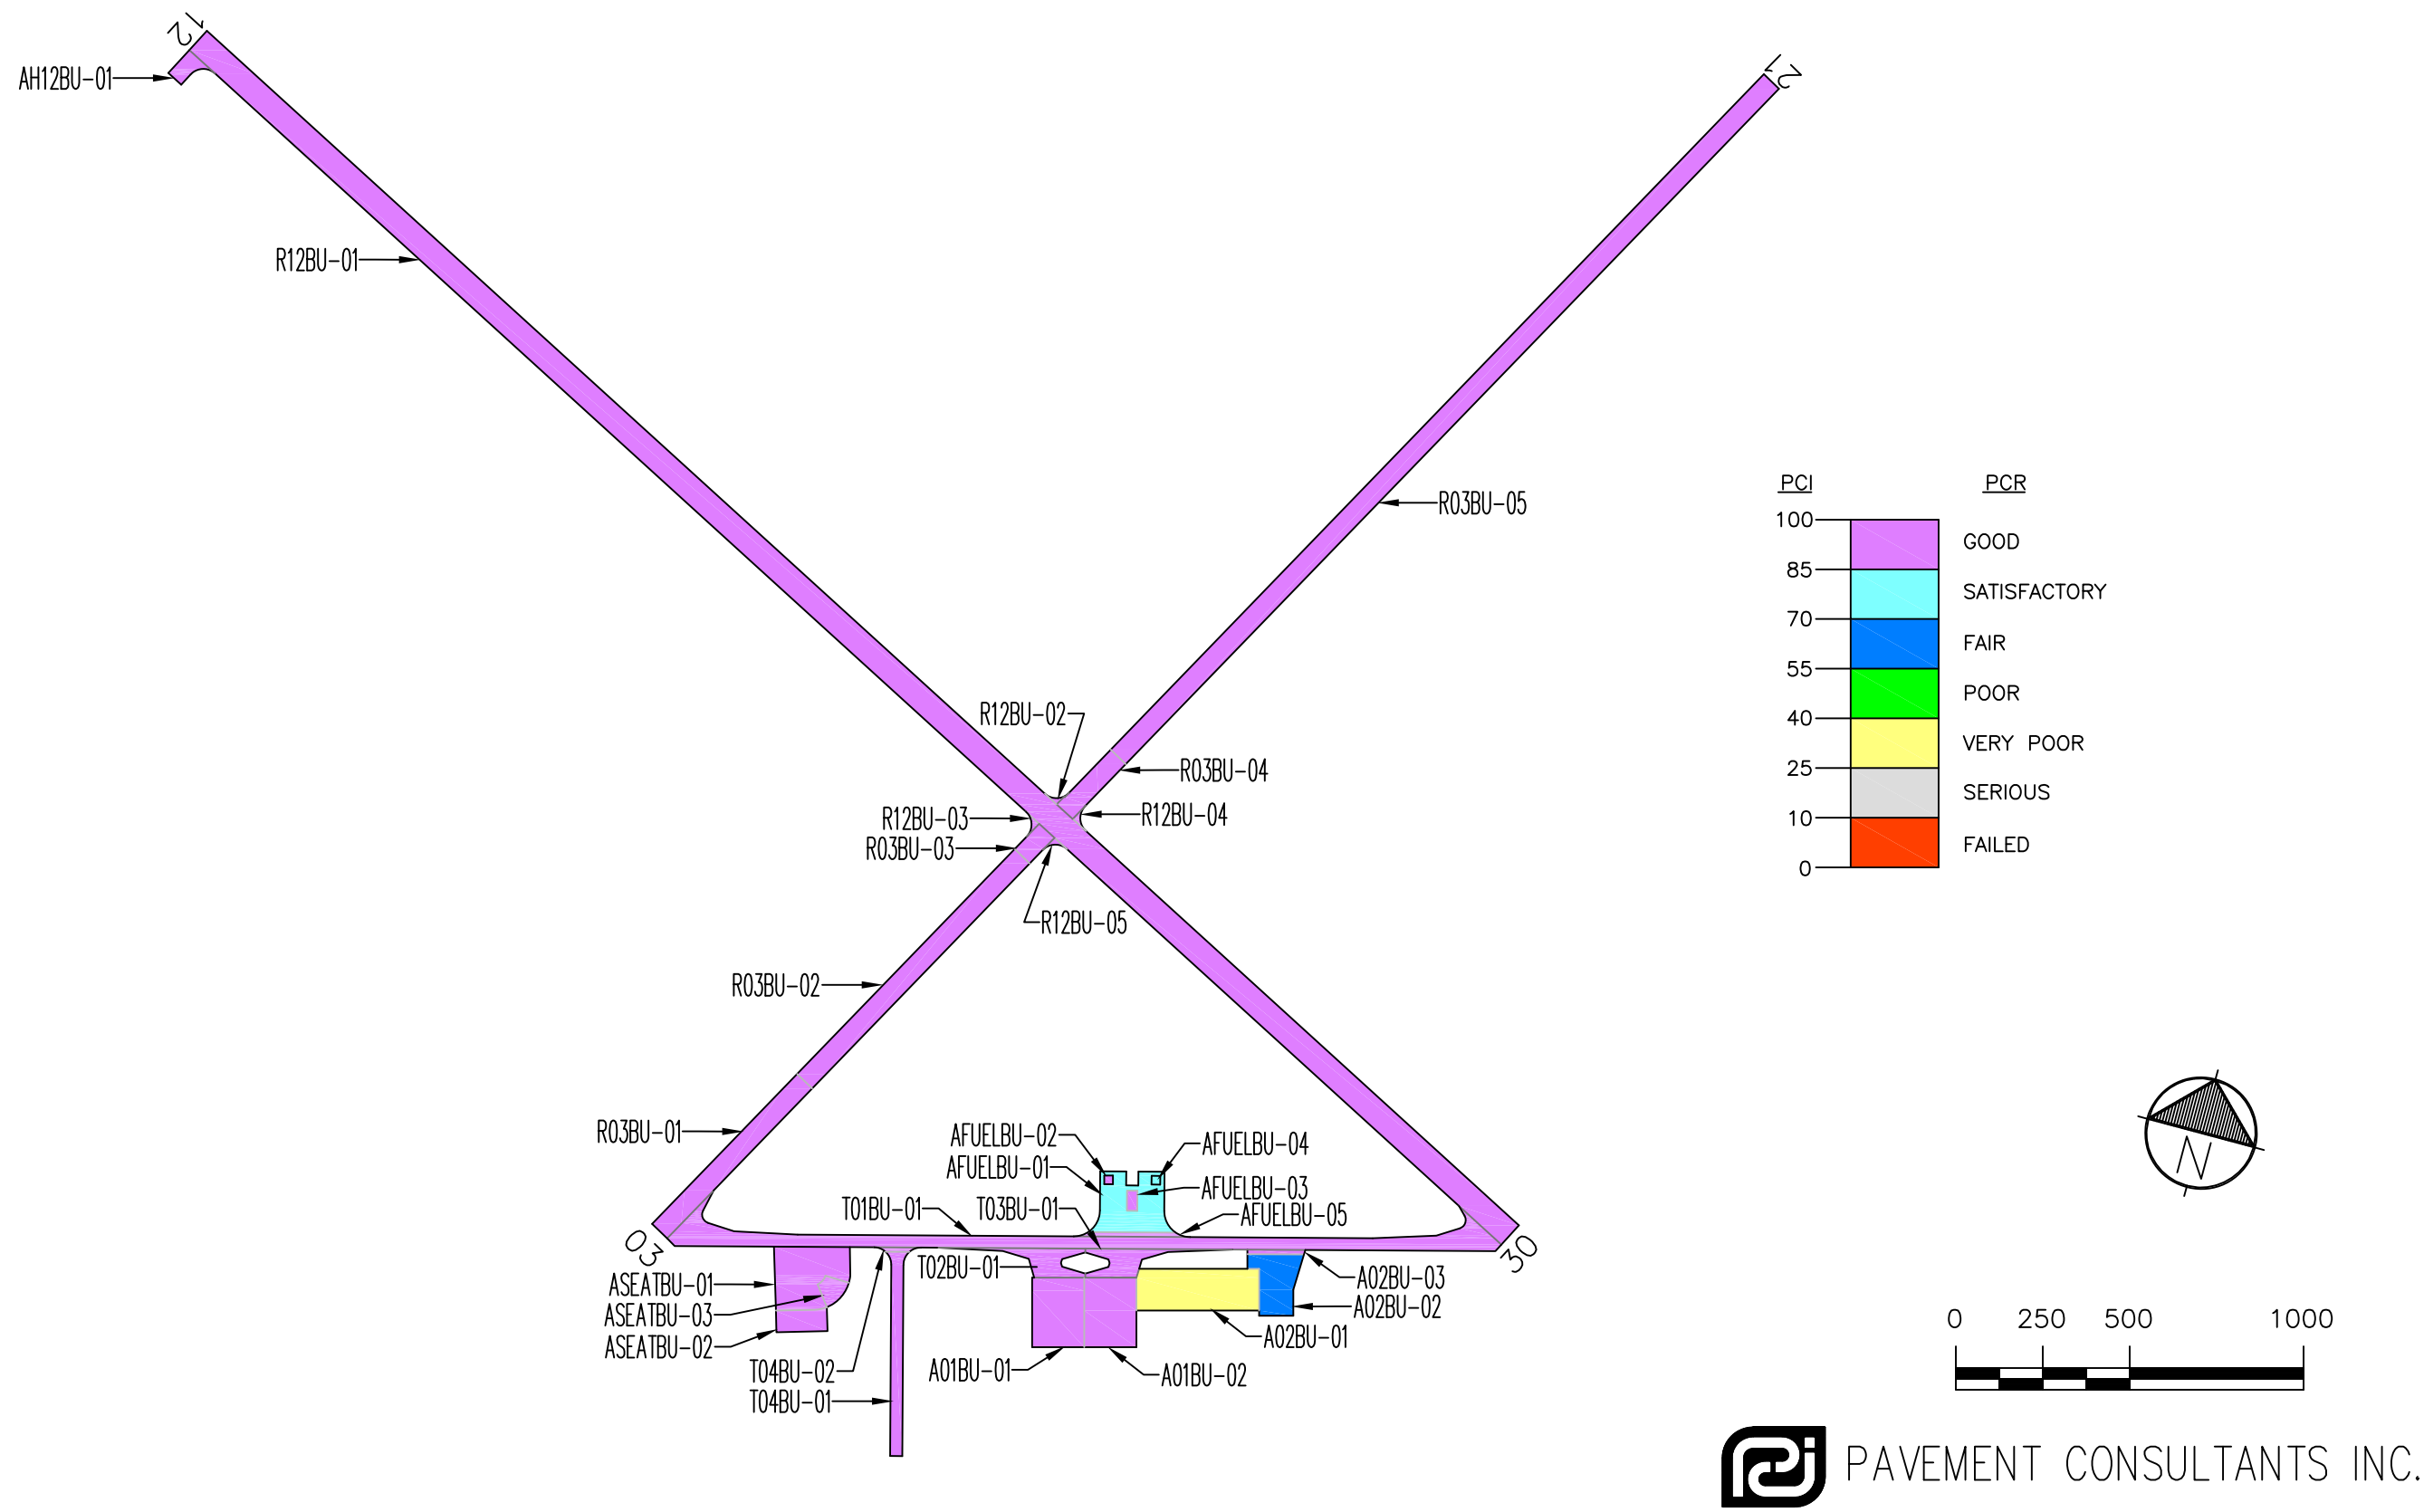
Figure BU-3. Pavement Condition in June 2017.  
Burns Municipal Airport

The Branch Condition Report in Appendix 1 summarizes current pavement condition by branch while the Section Condition Report in Appendix 2 lists pavement condition by section. The current Pavement Condition Rating (PCR) is shown graphically in Figure BU-3.

Section PCIs at Burns Municipal Airport range from a low of 31 (a PCR of “Very Poor”) to a high of 100 (a PCR of “Good”). The area-weighted average PCI for all airport pavements is 94, corresponding to an overall PCR of “Good”. Figure BU-4 shows how much pavement area is associated with each Pavement Condition Rating category and also shows pavement condition distribution from the inspections conducted in 2011 and 2014.

The primary distresses observed during the inspection of asphalt concrete pavements were: longitudinal and transverse cracking, depressions, and patching, with isolated occurrences of raveling, alligator cracking and weathering. The primary distresses observed during the inspection of portland cement concrete pavements were: corner spalls, joint spalls, small patches, linear cracks, corner breaks, and shrinkage cracks, with an isolated occurrence of faulting.

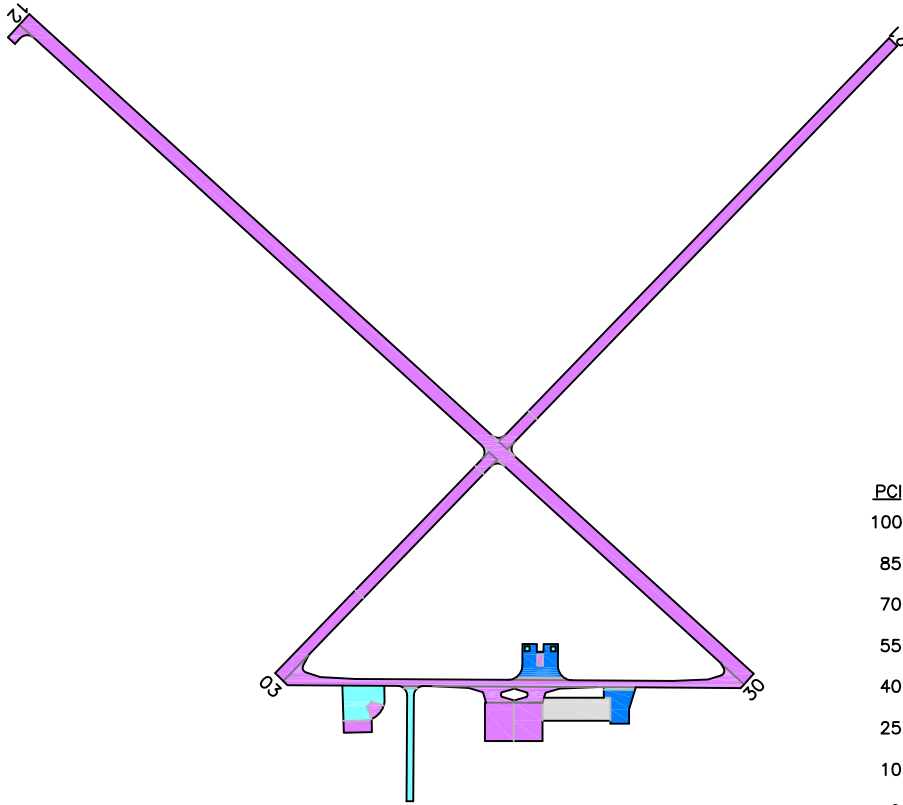
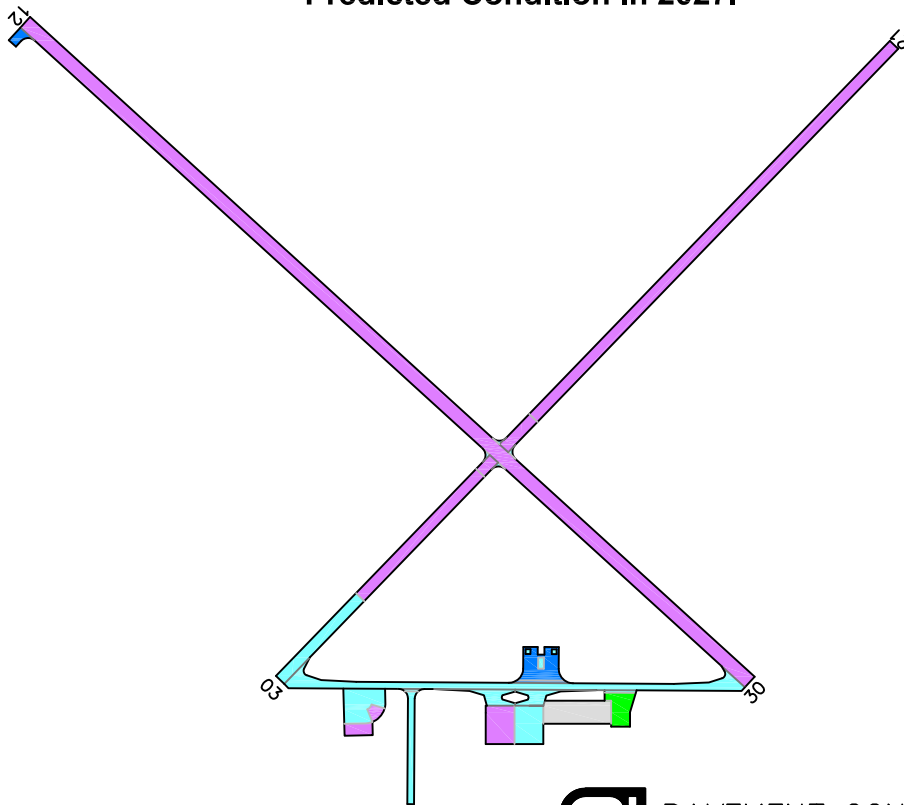
**Figure BU-5. Future Pavement Condition.**

A graphical representation of the projected PCIs listed in Table 1 is shown in Figure BU-5.
