COLUMBIA GORGE REGIONAL / THE DALLES MUNICIPAL AIRPORT

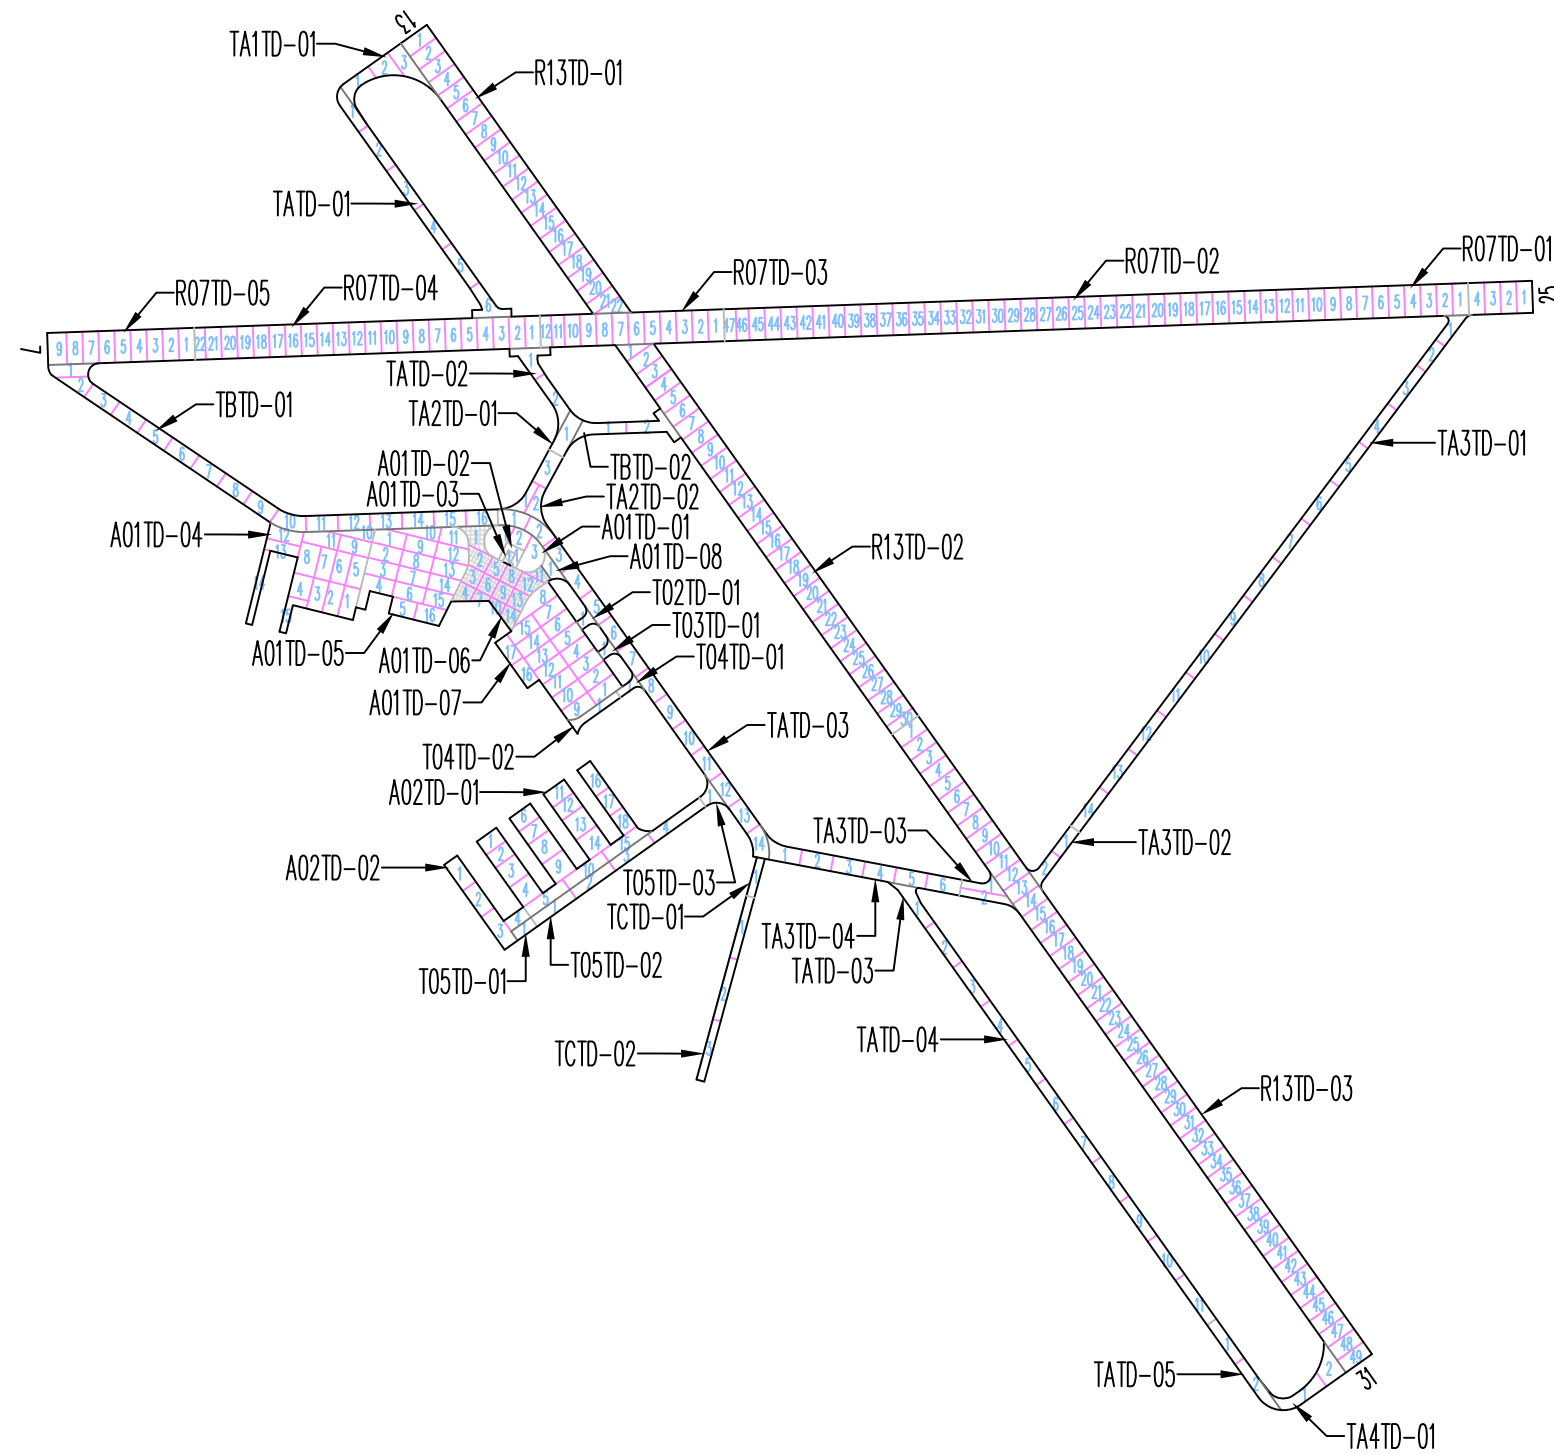
Figure TD-2. Pavement Branch, Section and Sample Unit Layout.
 Columbia Gorge Regional / The Dalles Municipal Airport

The pavements at your airport were divided into branches, sections and sample units in accordance with the methodology outlined in the current edition of ASTM D5430, *Standard Test Method for Airport Condition Index Surveys*. The branches, sections and sample units established at your airport are shown in Figure TD-2. A Branch Condition Report showing all branches, their associated areas, and their area-weighted average condition is provided in Appendix 1. Additionally, the Appendix 2 Section Condition Report provides information used to define each branch and section in the PAVER database.

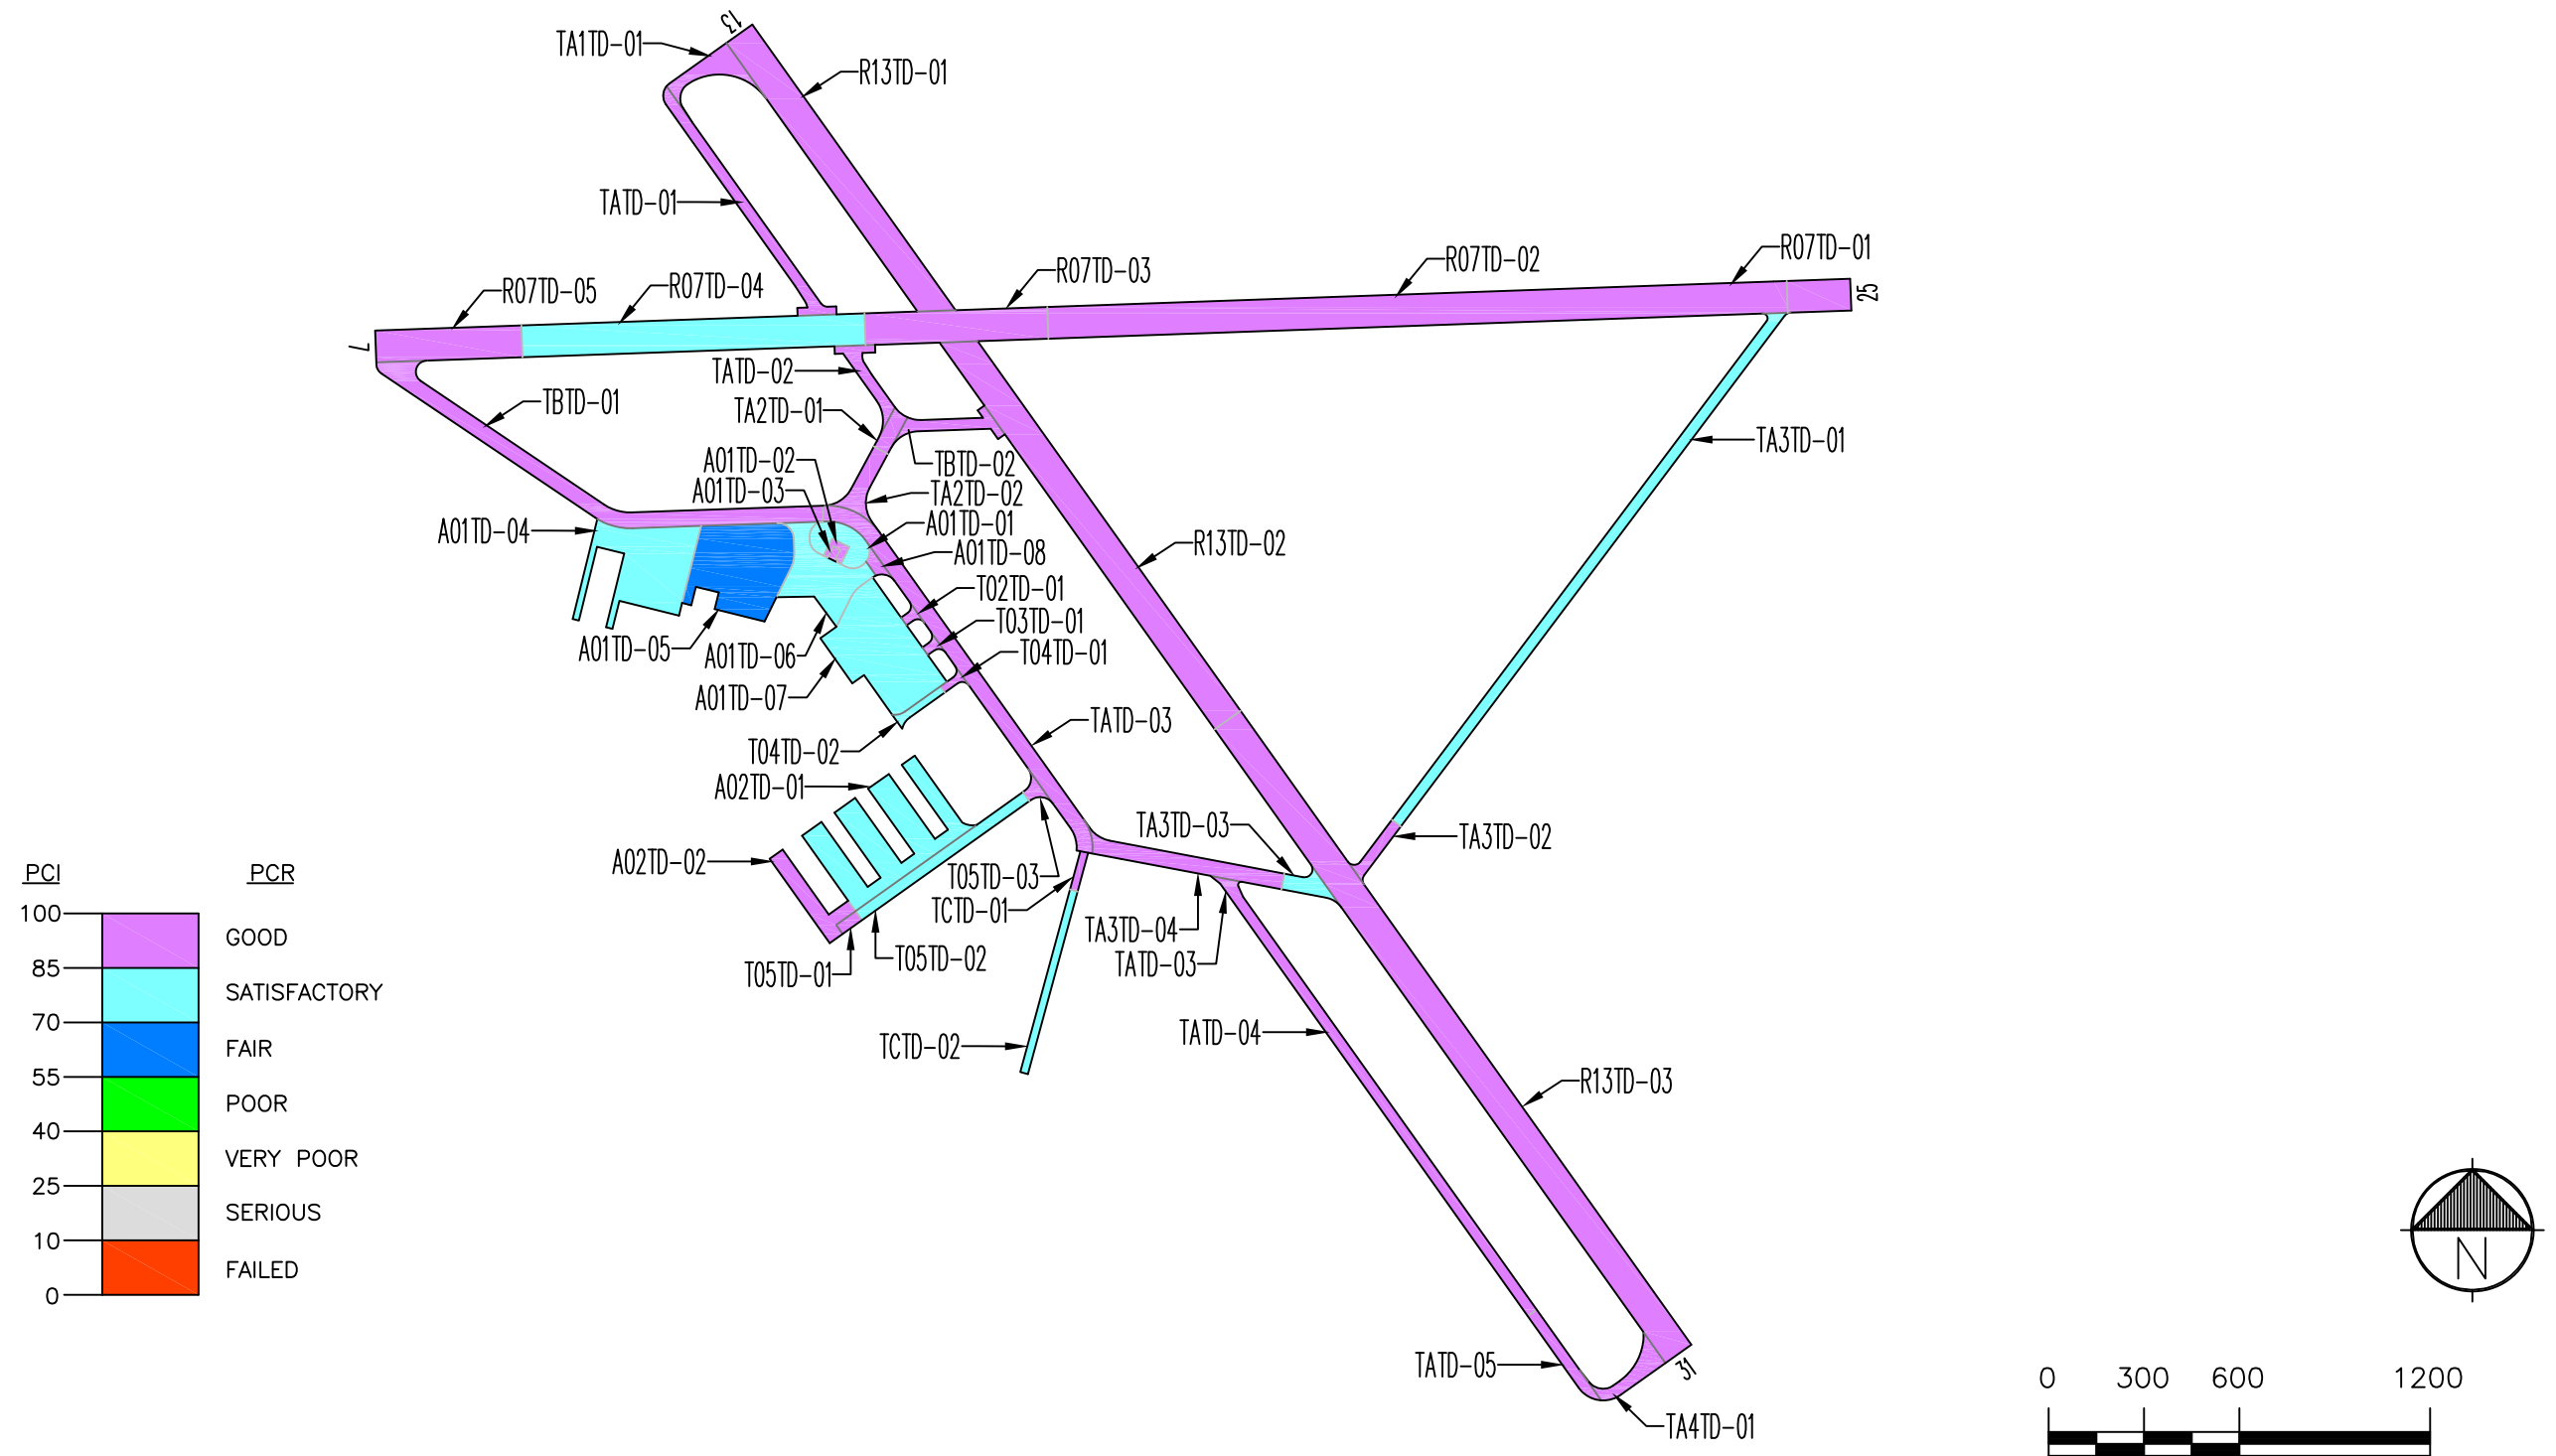
Figure TD-3. Pavement Condition in June 2017.
Columbia Gorge Regional / The Dalles Municipal Airport

The Branch Condition Report in Appendix 1 summarizes current pavement condition by branch while the Section Condition Report in Appendix 2 lists pavement condition by section. The current Pavement Condition Rating (PCR) is shown graphically in Figure TD-3.

Section PCIs at Columbia Gorge Regional / The Dalles Municipal Airport range from a low of 62 (a PCR of “Fair”) to a high of 100 (a PCR of “Good”). The area-weighted average PCI for all airport pavements is 90, corresponding to an overall PCR of “Good”. Figure TD-4 shows how much pavement area is associated with each Pavement Condition Rating category and also shows pavement condition distribution from the inspections conducted in 2011 and 2014.

The primary distresses observed during the inspection of asphalt concrete pavements were: longitudinal and transverse cracking, weathering, patching, and raveling, with isolated occurrences of block cracking and alligator cracking. The primary distresses observed during the inspection of portland cement concrete pavements were: small patches, linear cracks, large patches, joint seal damage, corner spalls, shrinkage cracks and faulting.

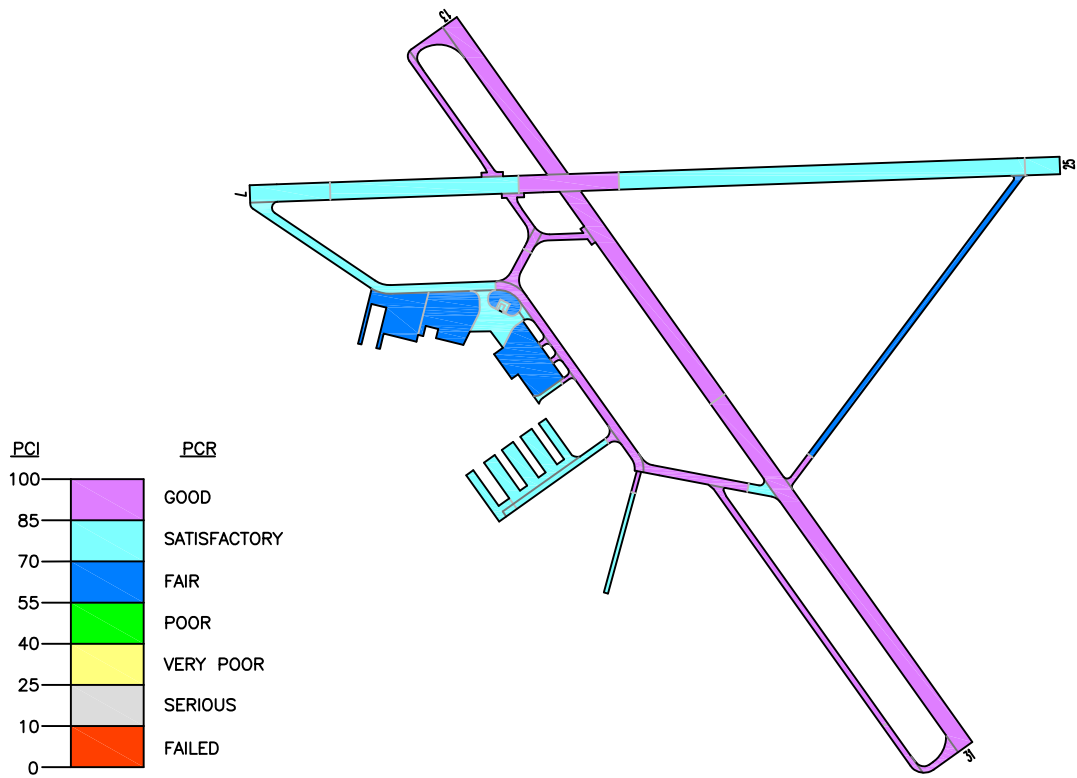
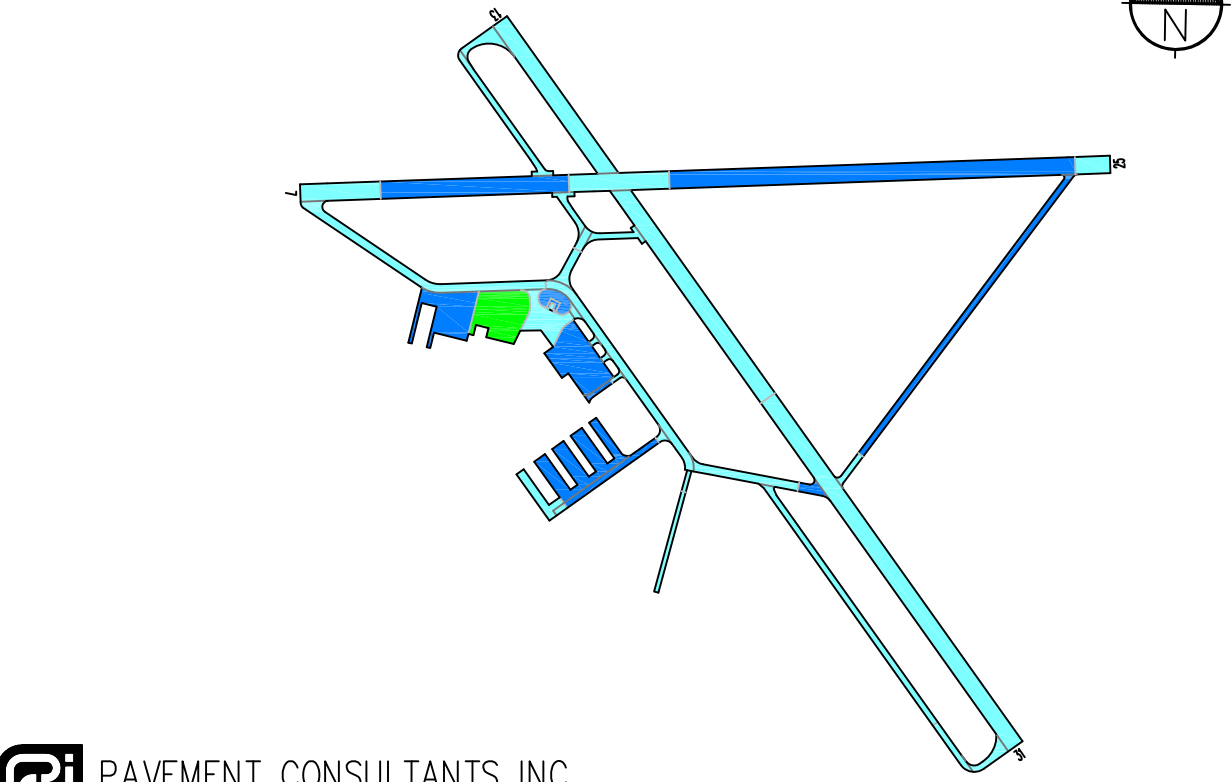
Figure TD-5. Future Pavement Condition.

A graphical representation of the projected PCIs listed in Table 1 is shown in Figure TD-5.
