CONDON STATE AIRPORT – PAULING FIELD

This report describes how your Pavement Maintenance Management Program (PMMP) was developed. Your Program was developed as part of the Oregon Continuous Aviation System Plan sponsored in part by the Oregon Department of Aviation and the Federal Aviation Administration (FAA). The information and data contained in this report ensures you comply with the requirements of FAA Grant Assurance Number 11 which states that any airport requesting federal funds for pavement improvement projects must have implemented a pavement maintenance management program.

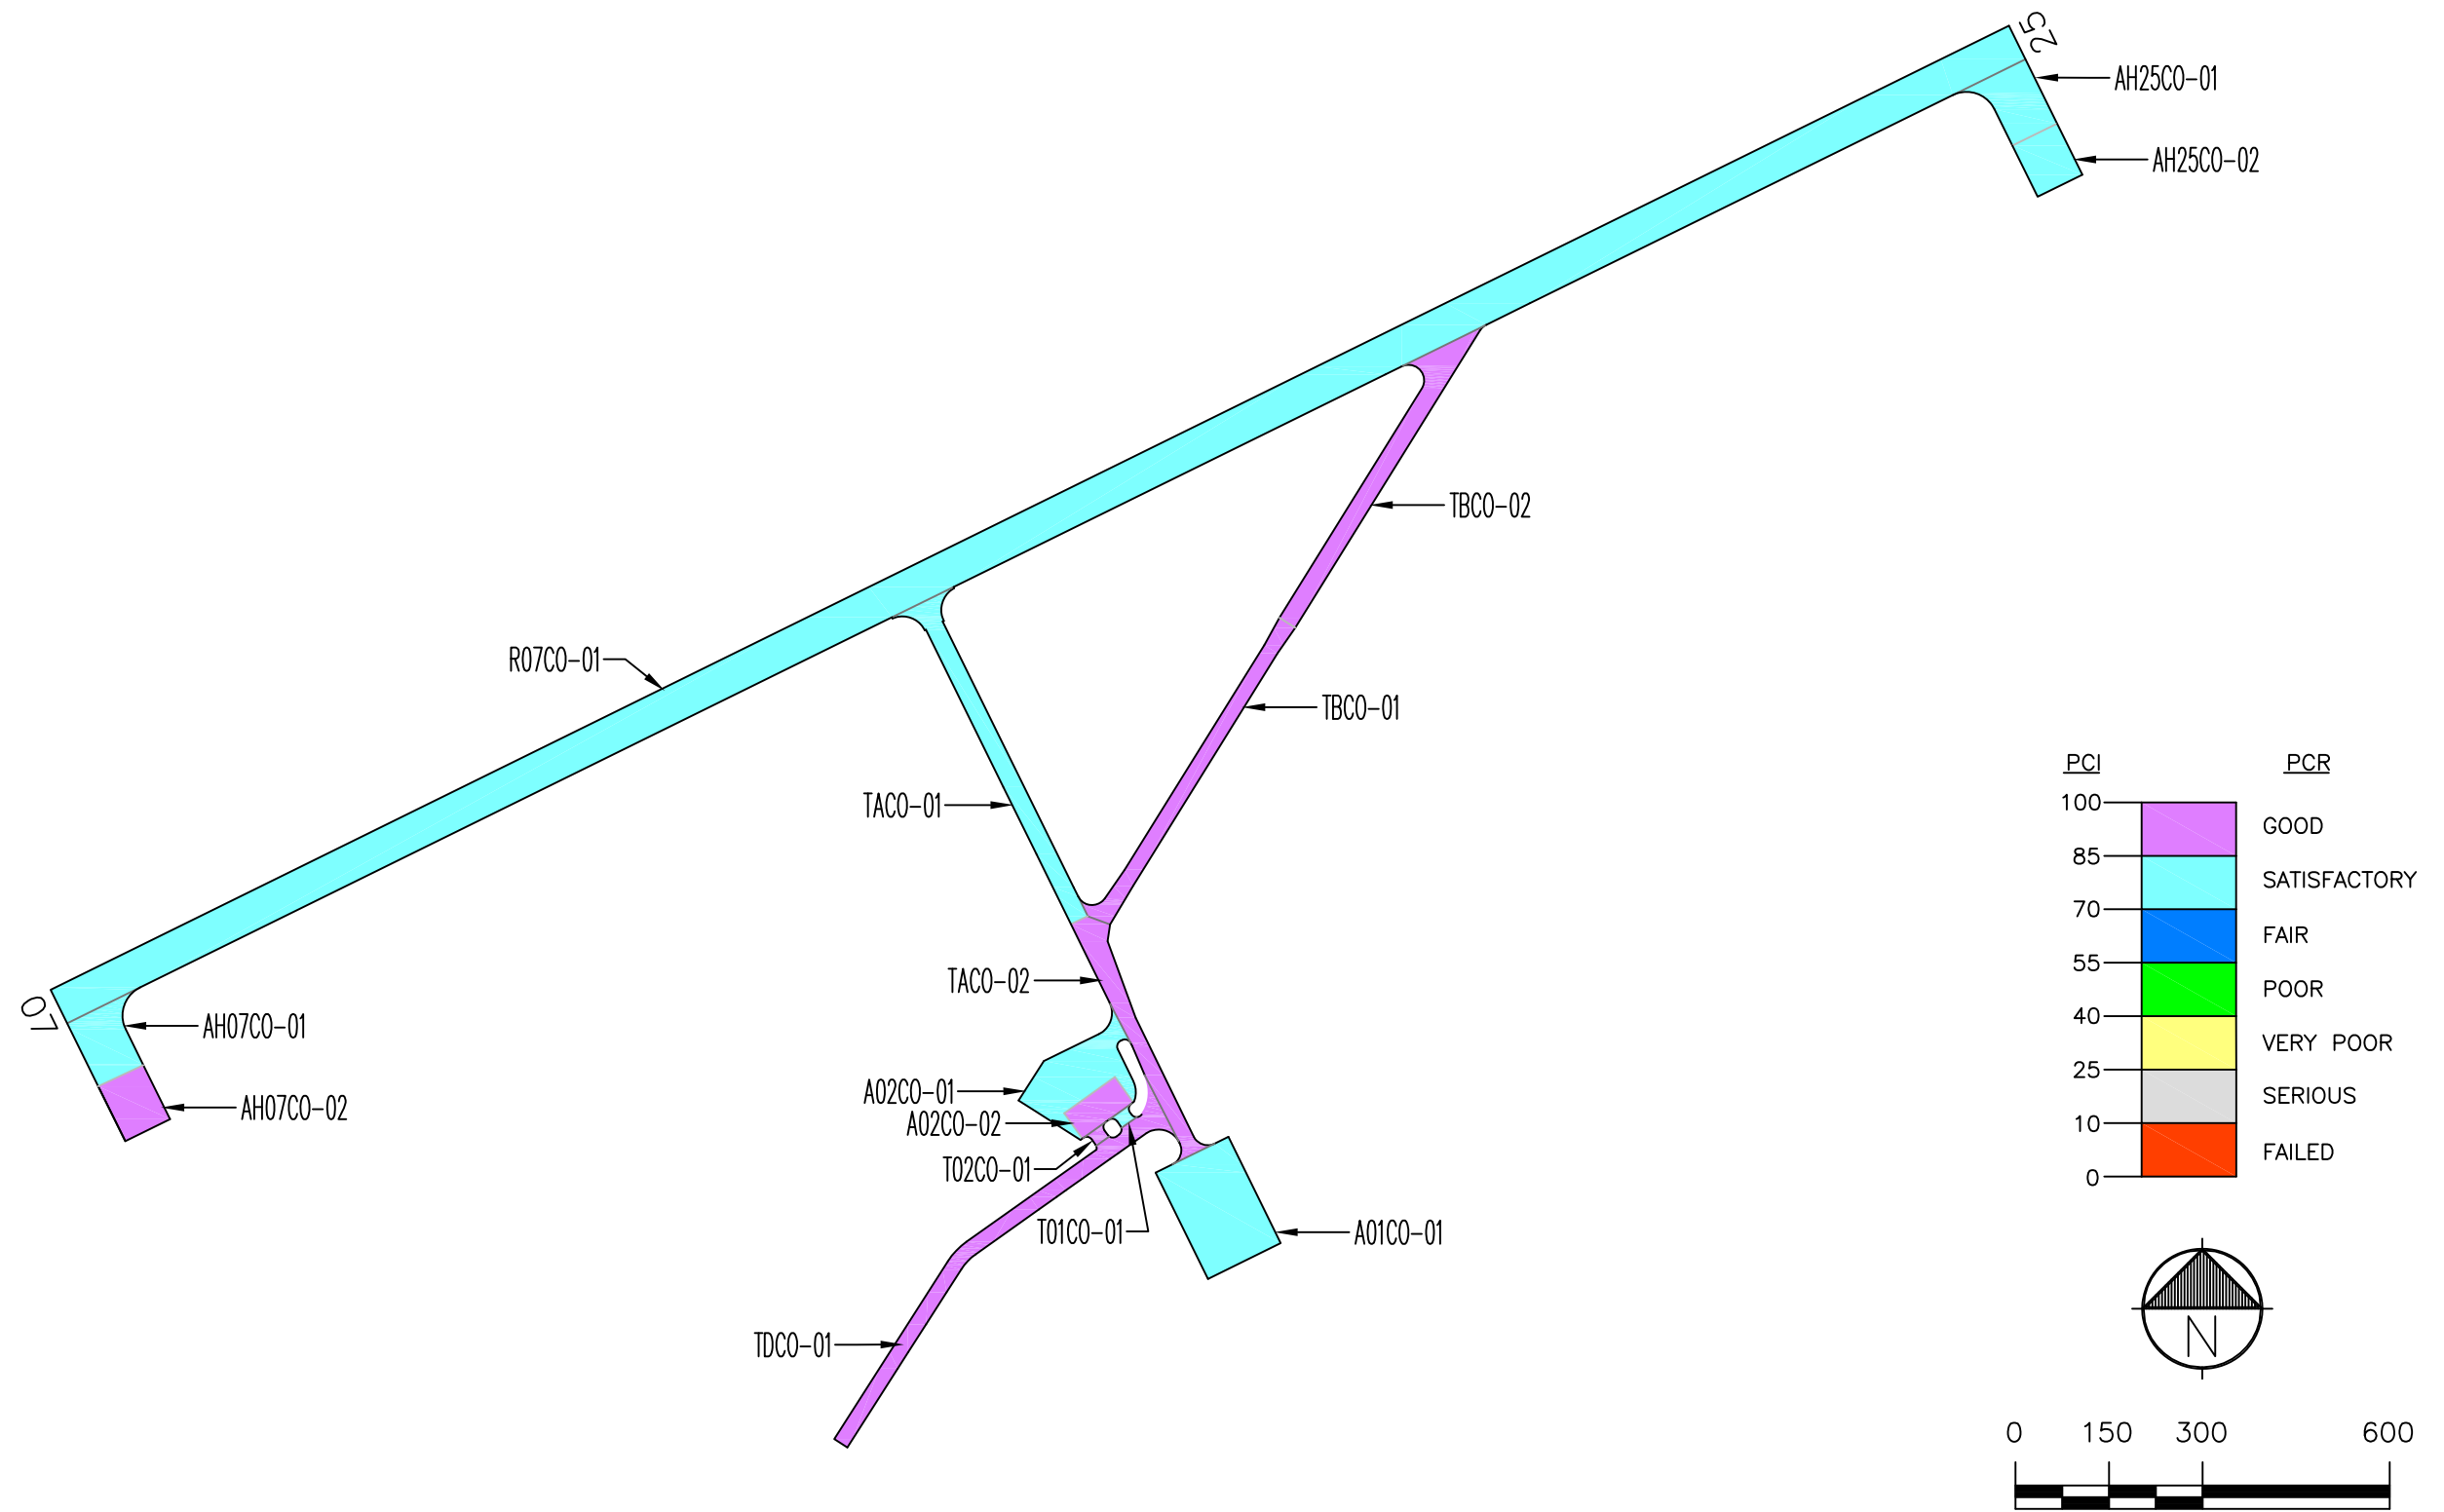
Figure CO-3. Pavement Condition in June 2017.
 Condon State Airport – Pauling Field

The Branch Condition Report in Appendix 1 summarizes current pavement condition by branch while the Section Condition Report in Appendix 2 lists pavement condition by section. The current Pavement Condition Rating (PCR) is shown graphically in Figure CO-3.

Section PCIs at Condon State Airport range from a low of 74 (a PCR of "Satisfactory") to a high of 100 (a PCR of "Good"). The area-weighted average PCI for all airport pavements is 79, corresponding to an overall PCR of "Satisfactory". Figure CO-4 shows how much pavement area is associated with each Pavement Condition Rating category and also shows pavement condition distribution from the inspections conducted in 2011 and 2014.

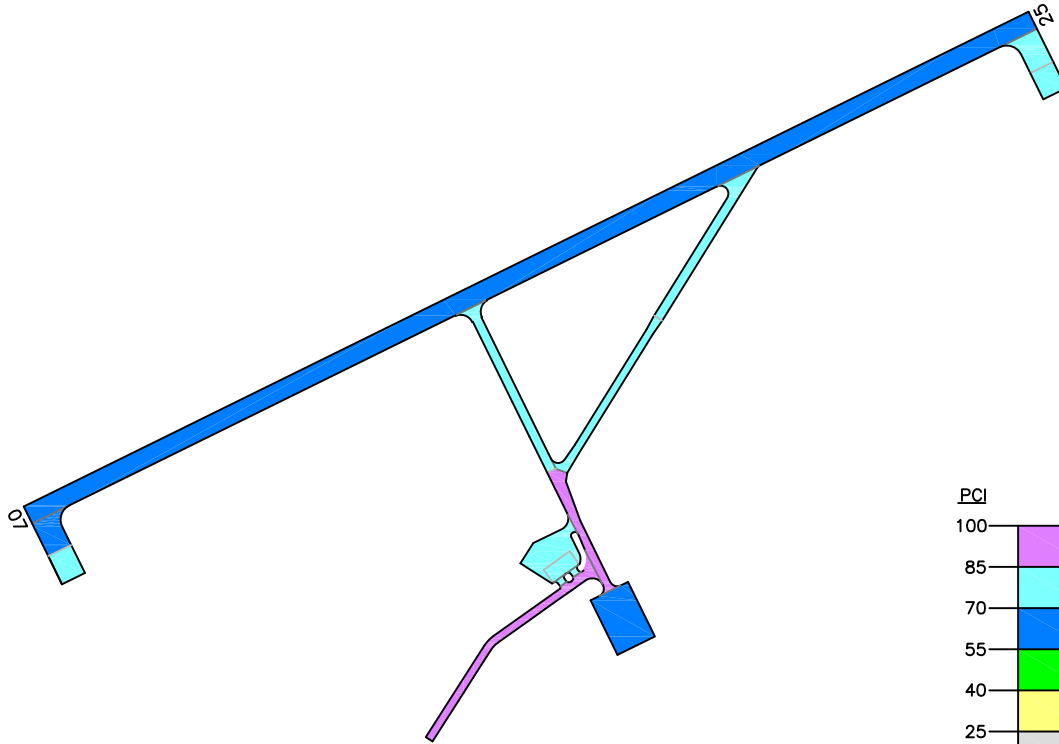
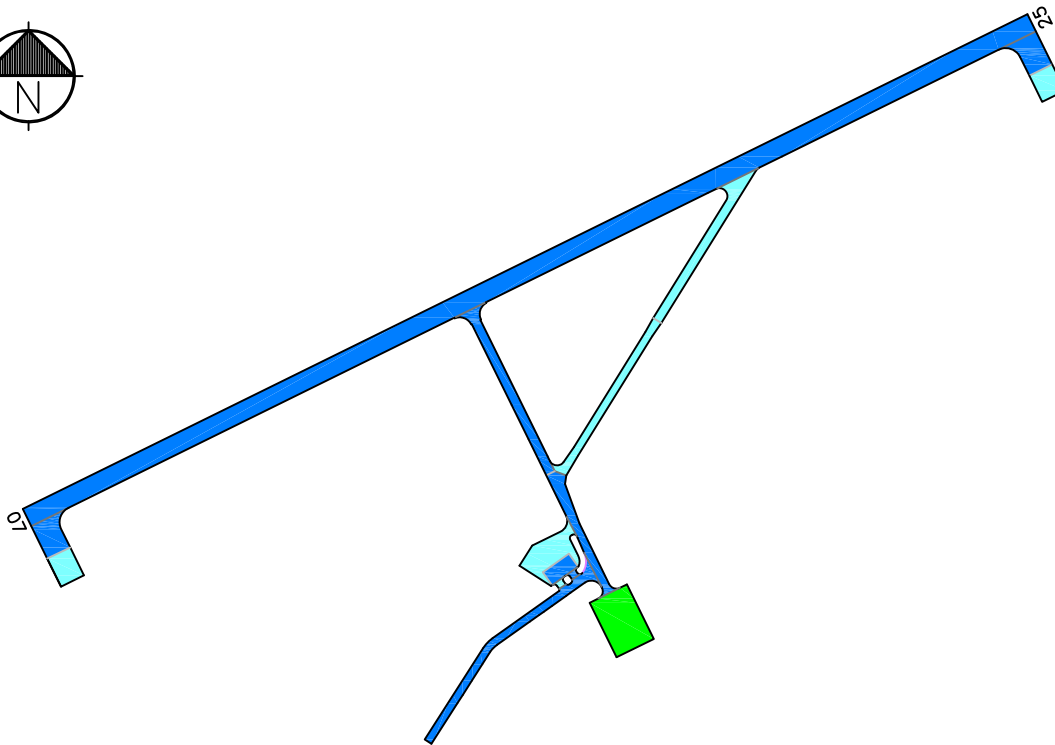
Figure CO-5. Future Pavement Condition.

A graphical representation of the projected PCIs listed in Table 1 is shown in Figure CO-5.
