ENTERPRISE MUNICIPAL AIRPORT

Figure EN-1. Airport Layout, Dimensions and Pavement Cross-Sections.
Enterprise Municipal Airport

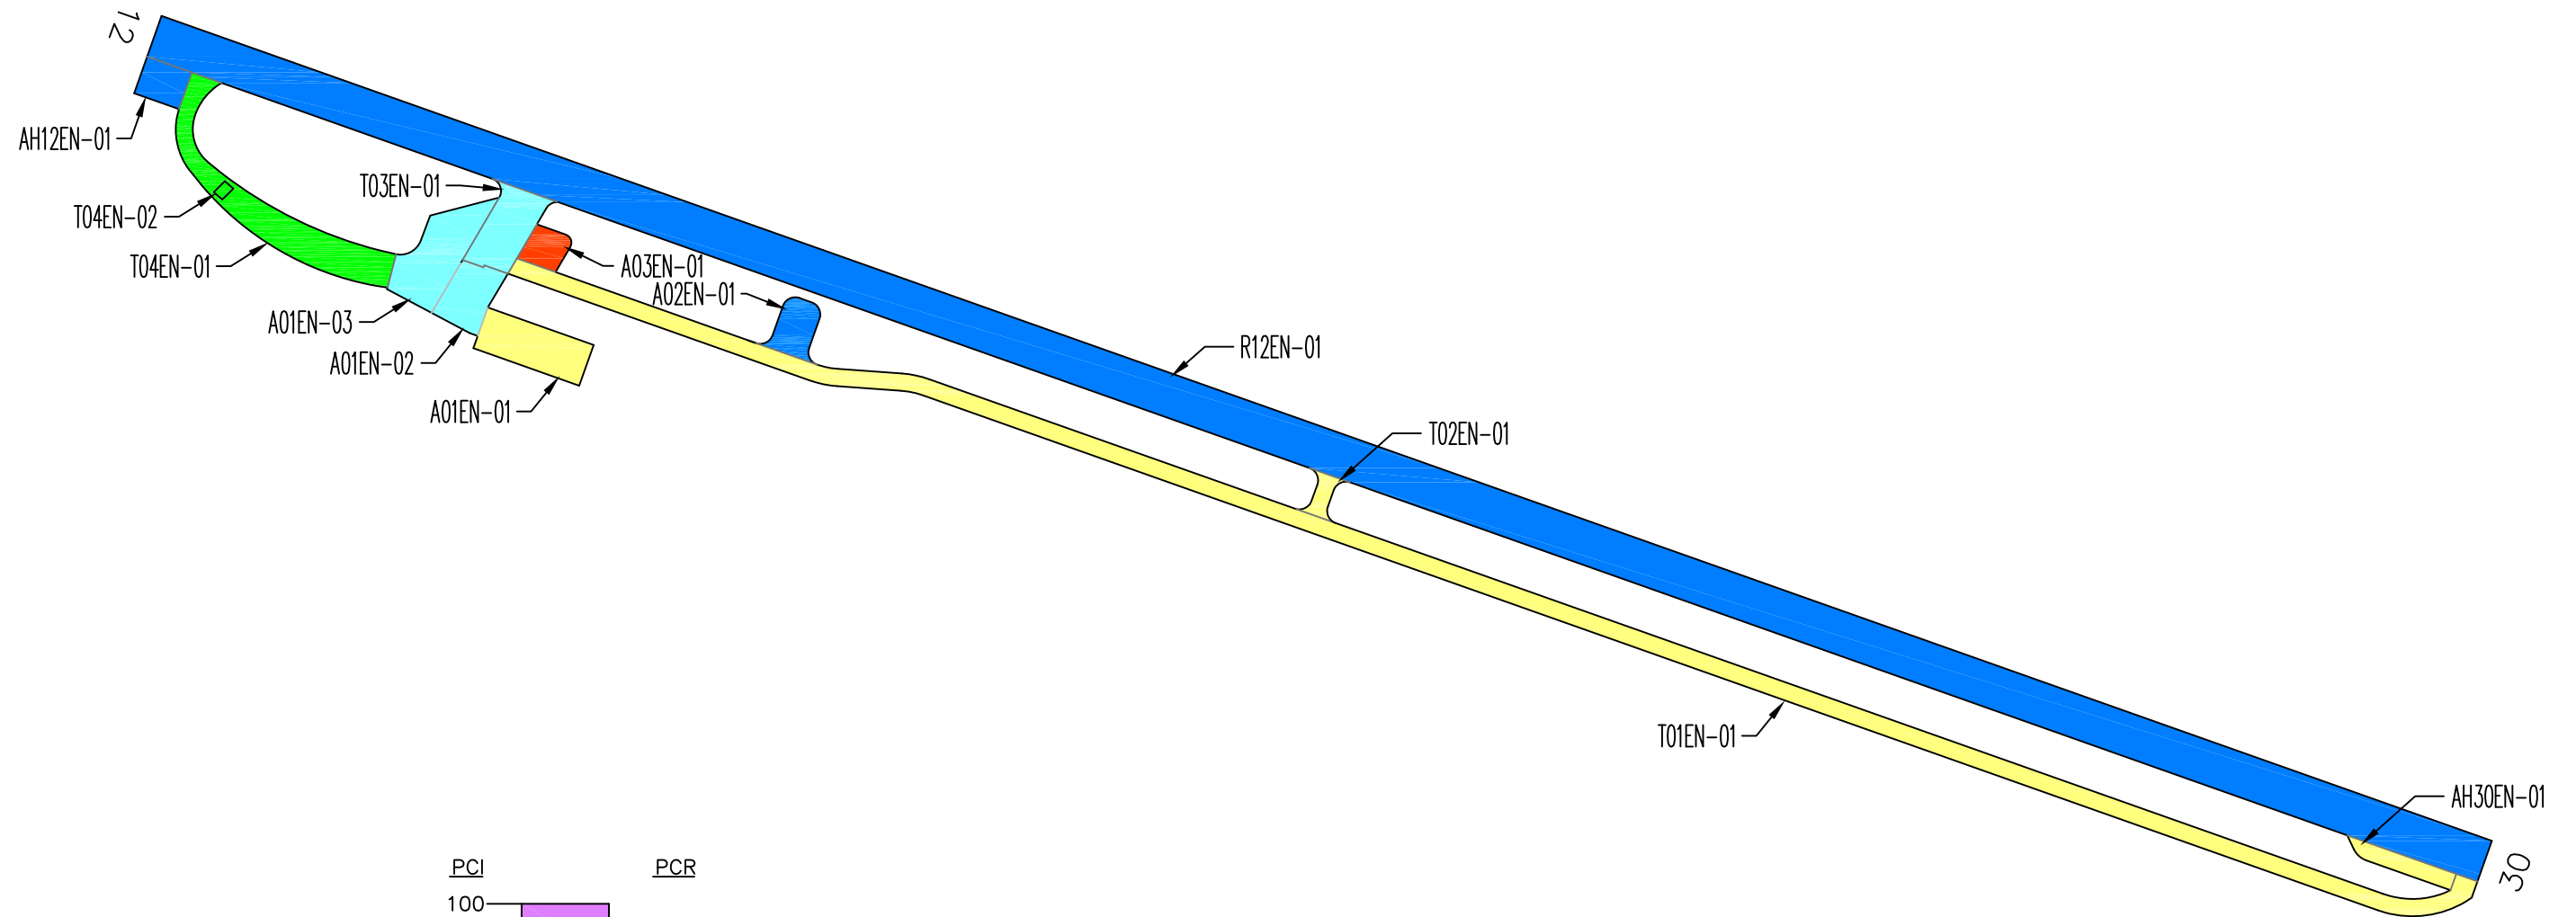
Figure EN-3. Pavement Condition in June 2017.
Enterprise Municipal Airport

Section PCIs at Enterprise Municipal Airport range from a low of 1 (a PCR of “Failed”) to a high of 78 (a PCR of “Satisfactory”). The area-weighted average PCI for all airport pavements is 52, corresponding to an overall PCR of “Poor”. Figure EN-4 shows how much pavement area is associated with each Pavement Condition Rating category and also shows pavement condition distribution from the inspections conducted in 2011 and 2014.

The primary distresses observed during the inspection of asphalt concrete pavements were: longitudinal and transverse cracking, alligator cracking, depressions, weathering, patching, raveling, block cracking and bleeding. The primary distress observed during the inspection of the portland cement concrete pavement was shattered slab.

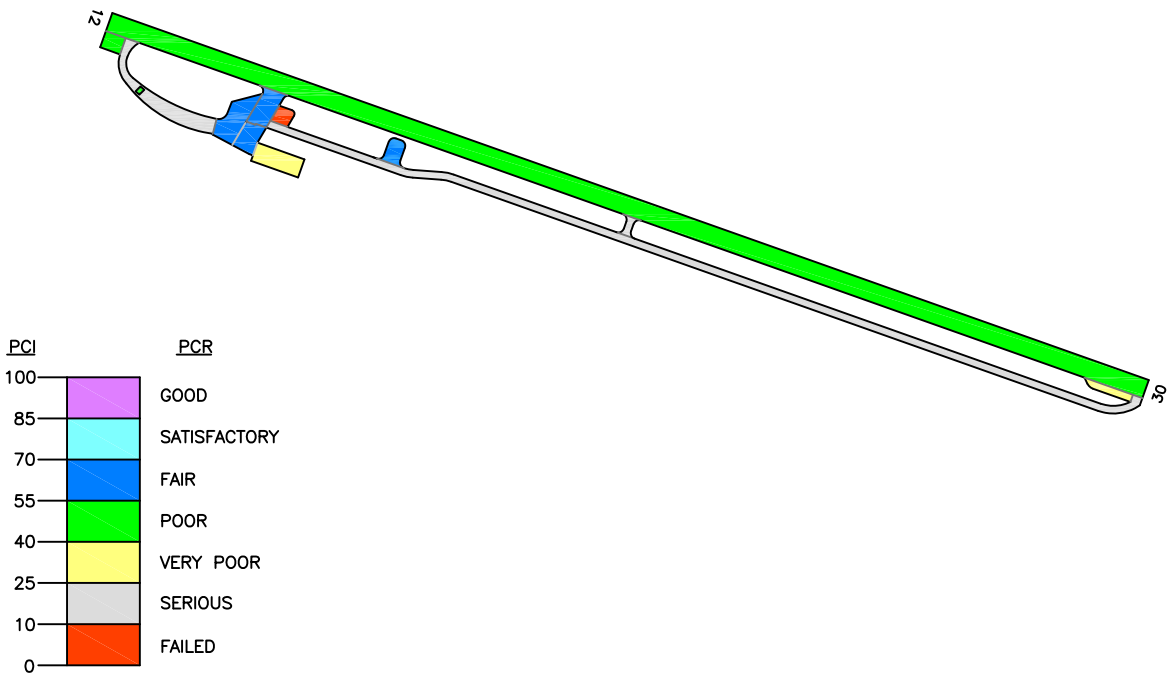
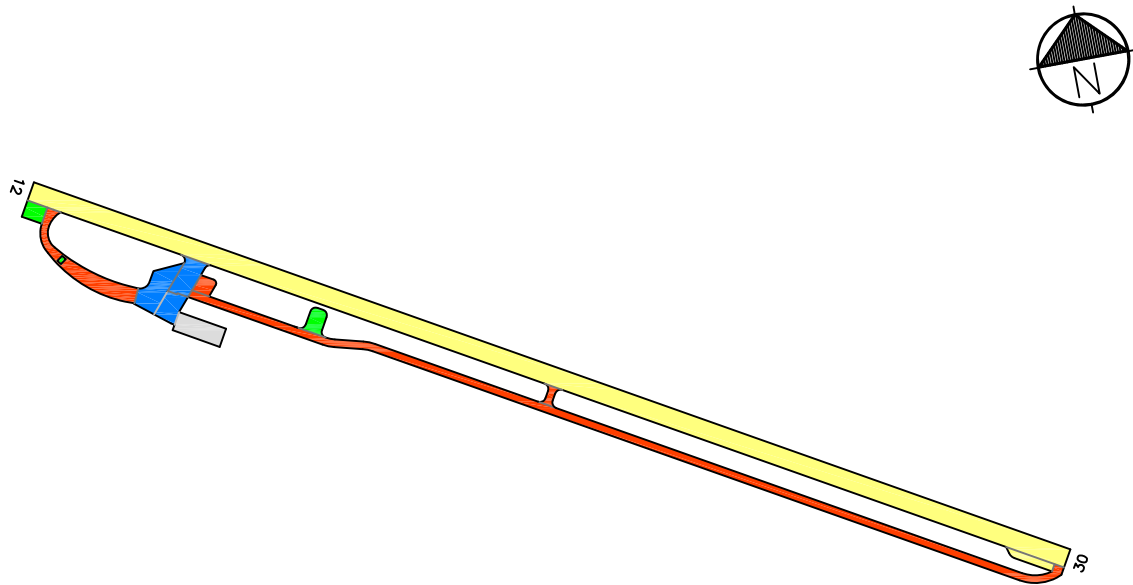
Figure EN-5. Future Pavement Condition.

Branch	Section	Inspections			Forecast	
		2011	2014	2017	2022	2027
A01EN	01	81	58	27	26	25
A01EN	02	85	67	71	66	63
A01EN	03	90	79	78	68	59
A02EN	01	91	78	68	59	53
A03EN	01	15	5	1	1	0
AH12EN	01	70	66	59	52	47
AH30EN	01	51	39	31	31	30
R12EN	01	64	55	57	45	33
T01EN	01	77	65	36	18	0
T02EN	01	52	46	33	15	0
T03EN	01	59	66	71	67	66
T04EN	01	69	46	43	25	7
T04EN	02	43	43	43	43	42
