# GRANT COUNTY REGIONAL AIRPORT / OGILVIE FIELD

This report describes how your Pavement Maintenance Management Program (PMMP) was developed. Your Program was developed as part of the Oregon Continuous Aviation System Plan sponsored in part by the Oregon Department of Aviation and the Federal Aviation Administration (FAA). The information and data contained in this report ensures you comply with the requirements of FAA Grant Assurance Number 11 which states that any airport requesting federal funds for pavement improvement projects must have implemented a pavement maintenance management program.

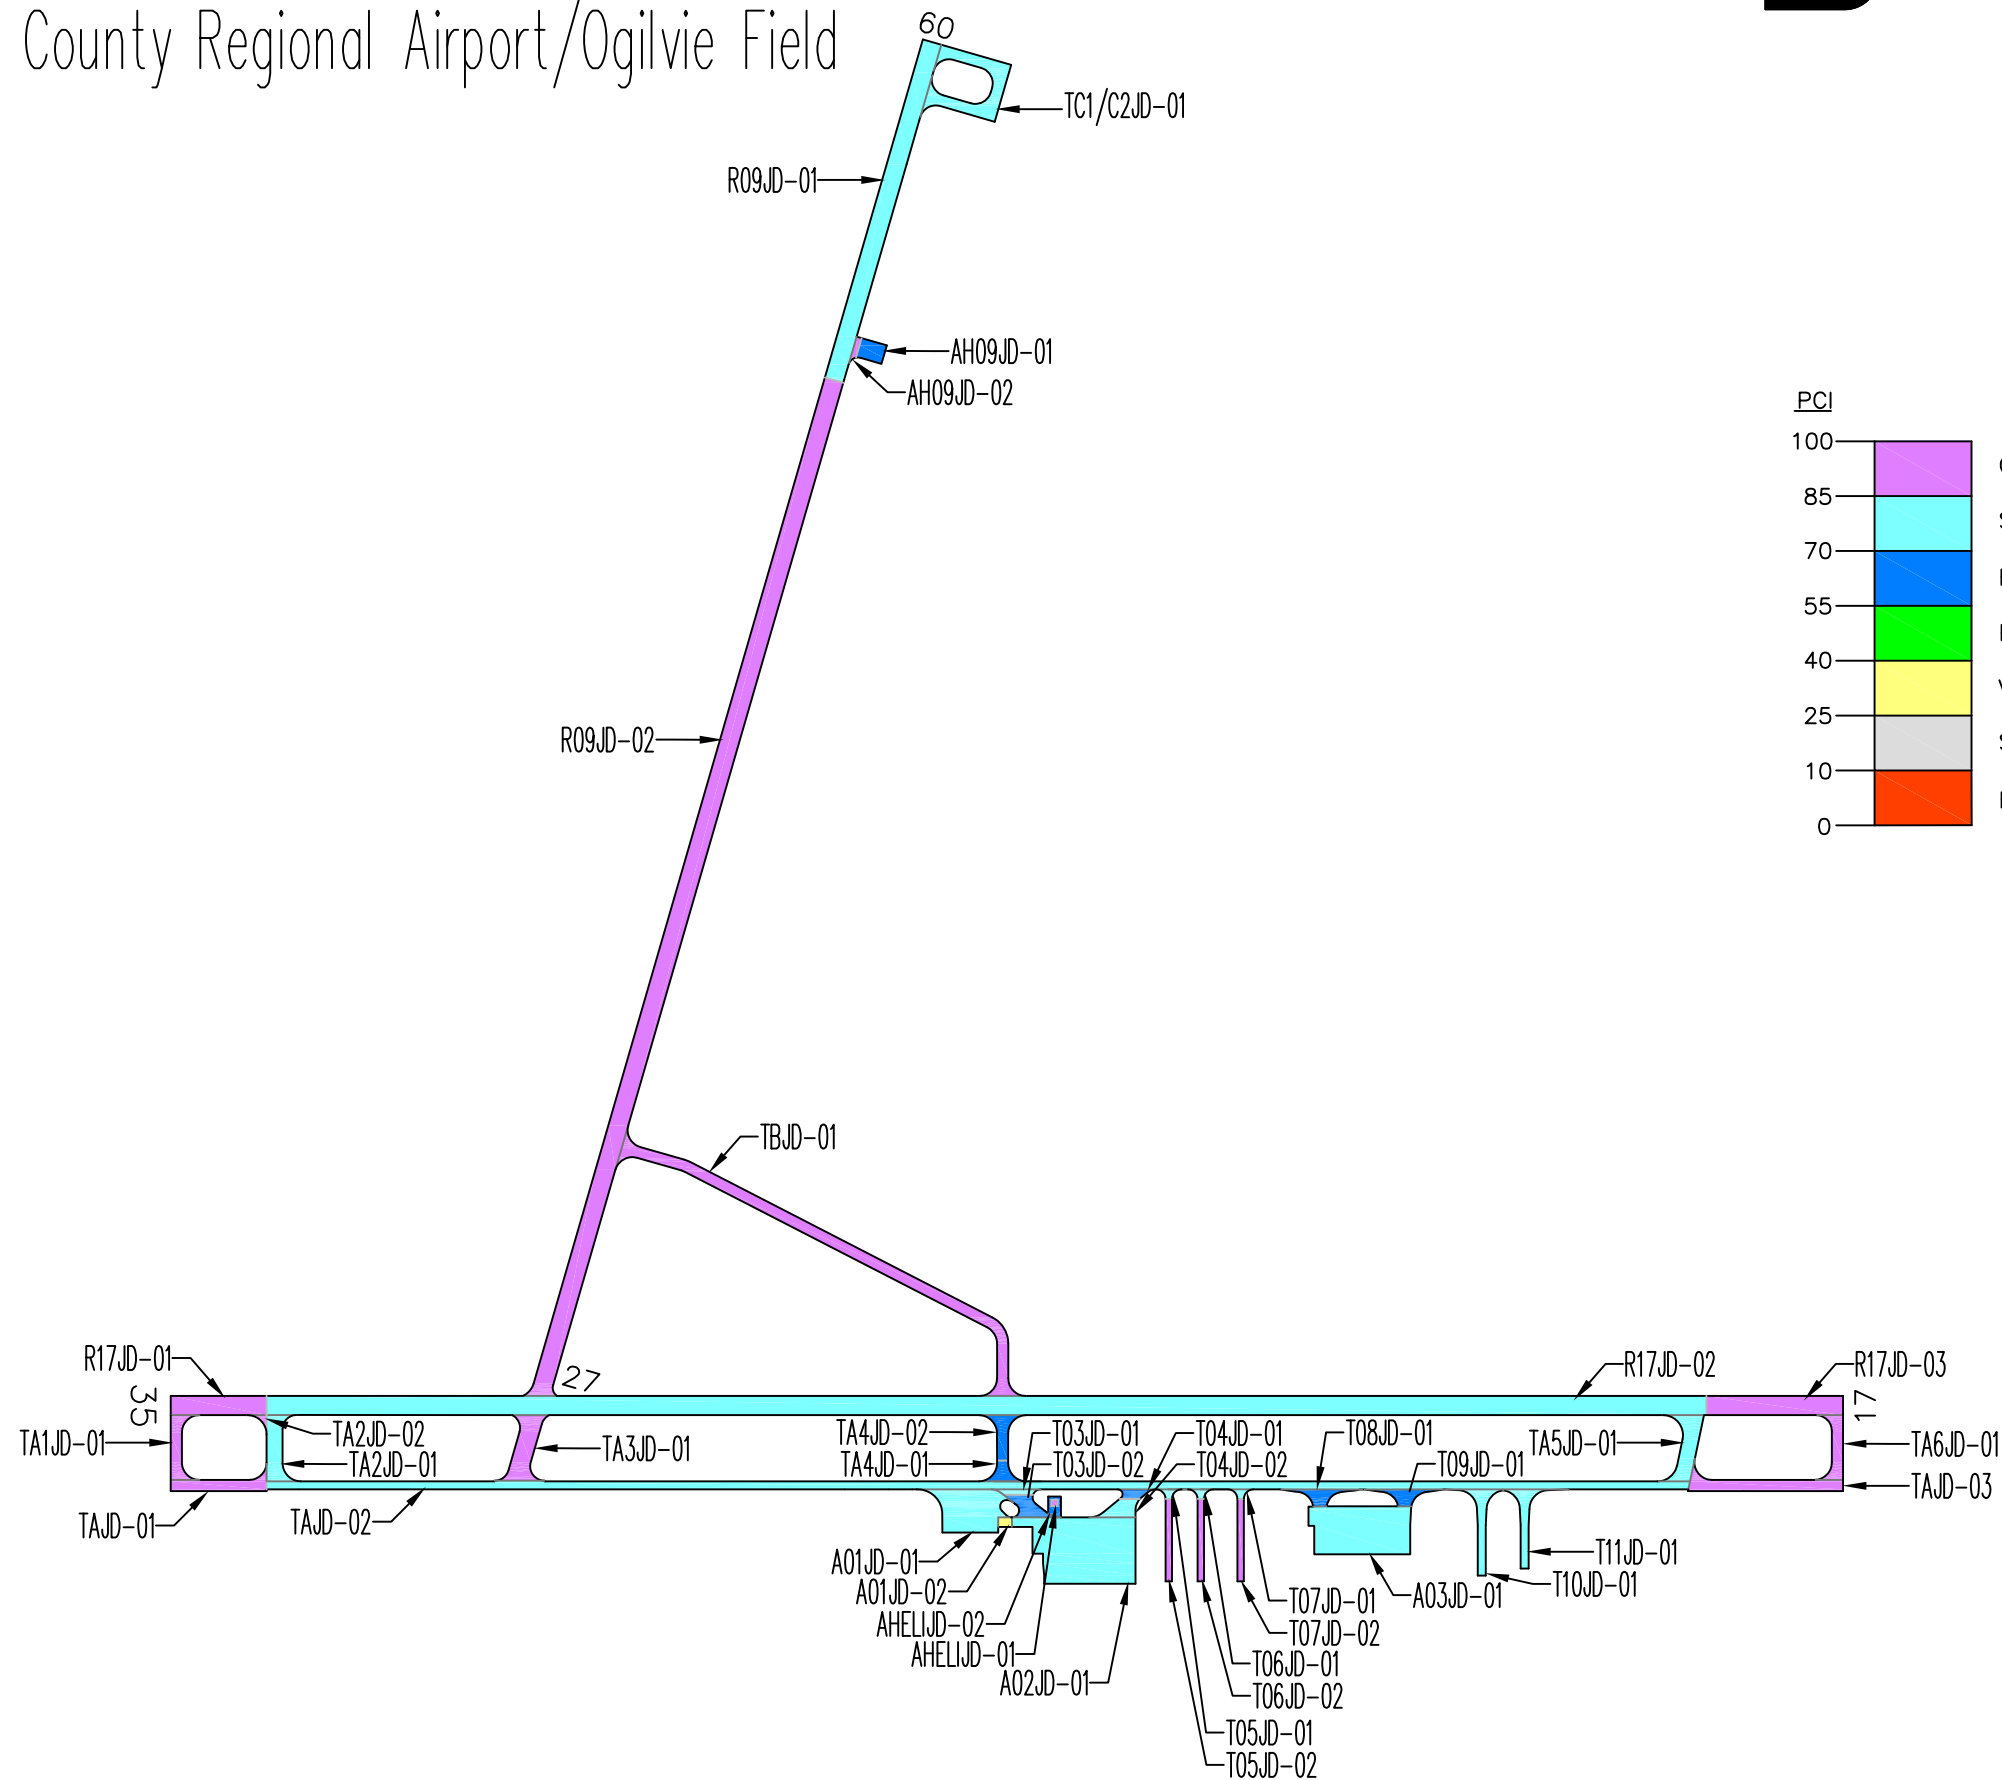
Figure JD-3. Pavement Condition in June 2017  
 Grant County Regional Airport/Ogilvie Field

Section PCIs at Grant County Regional Airport/Ogilvie Field range from a low of 39 (a PCR of “Very Poor”) to a high of 100 (a PCR of “Good”). The area-weighted average PCI for all airport pavements is 82, corresponding to an overall PCR of “Satisfactory”. Figure JD-4 shows how much pavement area is associated with each Pavement Condition Rating category and also shows pavement condition distribution from the inspections conducted in 2011 and 2014.

The primary distresses observed in the asphalt concrete pavements during the inspection were: longitudinal and transverse cracking, weathering, patching, alligator cracking and depressions. Shrinkage cracks were observed in the portland cement concrete pavement section.

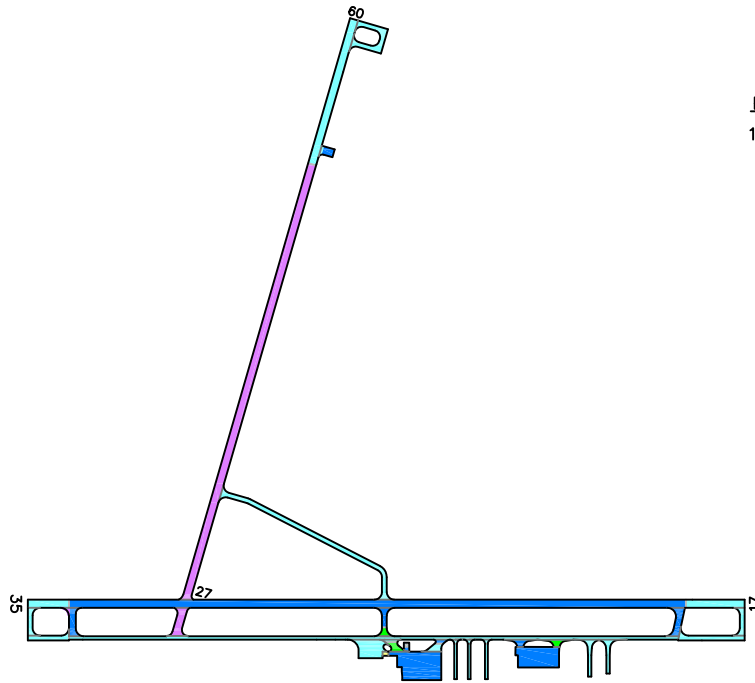
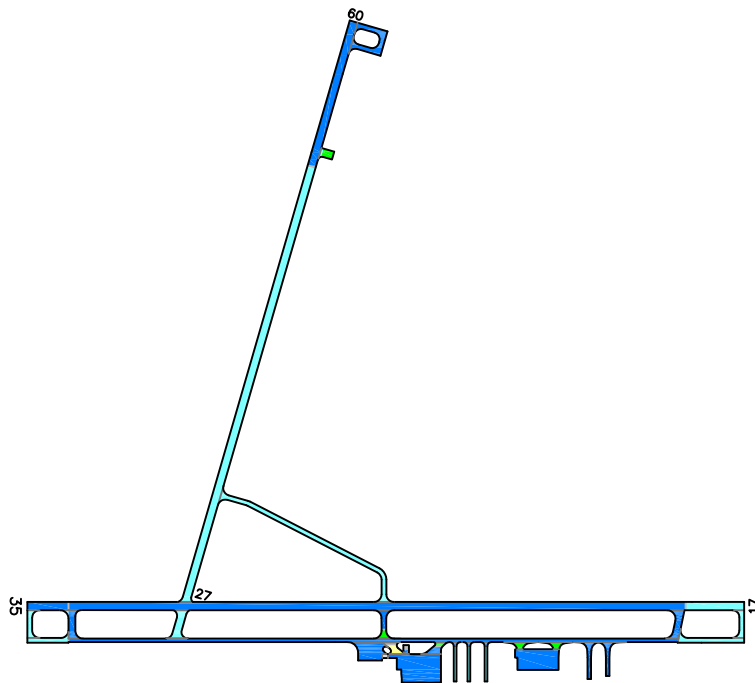
Figure JD-5. Future Pavement Condition.

A graphical representation of the projected PCIs listed in Table 1 is shown in Figure JD-5.
