HERMISTON MUNICIPAL AIRPORT

This report describes how your Pavement Maintenance Management Program (PMMP) was developed. Your Program was developed as part of the Oregon Continuous Aviation System Plan sponsored in part by the Oregon Department of Aviation and the Federal Aviation Administration (FAA). The information and data contained in this report ensures you comply with the requirements of FAA Grant Assurance Number 11 which states that any airport requesting federal funds for pavement improvement projects must have implemented a pavement maintenance management program.

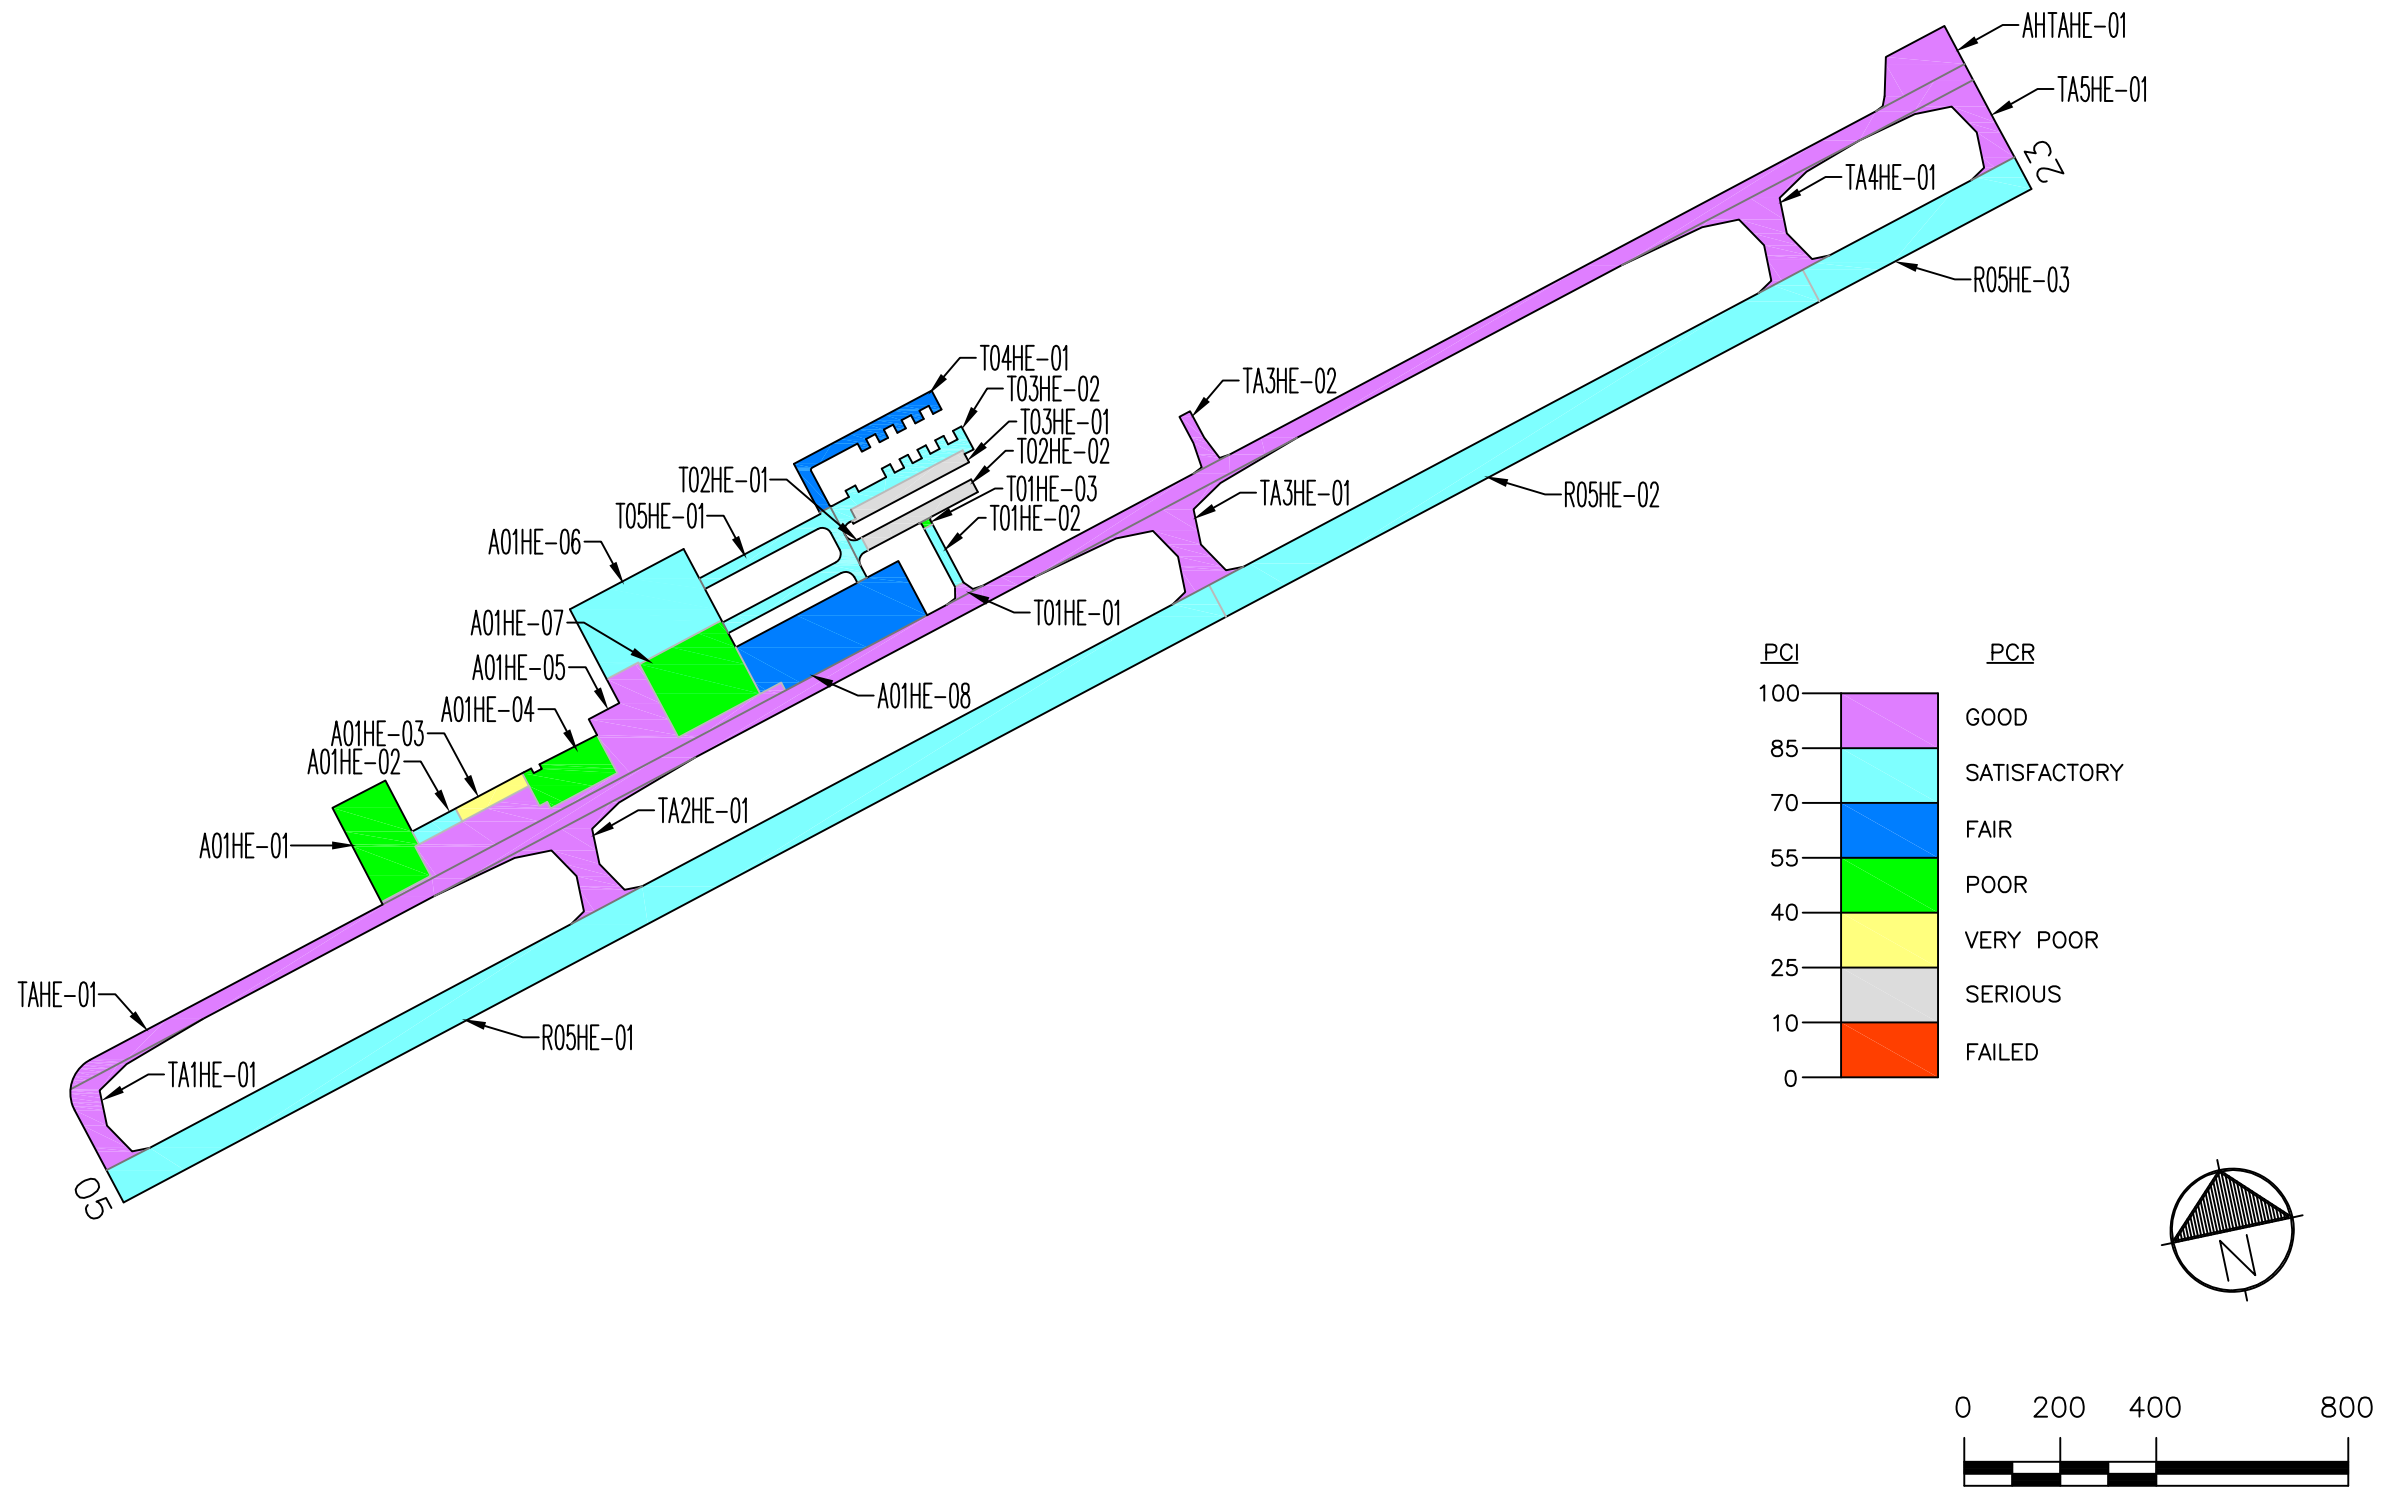
Figure HE-3. Pavement Condition in June 2017.
Hermiston Municipal Airport

The Branch Condition Report in Appendix 1 summarizes current pavement condition by branch while the Section Condition Report in Appendix 2 lists pavement condition by section. The current Pavement Condition Rating (PCR) is shown graphically in Figure HE-3.

Section PCIs at Hermiston Municipal Airport range from a low of 16 (a PCR of “Serious”) to a high of 100 (a PCR of “Good”). The area-weighted average PCI for all airport pavements is 80, corresponding to an overall PCR of “Satisfactory”. Figure HE-4 shows how much pavement area is associated with each Pavement Condition Rating category and also shows pavement condition distribution from the inspections conducted in 2011 and 2014.

The primary distresses observed during the inspection were: weathering, longitudinal and transverse cracking, block cracking, alligator cracking, and raveling, with an isolated occurrence of patching.

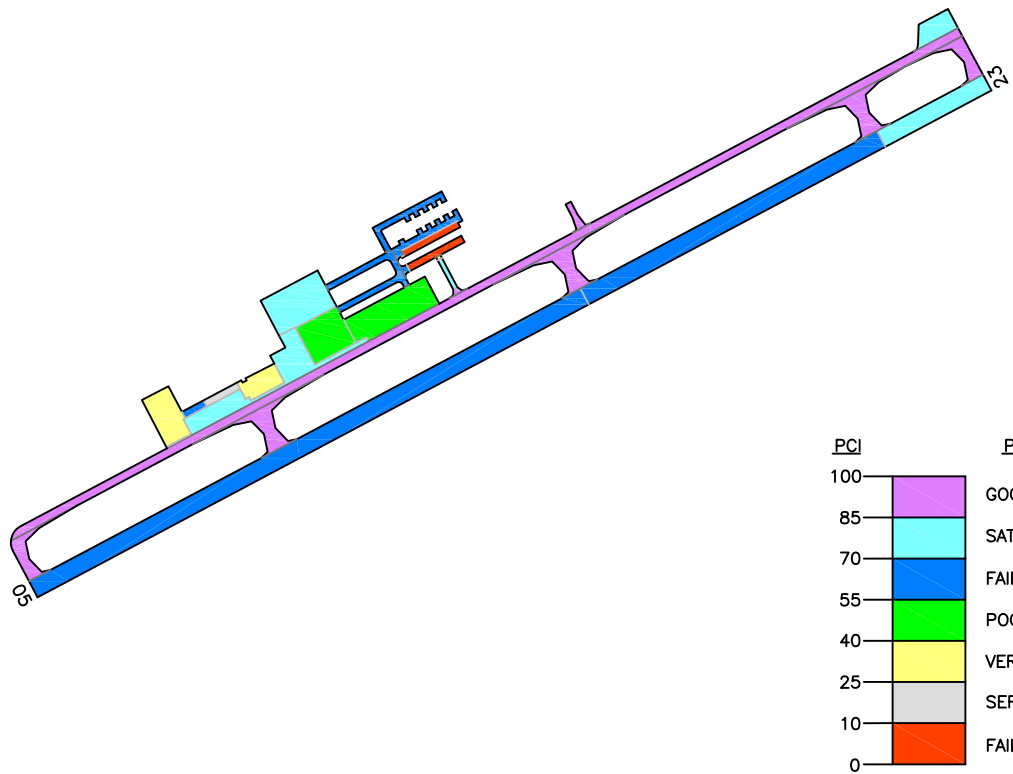
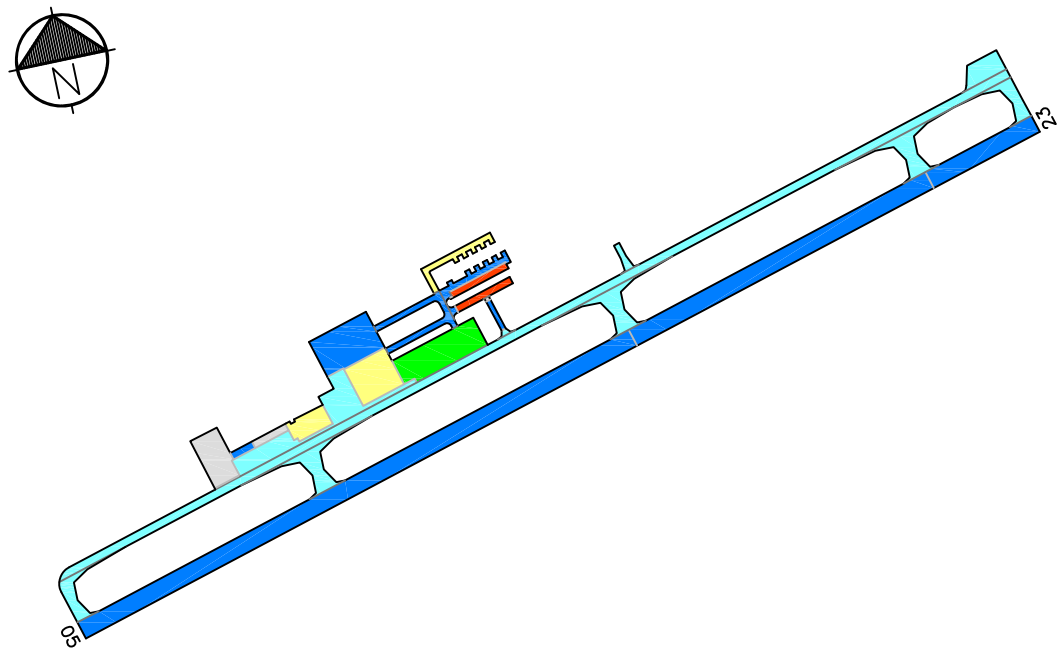
Figure HE-5. Future Pavement Condition.

A graphical representation of the projected PCIs listed in Table 1 is shown in Figure HE-5.
