JOSEPH STATE AIRPORT

Figure JO-1. Airport Layout, Dimensions and Pavement Cross-Sections.
Joseph State Airport

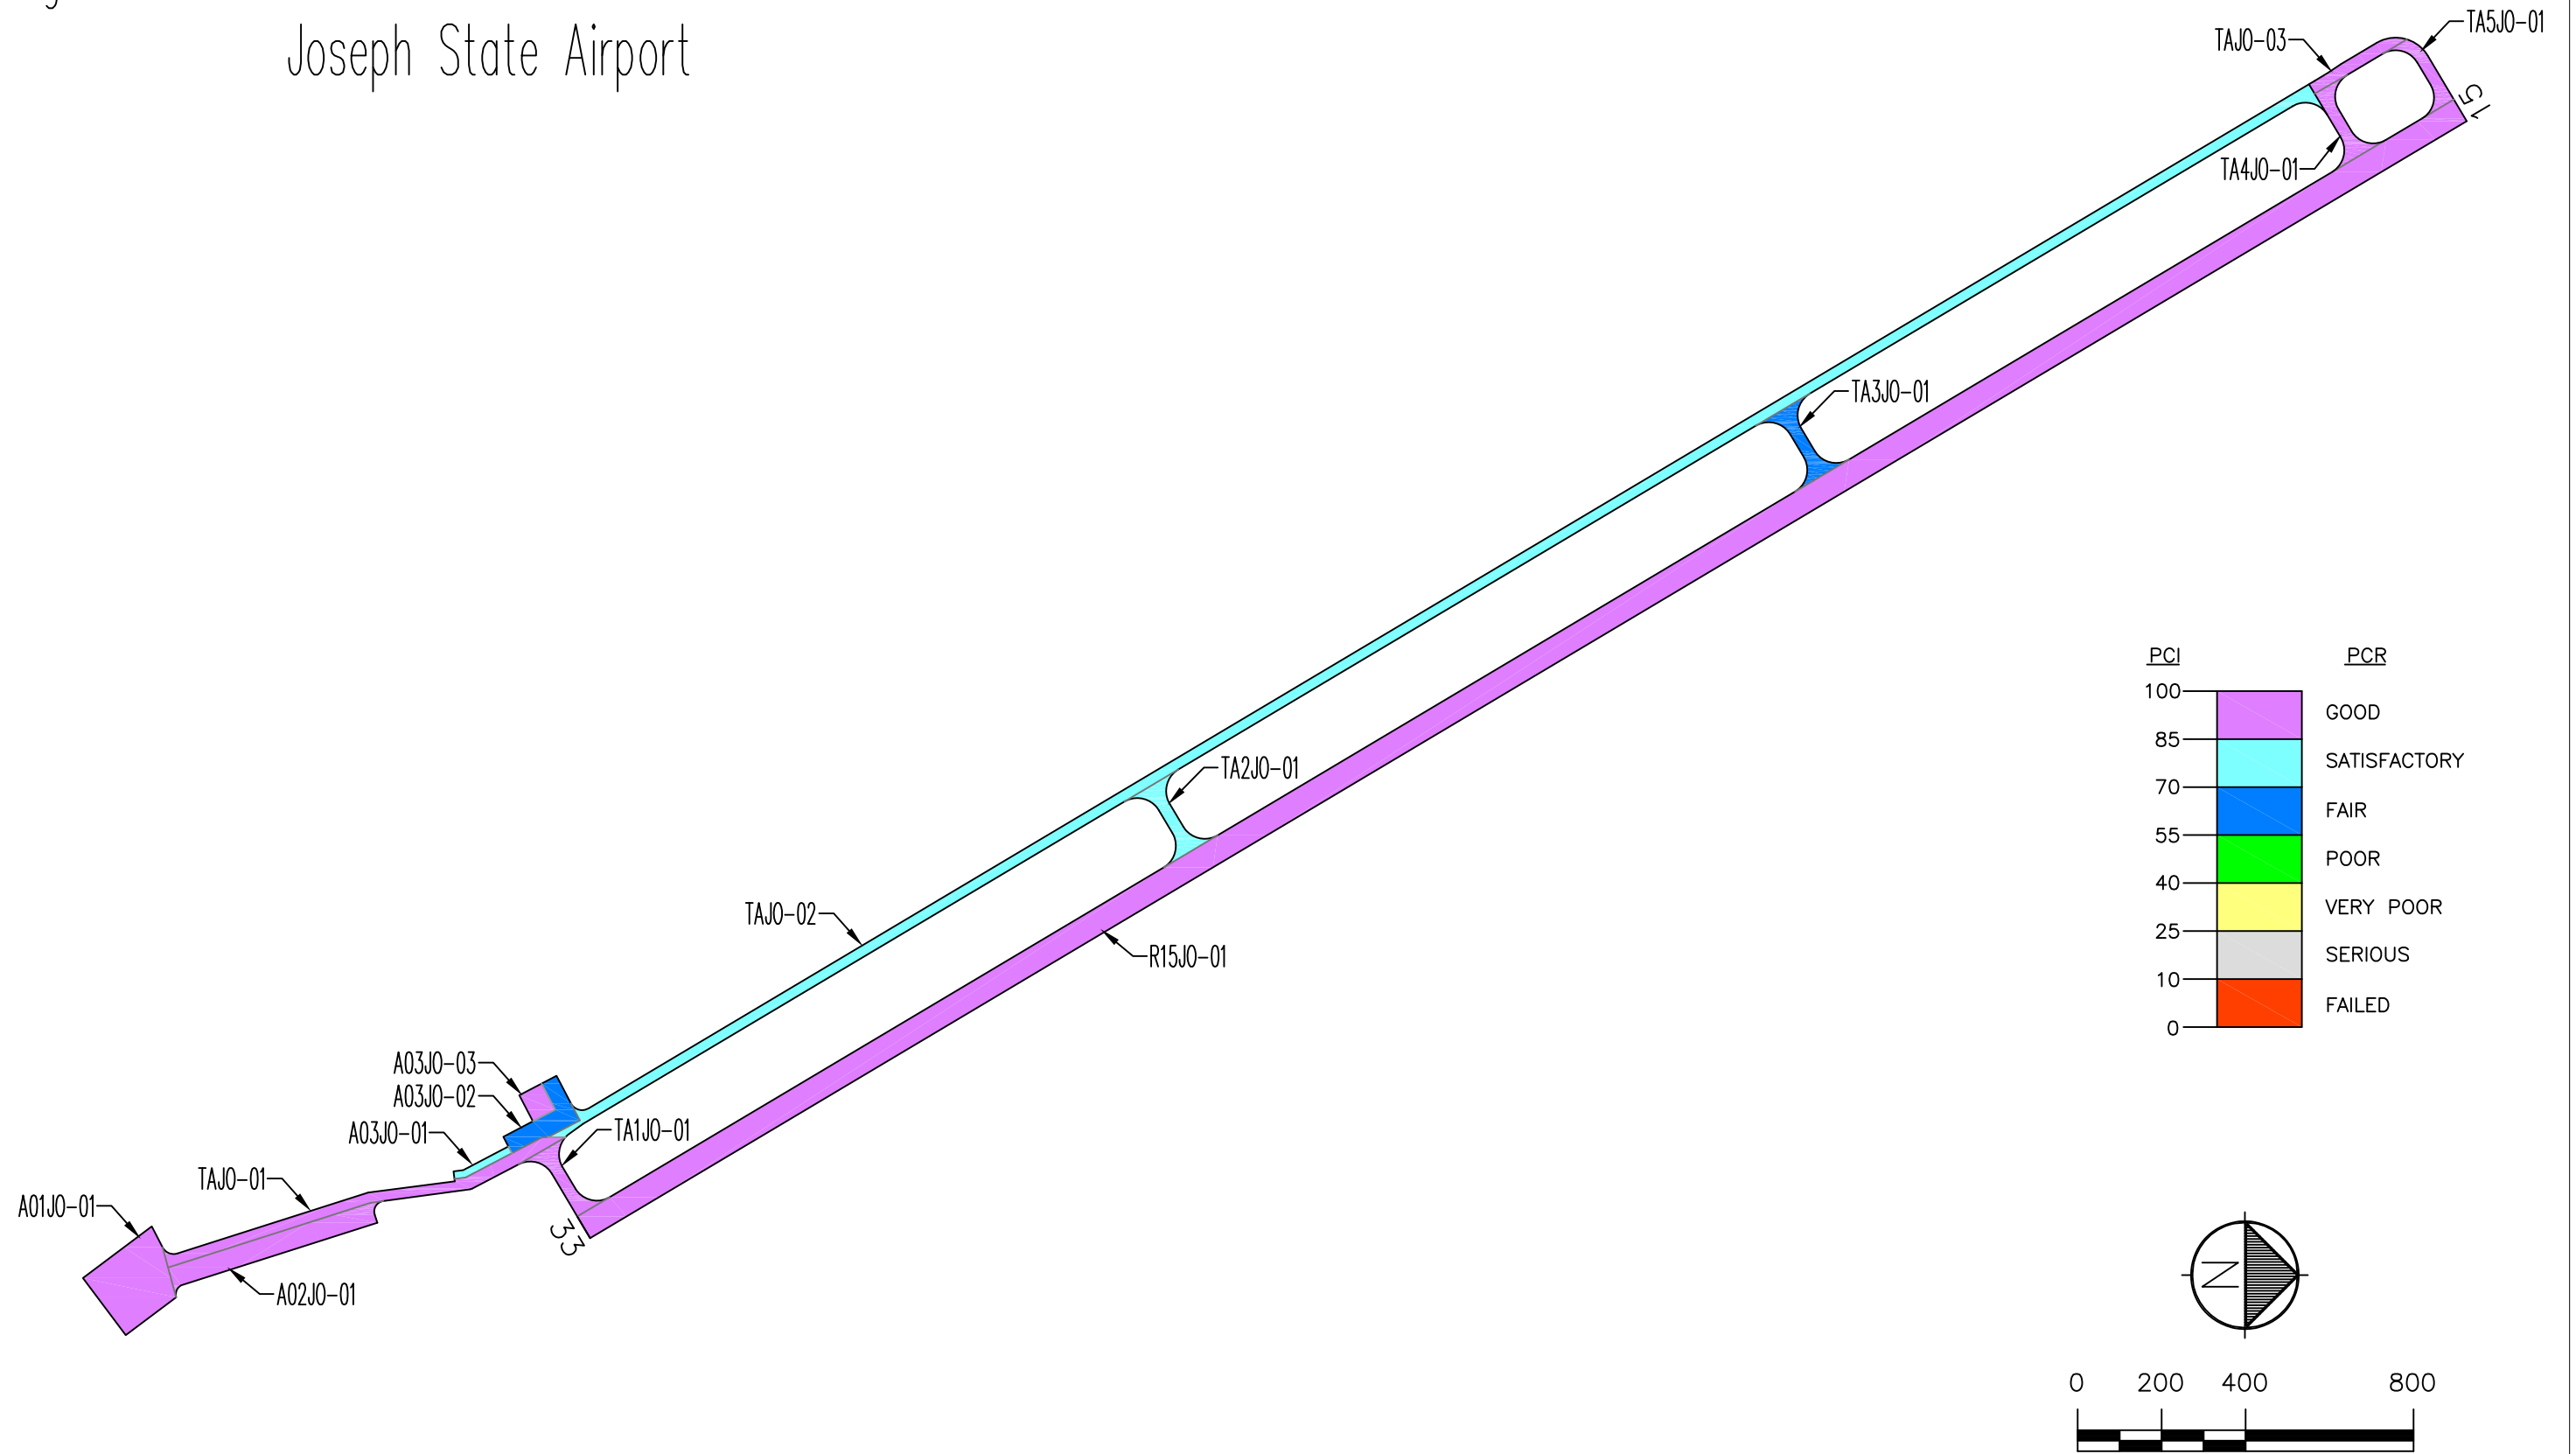
Figure J0-3. Pavement Condition in June 2017.
Joseph State Airport

The Branch Condition Report in Appendix 1 summarizes current pavement condition by branch while the Section Condition Report in Appendix 2 lists pavement condition by section. The current Pavement Condition Rating (PCR) is shown graphically in Figure JO-3.

Section PCIs at Joseph State Airport range from a low of 67 (a PCR of “Fair”) to a high of 100 (a PCR of “Good”). The area-weighted average PCI for all airport pavements is 91, corresponding to an overall PCR of “Good”. Figure JO-4 shows how much pavement area is associated with each Pavement Condition Rating category and also shows pavement condition distribution from the inspection conducted in 2006 and 2014. Joseph State Airport was not inspected in 2011.

The primary distresses observed during the inspection of asphalt concrete pavements were: longitudinal and transverse cracking, weathering and alligator cracking. No distress was observed in the portland cement concrete pavement.

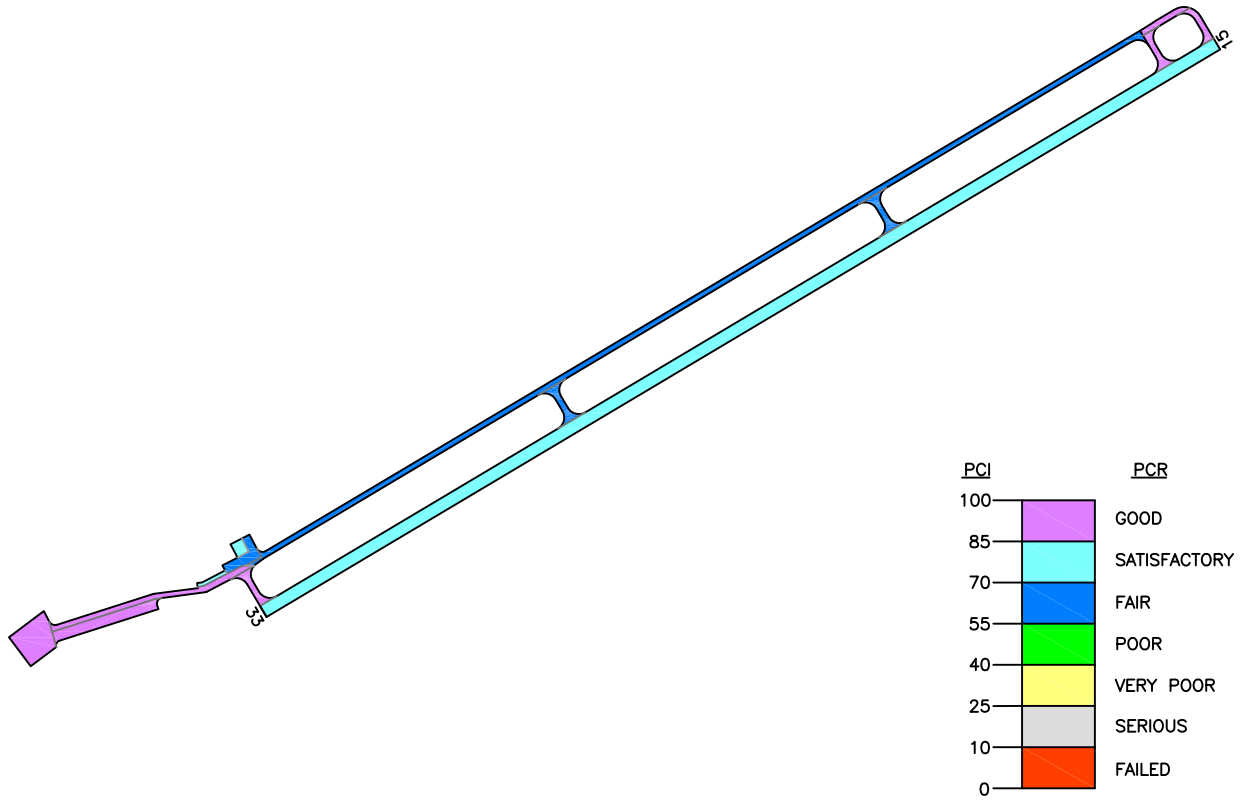
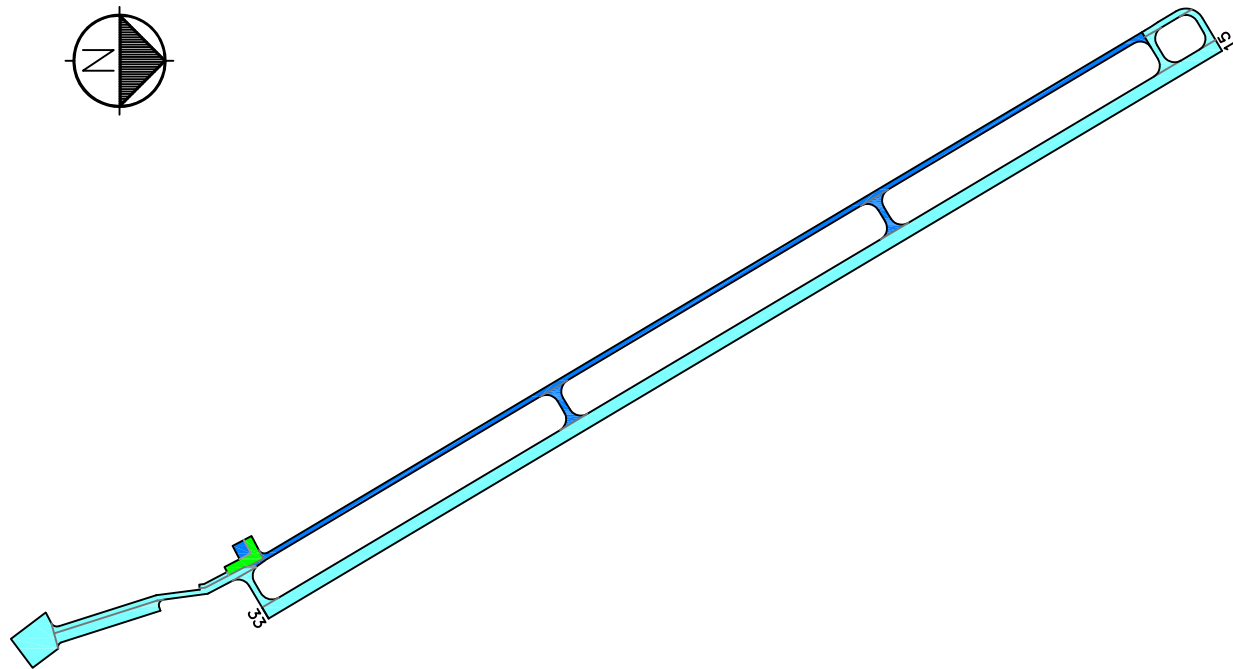
Figure JO-5. Future Pavement Condition.

A graphical representation of the projected PCIs listed in Table 1 is shown in Figure JO-5.
