KEN JERNSTEDT AIRFIELD

Figure HR-1. Airport Layout, Dimensions and Pavement Cross-Sections.
Ken Jernstedt Airfield

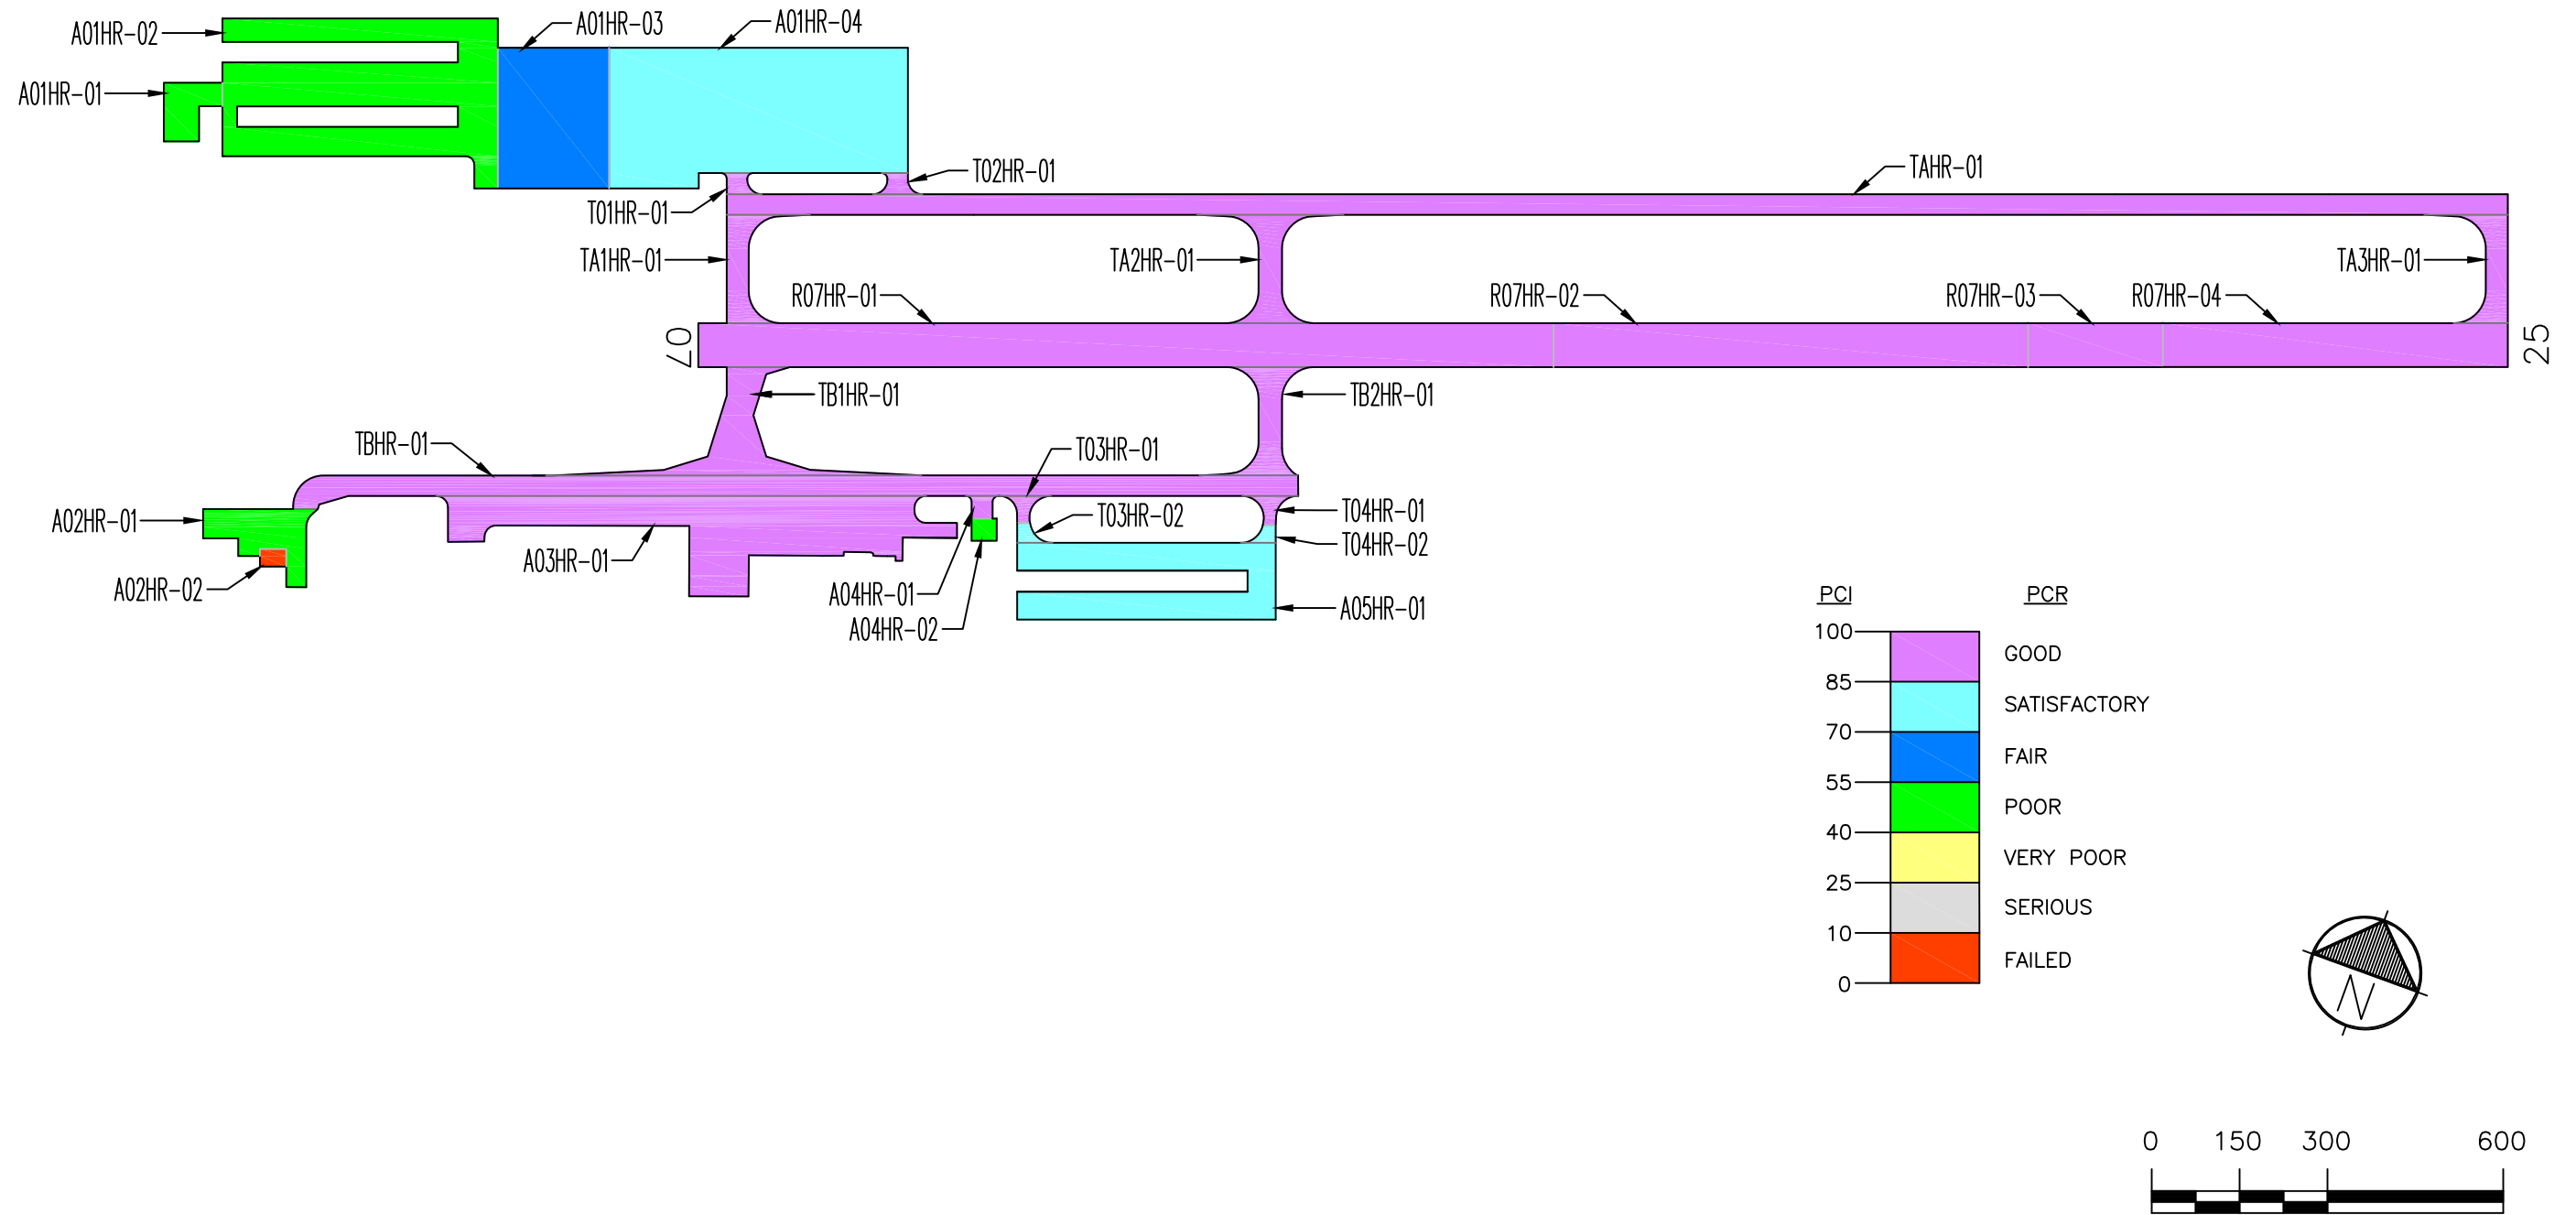
Figure HR-3. Pavement Condition in June 2017.
Ken Jernstedt Airfield

Section PCIs at Ken Jernstedt Airfield range from a low of 0 (a PCR of “Failed”) to a high of 100 (a PCR of “Good”). The area-weighted average PCI for all airport pavements is 86, corresponding to an overall PCR of “Good”. Figure HR-4 shows how much pavement area is associated with each Pavement Condition Rating category and also shows pavement condition distribution from the inspections conducted in 2011 and 2014.

The primary distresses observed during the inspection of asphalt concrete pavements were: longitudinal and transverse cracking, patching, weathering, alligator cracking, block cracking, and raveling, with an isolated occurrence of depressions. The primary distress observed during the inspection of portland cement concrete pavements was shattered slabs.

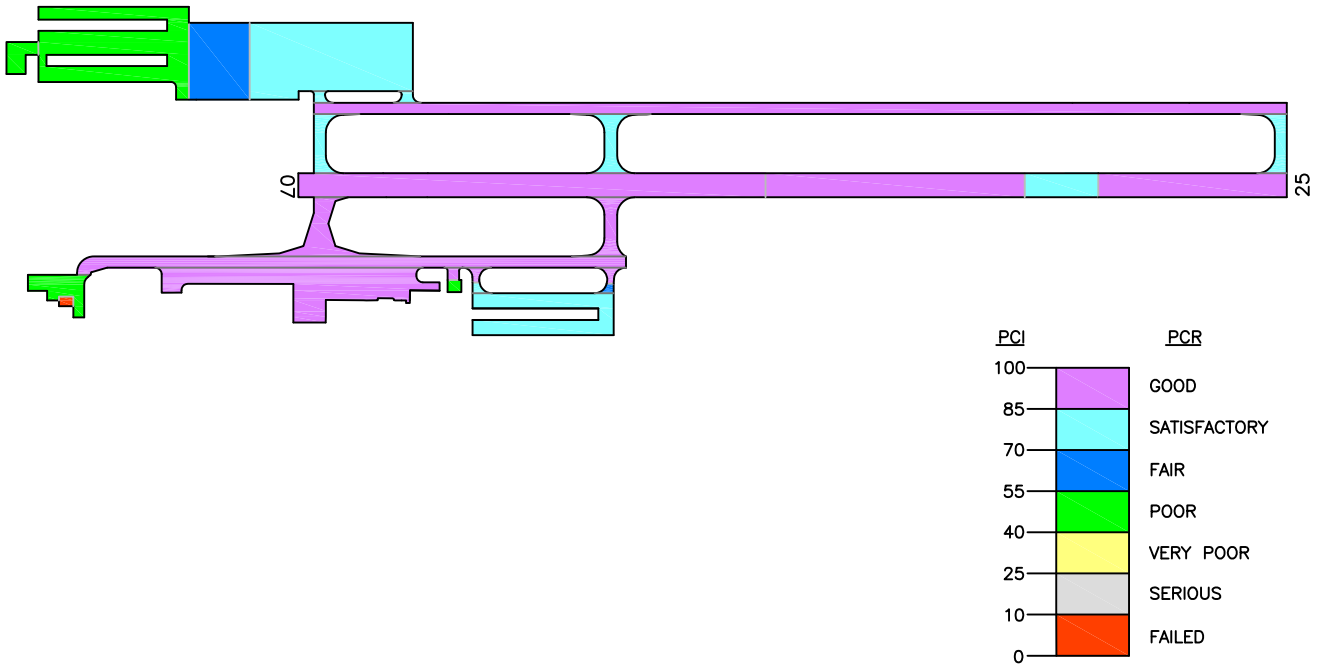
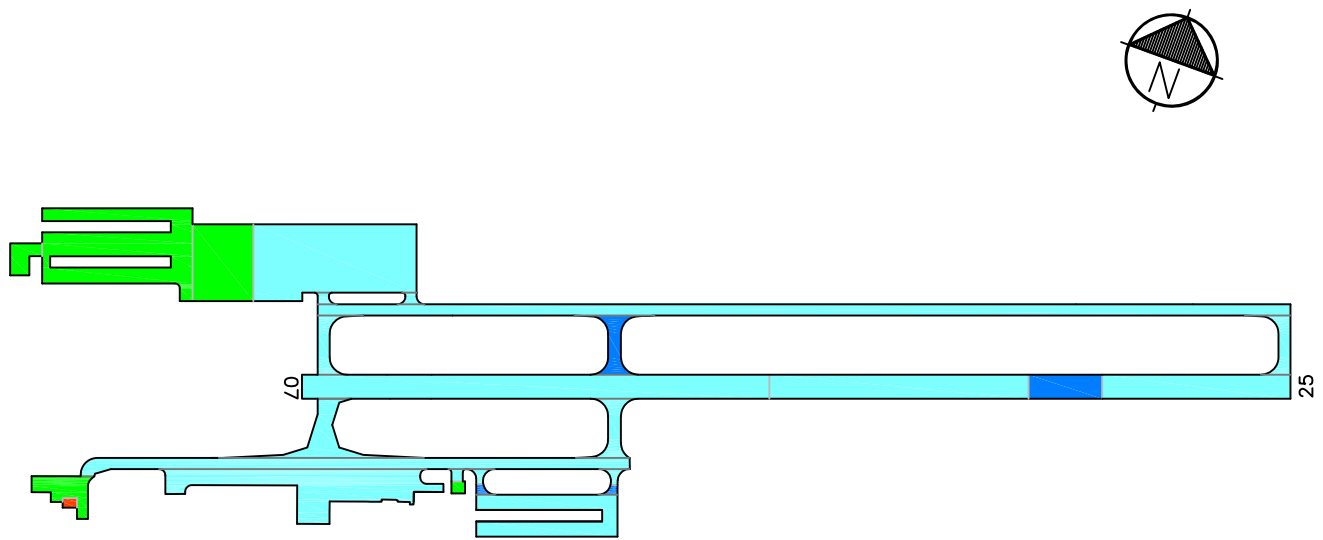
Figure HR-5. Future Pavement Condition.

A graphical representation of the projected PCIs listed in Table 1 is shown in Figure HR-5.
