LaGRANDE / UNION COUNTY AIRPORT

Using the branch, section and sample unit divisions established, a visual condition survey was conducted at LaGrande / Union County Airport June 2017 with the methodology outlined in ASTM D5430. This inspection ensures your airport complies with the “detailed inspection” requirement of FAA’s PMMP guidelines. After collection, the data were entered into the PAVER software for analysis. These data are reproduced in the Re-Inspection Report attached as Appendix 4.

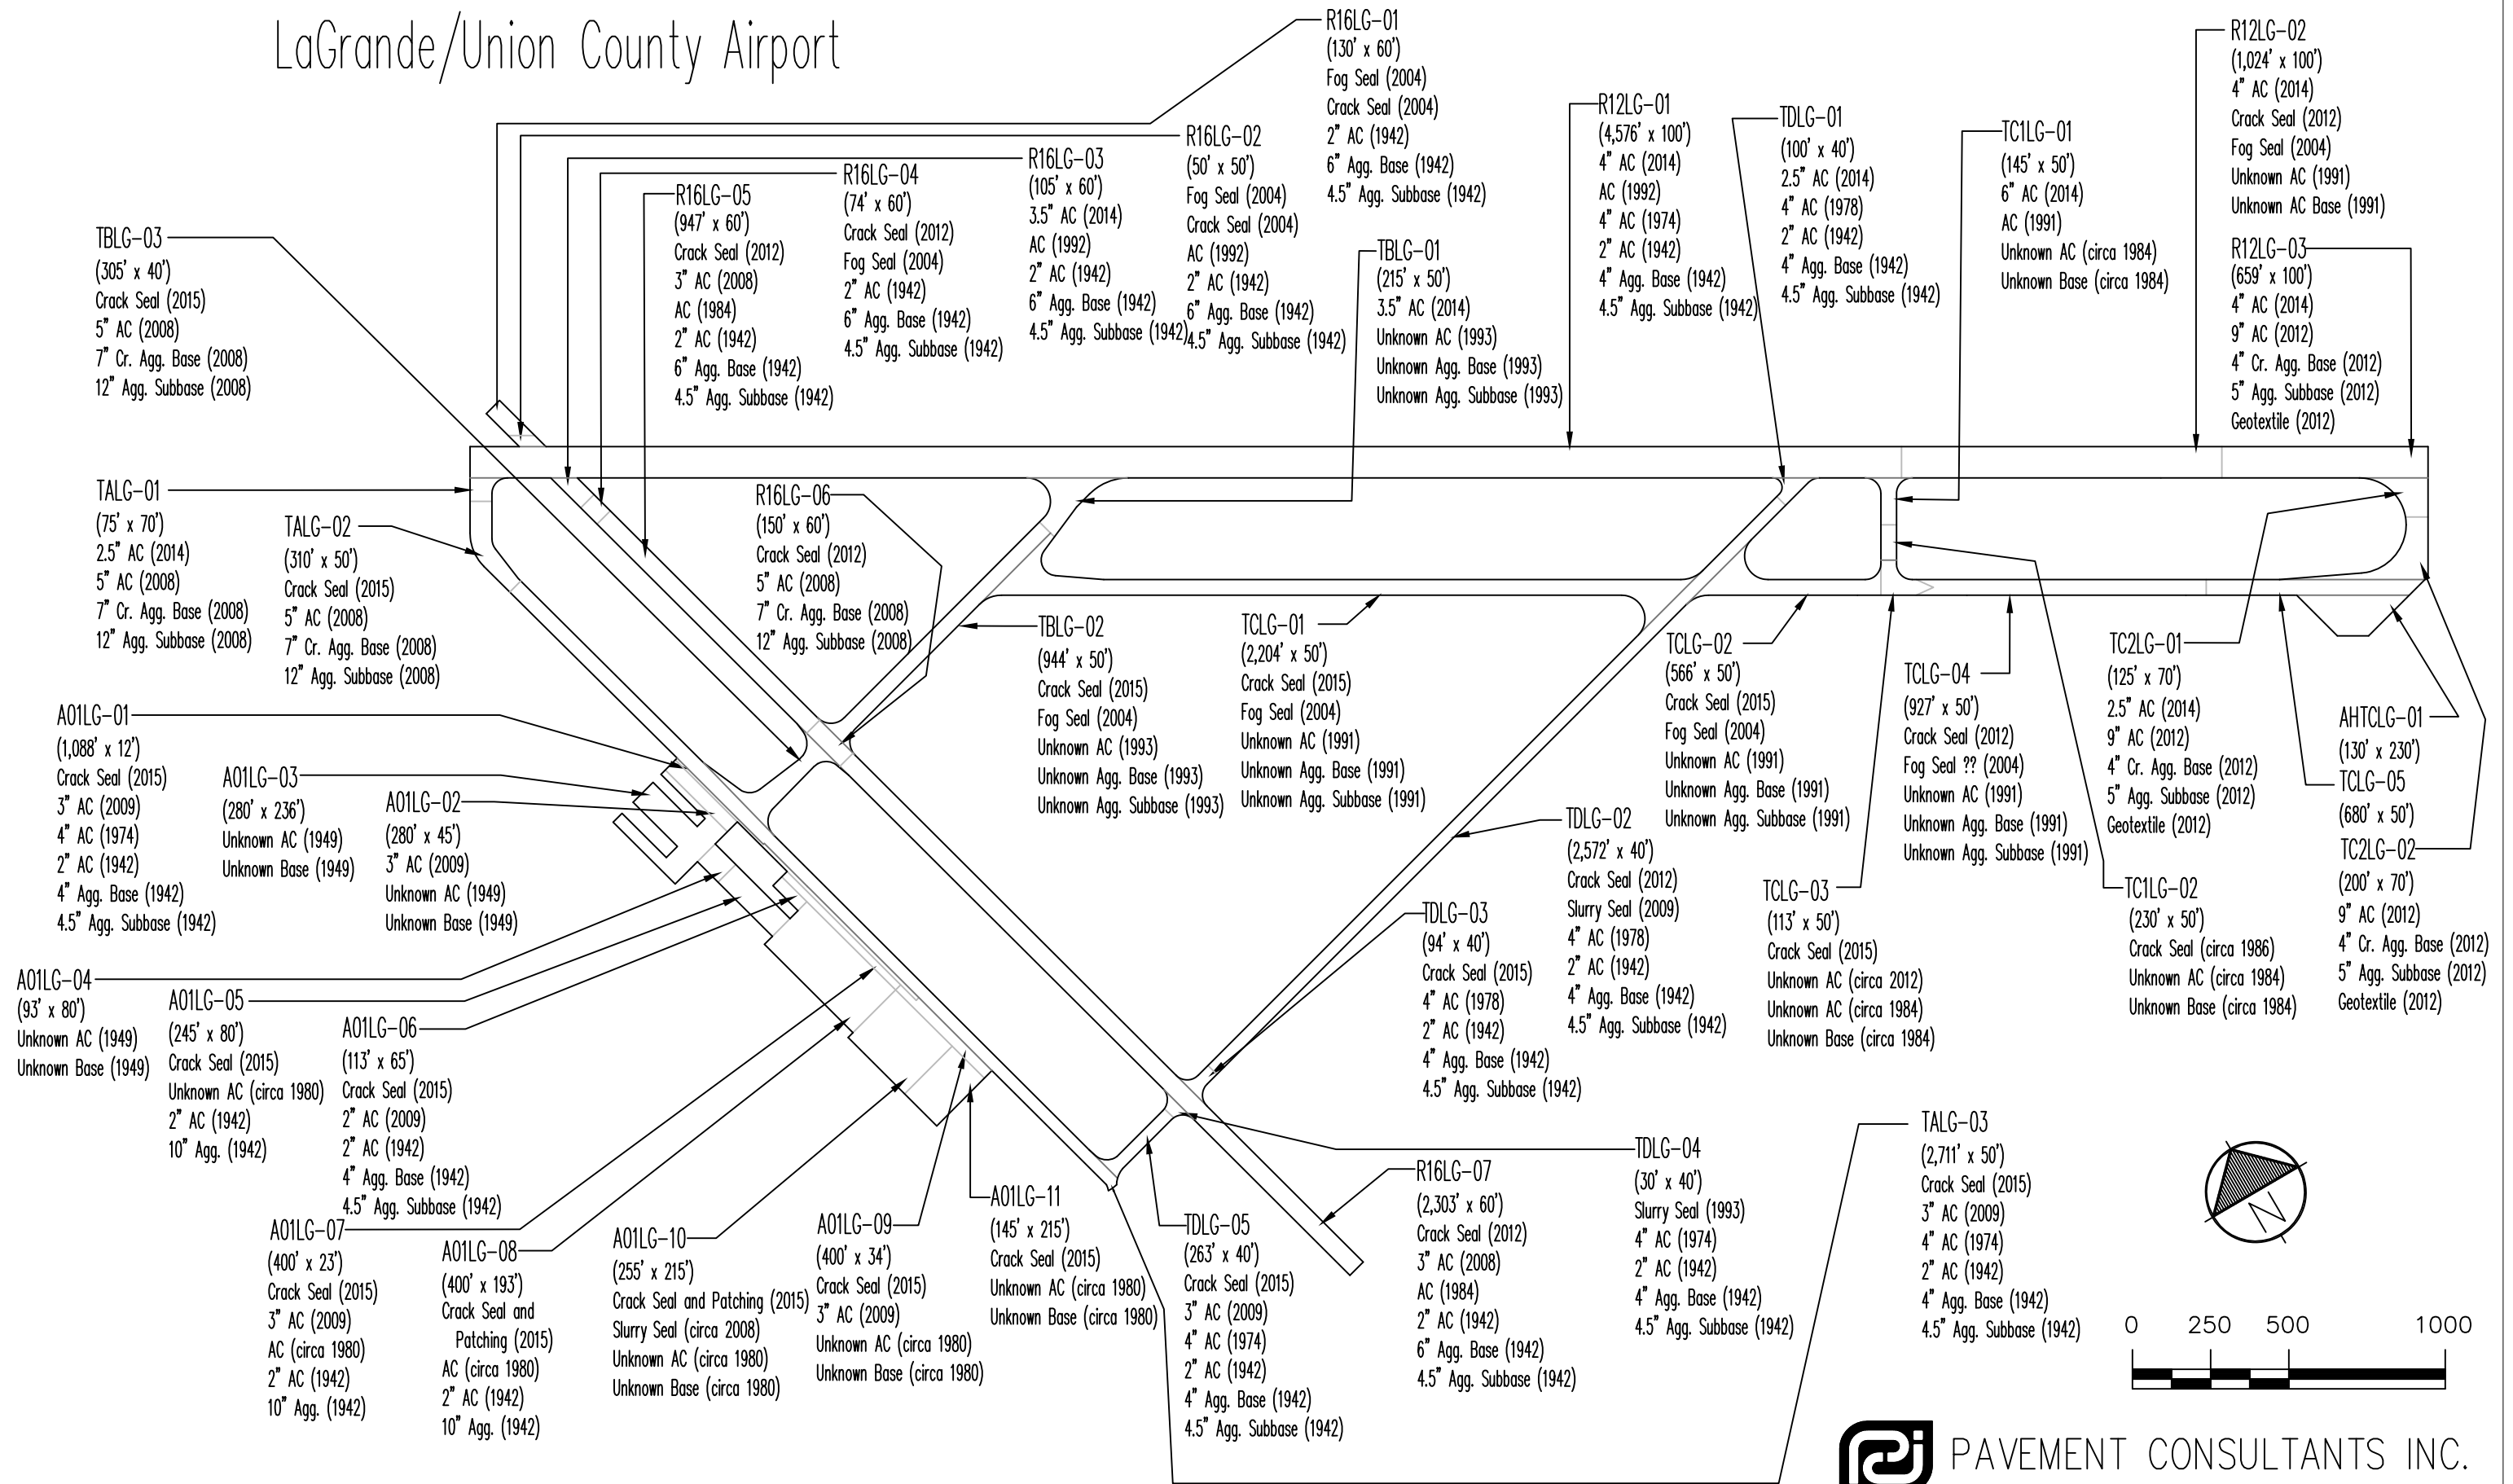
Figure LG-1. Airport Layout, Dimensions and Pavement Cross-Sections.

To determine how your pavements were constructed and their age, a records review was conducted. Figure LG-1 shows the records review results. This figure identifies pavement boundaries, dimensions, pavement layer types, thicknesses and dates of construction. The most recent construction date for each pavement can also be found in the Section Condition Report in Appendix 2. Figure LG-1 and the information contained in Appendices 1, 2 and 4 ensure that your airport complies with the “pavement inventory” requirement of FAA’s PMMP guidelines.

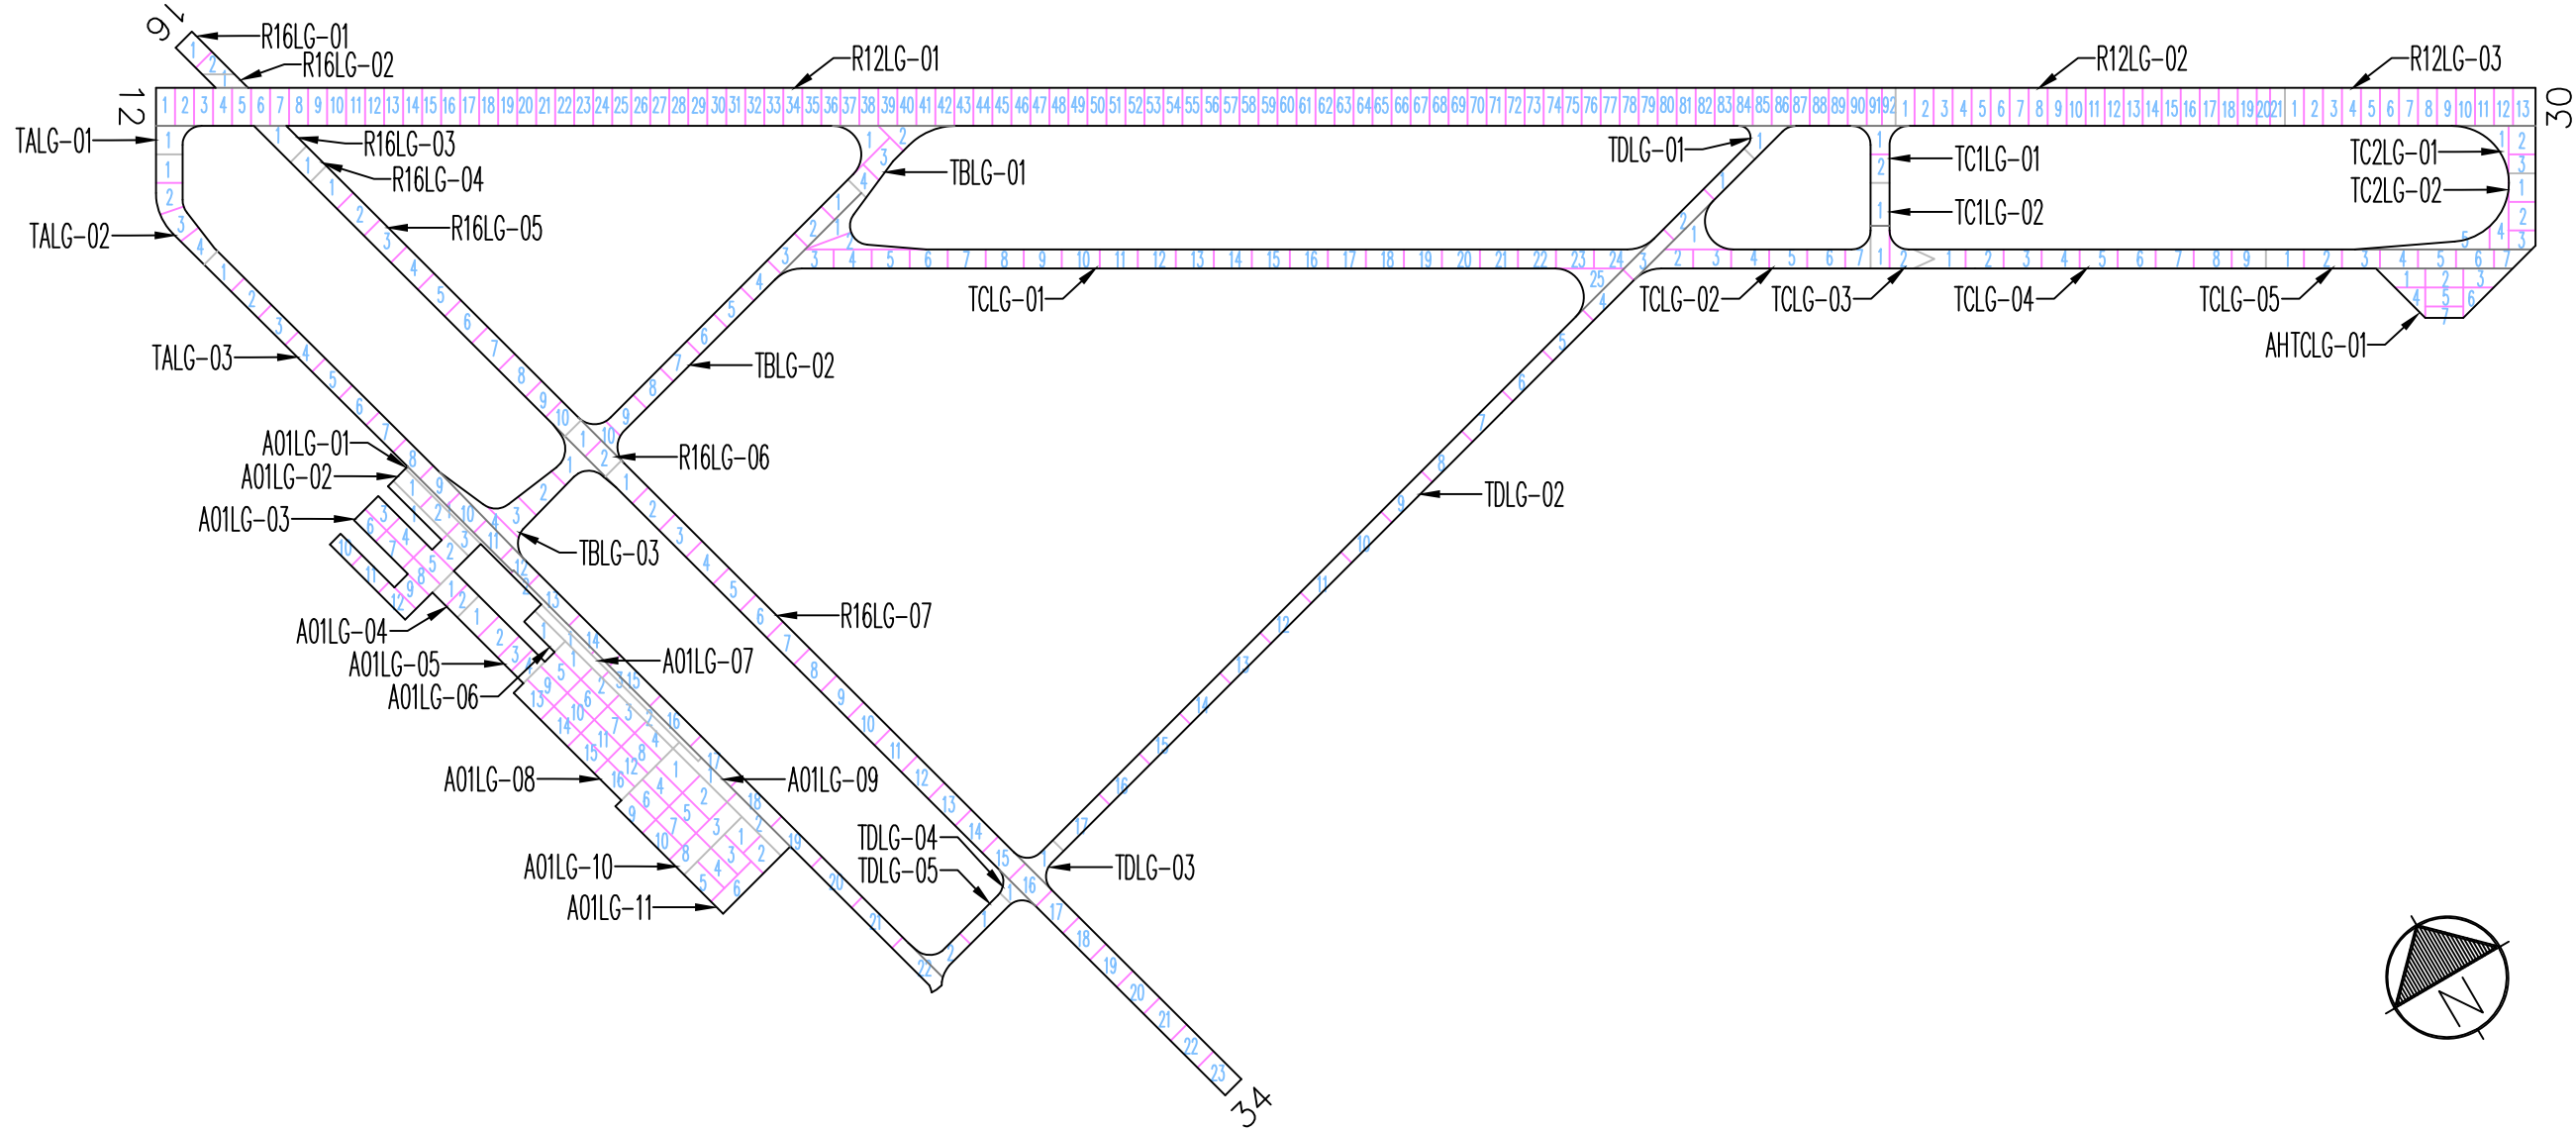
Figure LG-2. Pavement Branch, Section and Sample Unit Layout.
LaGrande/Union County Airport

The pavements at your airport were divided into branches, sections and sample units in accordance with the methodology outlined in the current edition of ASTM D5430, *Standard Test Method for Airport Condition Index Surveys*. The branches, sections and sample units established at your airport are shown in Figure LG-2. A Branch Condition Report showing all branches, their associated areas, and their area-weighted average condition is provided in Appendix 1. Additionally, the Appendix 2 Section Condition Report provides information used to define each branch and section in the PAVER database.

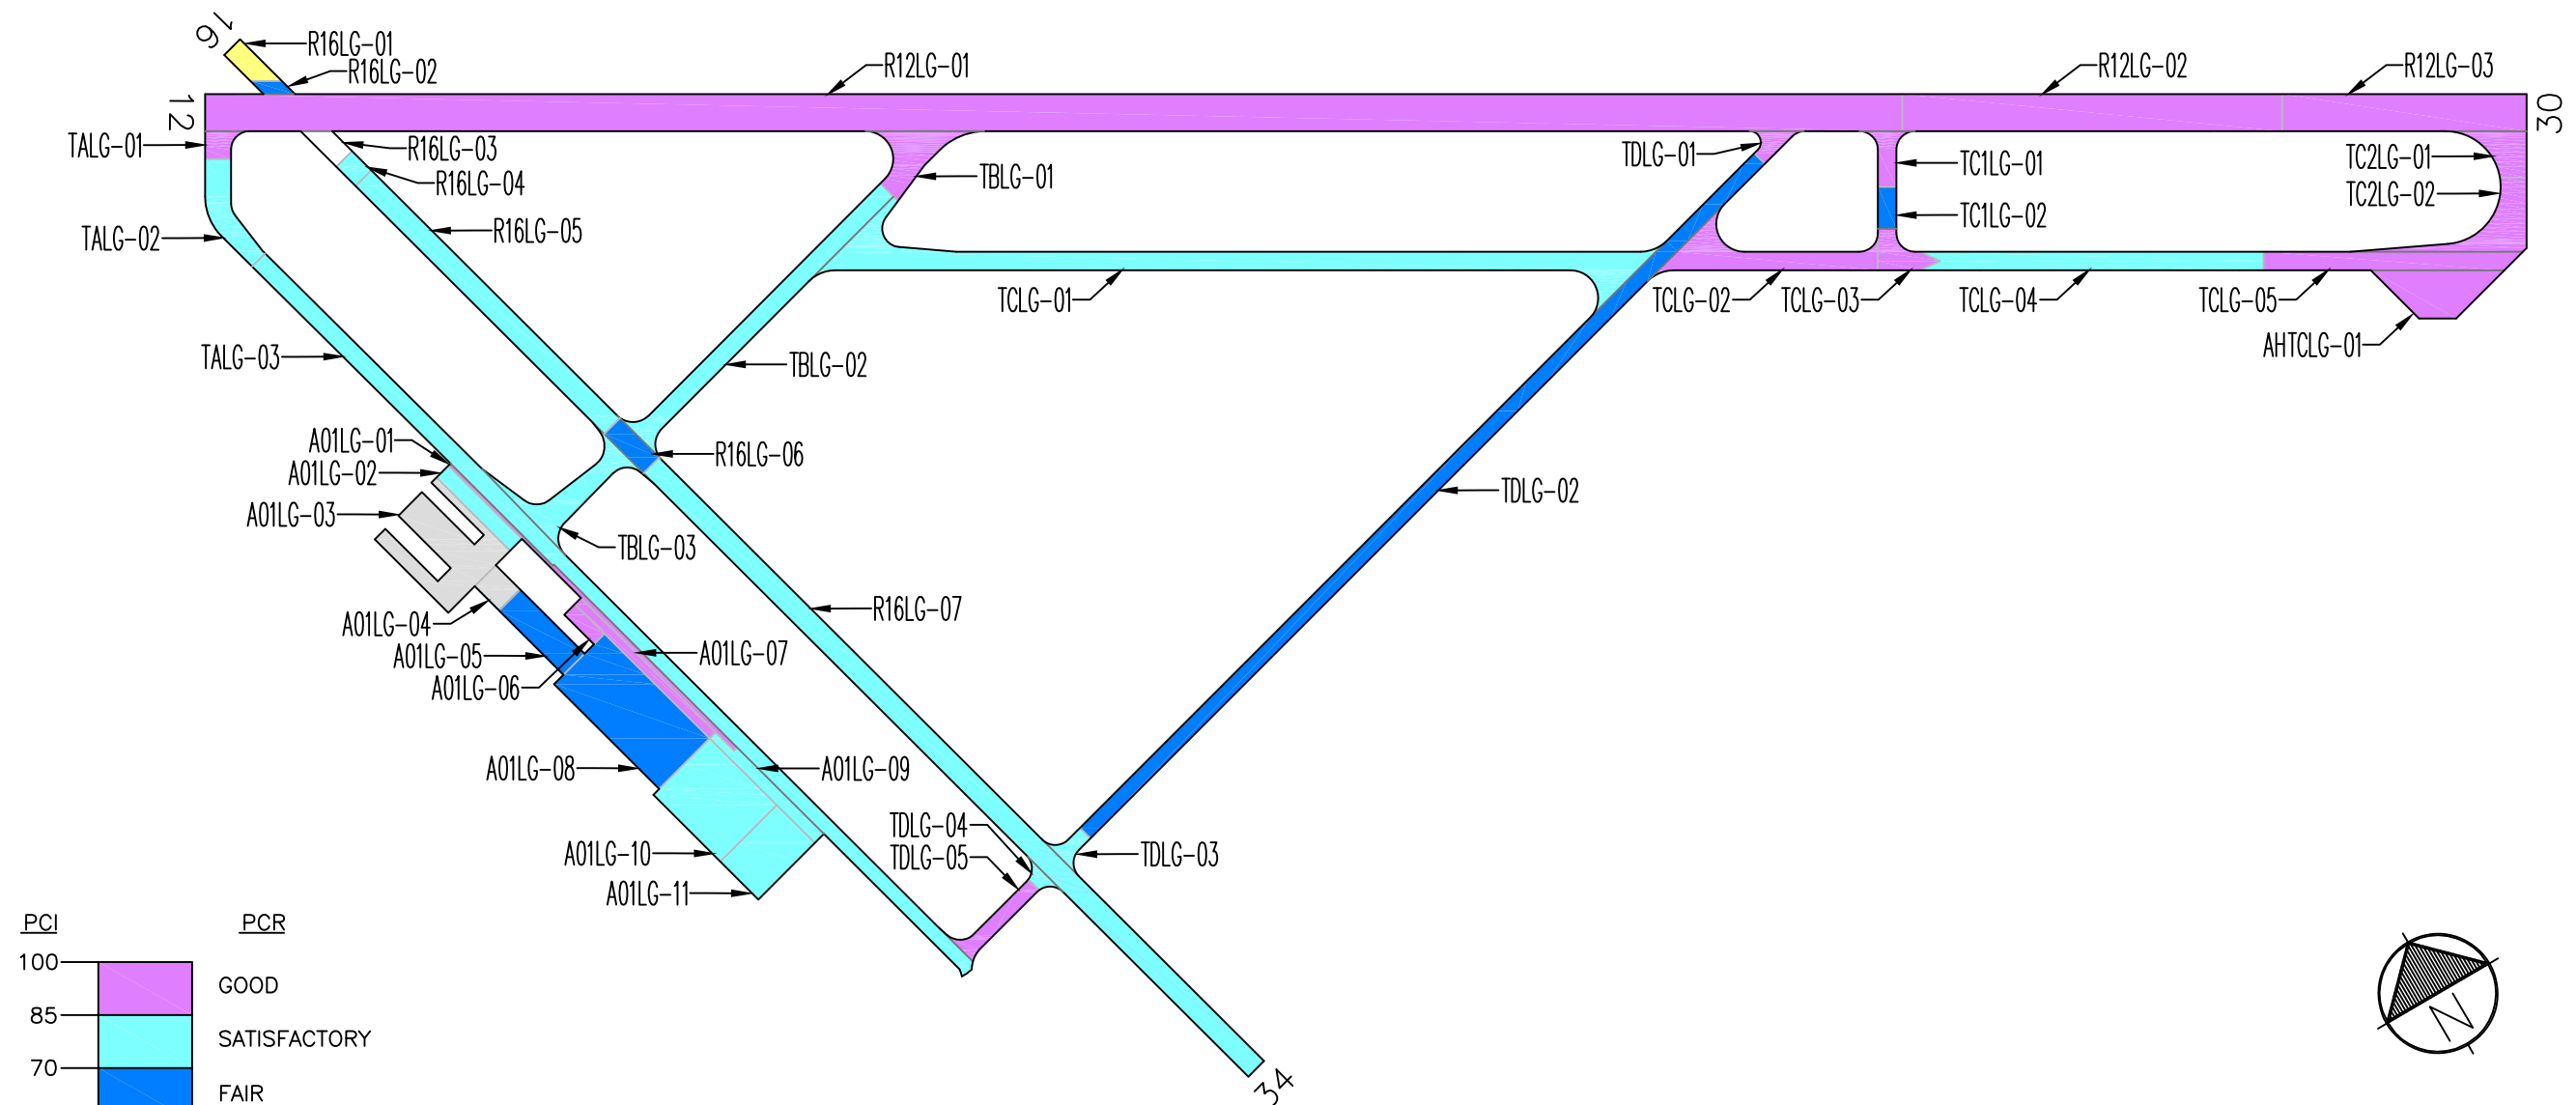
Figure LG-3. Pavement Condition in June 2017.
LaGrande/Union County Airport

The Branch Condition Report in Appendix 1 summarizes current pavement condition by branch while the Section Condition Report in Appendix 2 lists pavement condition by section. The current Pavement Condition Rating (PCR) is shown graphically in Figure LG-3.

Section PCIs at LaGrande (Union County) Airport range from a low of 13 (a PCR of “Serious”) to a high of 100 (a PCR of “Good”). The area-weighted average PCI for all airport pavements is 83, corresponding to an overall PCR of “Satisfactory”. Figure LG-4 shows how much pavement area is associated with each Pavement Condition Rating category and also shows pavement condition distribution from the inspections conducted in 2011 and 2014.

The primary distresses observed during the inspection were: longitudinal and transverse cracking, weathering, patching, raveling, depressions, block cracking, rutting and alligator cracking.

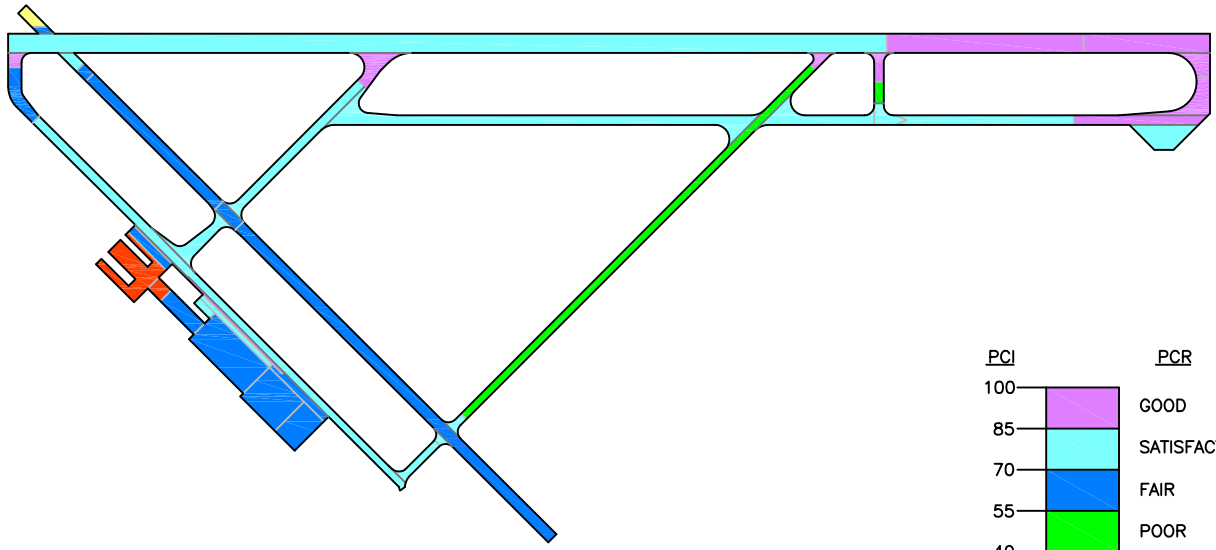
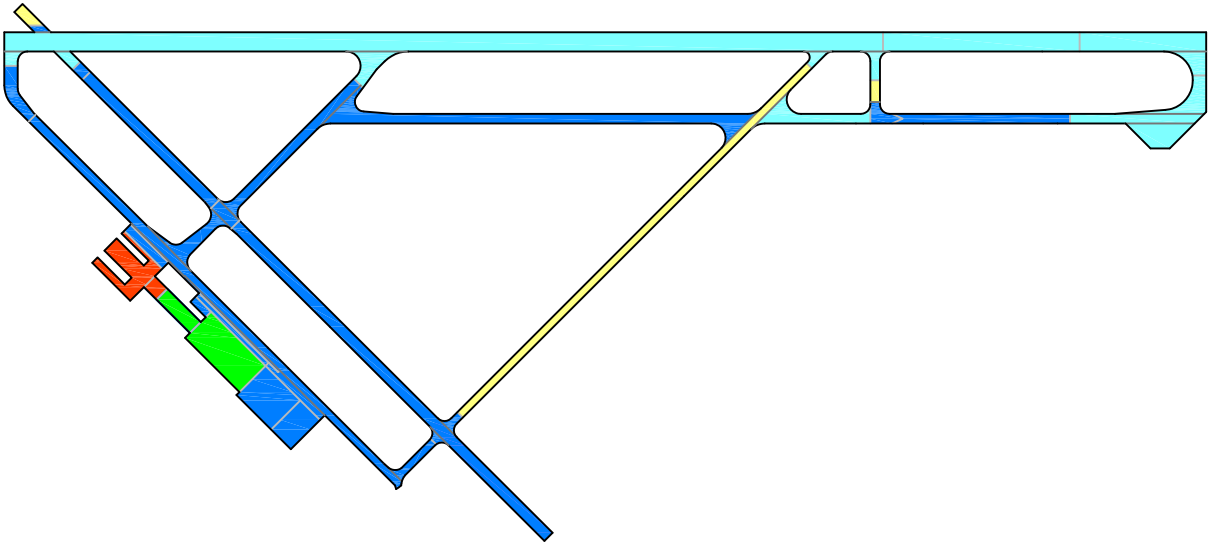
Figure LG-5. Future Pavement Condition.

A graphical representation of the projected PCIs listed in Table 1 is shown in Figure LG-5.
