LEXINGTON AIRPORT

Figure LX-1. Airport Layout, Dimensions and Pavement Cross-Sections.
Lexington Airport

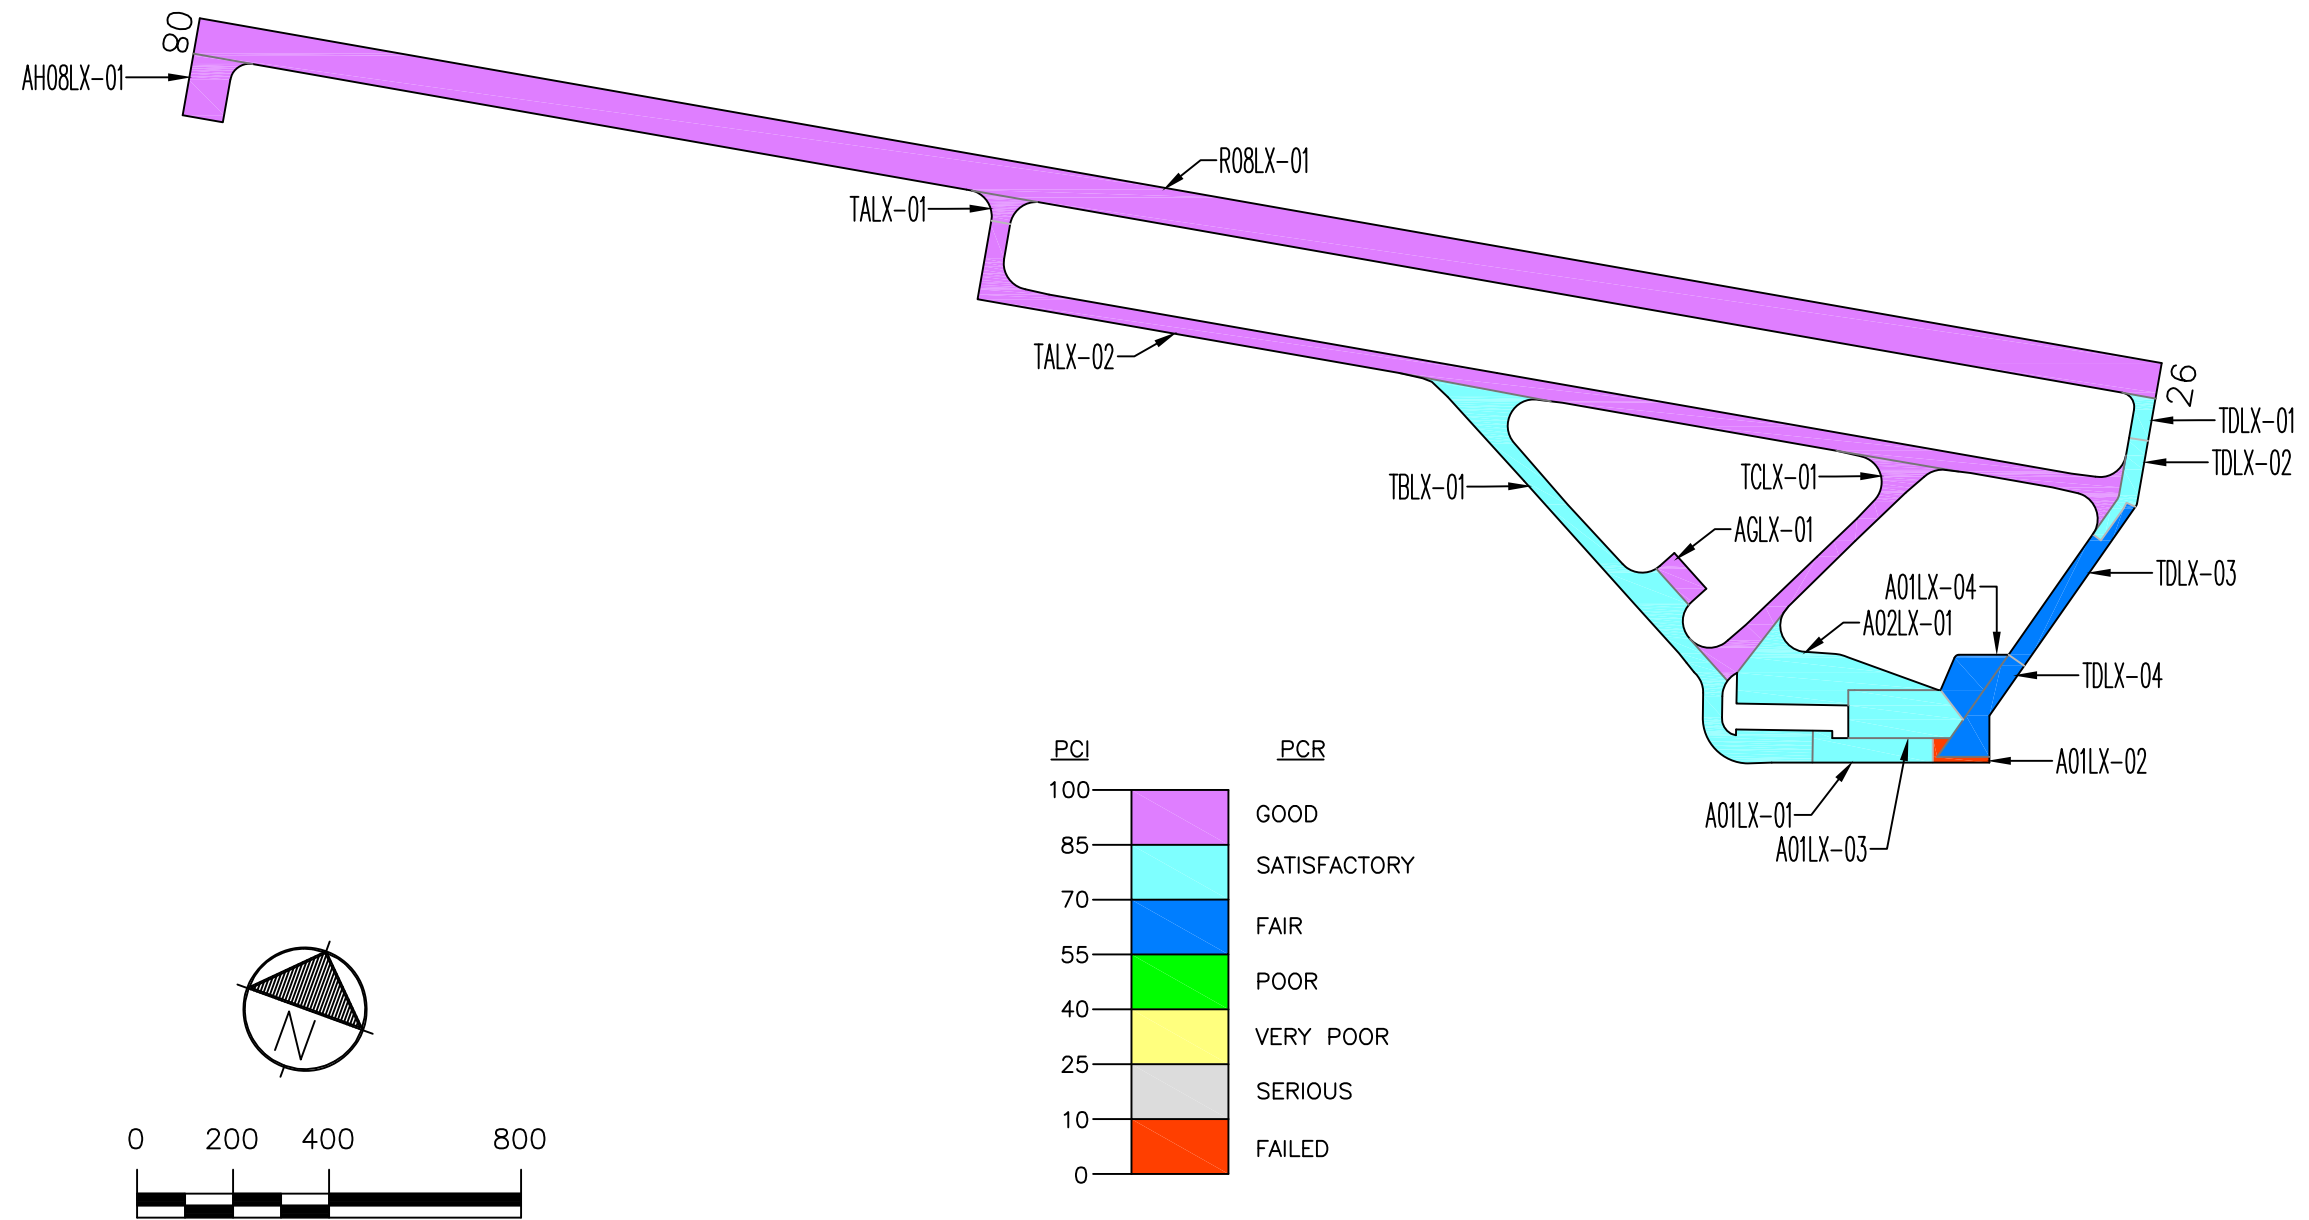
Figure LX-3. Pavement Condition in June 2017.
Lexington Airport

Section PCIs at Lexington Airport range from a low of 7 (a PCR of "Failed") to a high of 98 (a PCR of "Good"). The area-weighted average PCI for all airport pavements is 91, corresponding to an overall PCR of "Good". Figure LX-4 shows how much pavement area is associated with each Pavement Condition Rating category and also shows pavement condition distribution from the inspections conducted in 2011 and 2014.

The primary distresses observed during the inspection were: longitudinal and transverse cracking, weathering, and block cracking, with isolated occurrences of alligator cracking, raveling, patching and depressions.

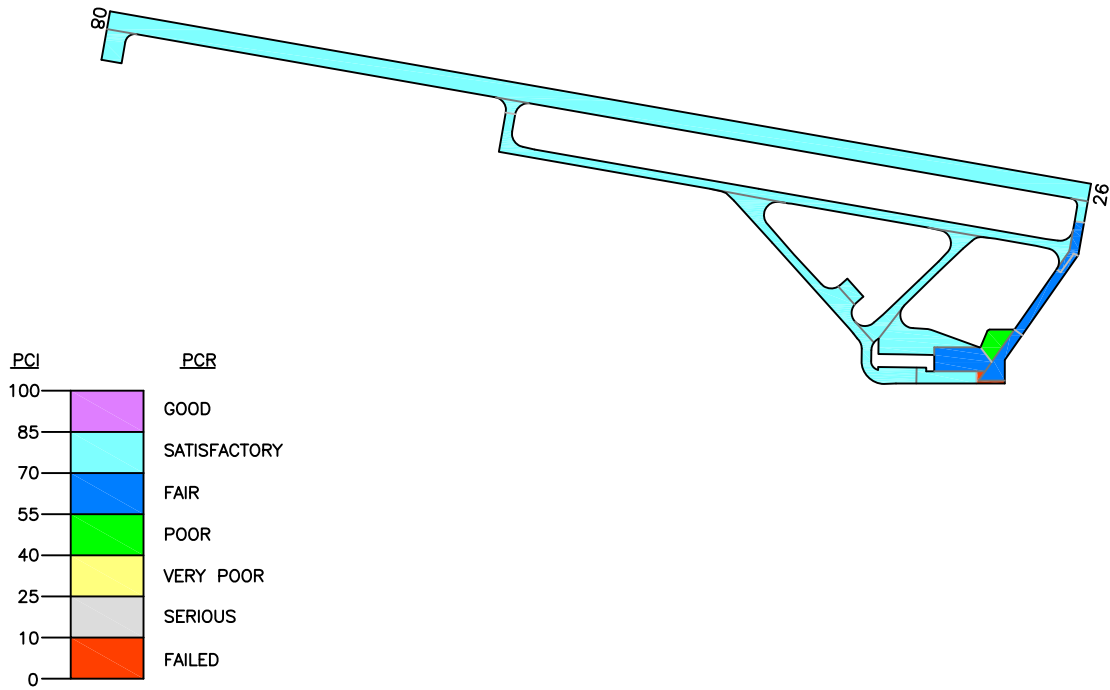
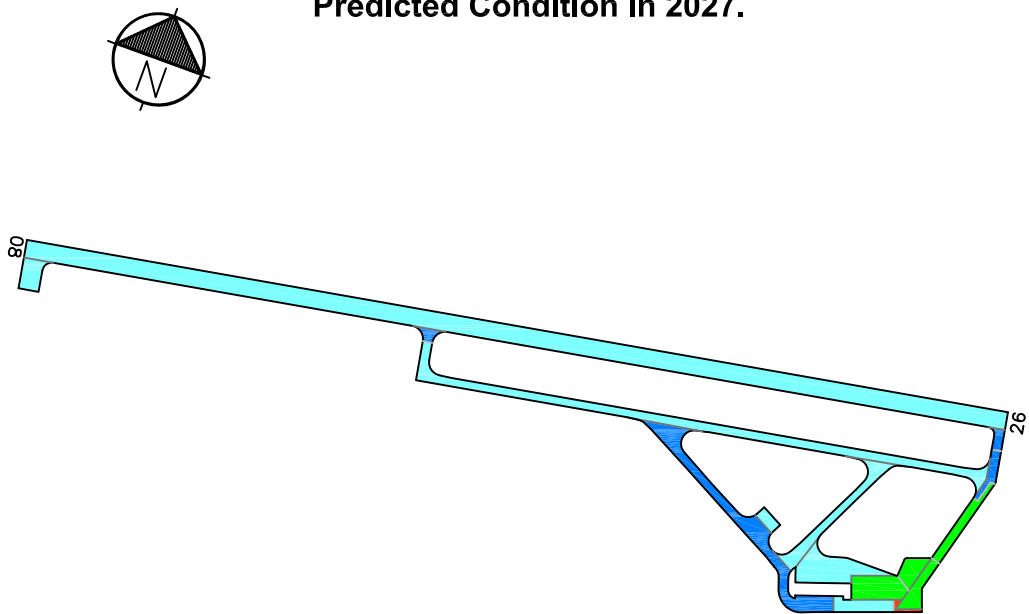
Figure LX-5. Future Pavement Condition.

A graphical representation of the projected PCIs listed in Table 1 is shown in Figure LX-5.
