# MADRAS MUNICIPAL AIRPORT

This report describes how your Pavement Maintenance Management Program (PMMP) was developed. Your Program was developed as part of the Oregon Continuous Aviation System Plan sponsored in part by the Oregon Department of Aviation and the Federal Aviation Administration (FAA). The information and data contained in this report ensures you comply with the requirements of FAA Grant Assurance Number 11 which states that any airport requesting federal funds for pavement improvement projects must have implemented a pavement maintenance management program.

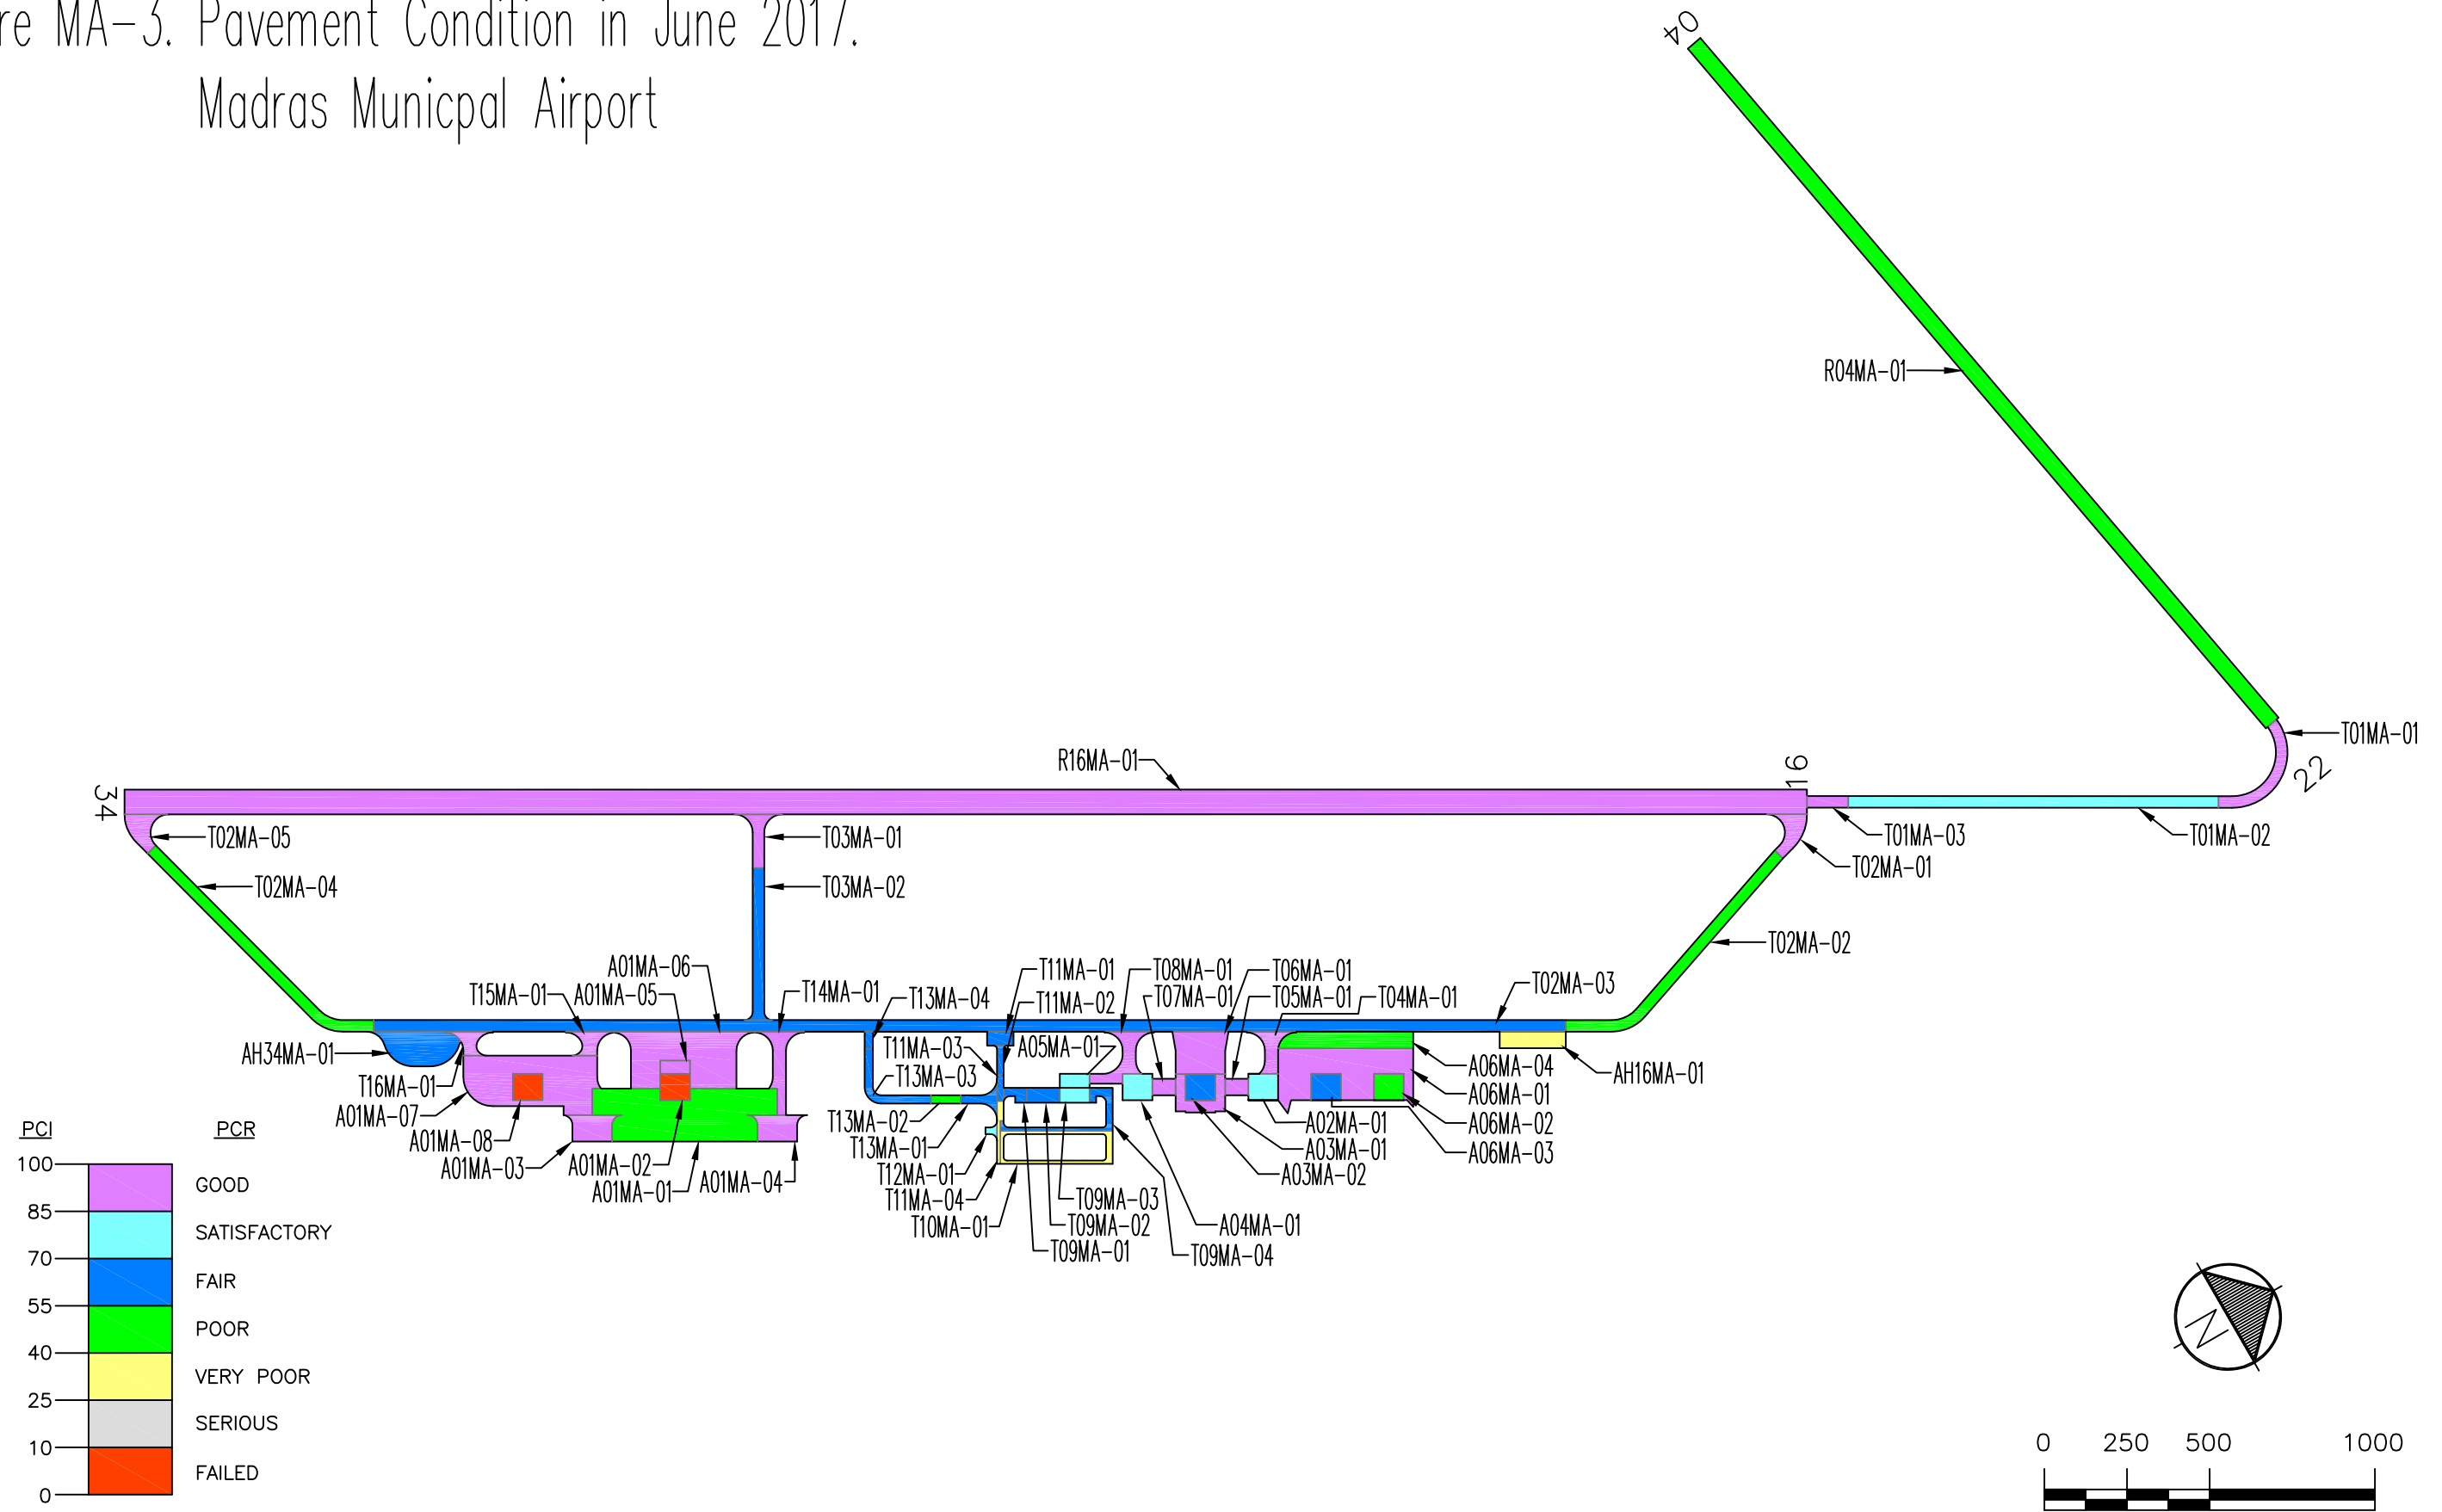
Figure MA-3. Pavement Condition in June 2017.  
 Madras Municipal Airport

The Branch Condition Report in Appendix 1 summarizes current pavement condition by branch while the Section Condition Report in Appendix 2 lists pavement condition by section. The current Pavement Condition Rating (PCR) is shown graphically in Figure MA-3.

Section PCIs at Madras Municipal Airport range from a low of 0 (a PCR of “Failed”) to a high of 100 (a PCR of “Good”). The area-weighted average PCI for all airport pavements is 78, corresponding to an overall PCR of “Satisfactory”. Figure MA-4 shows how much pavement area is associated with each Pavement Condition Rating category and also shows pavement condition distribution from the inspections conducted in 2011 and 2014.

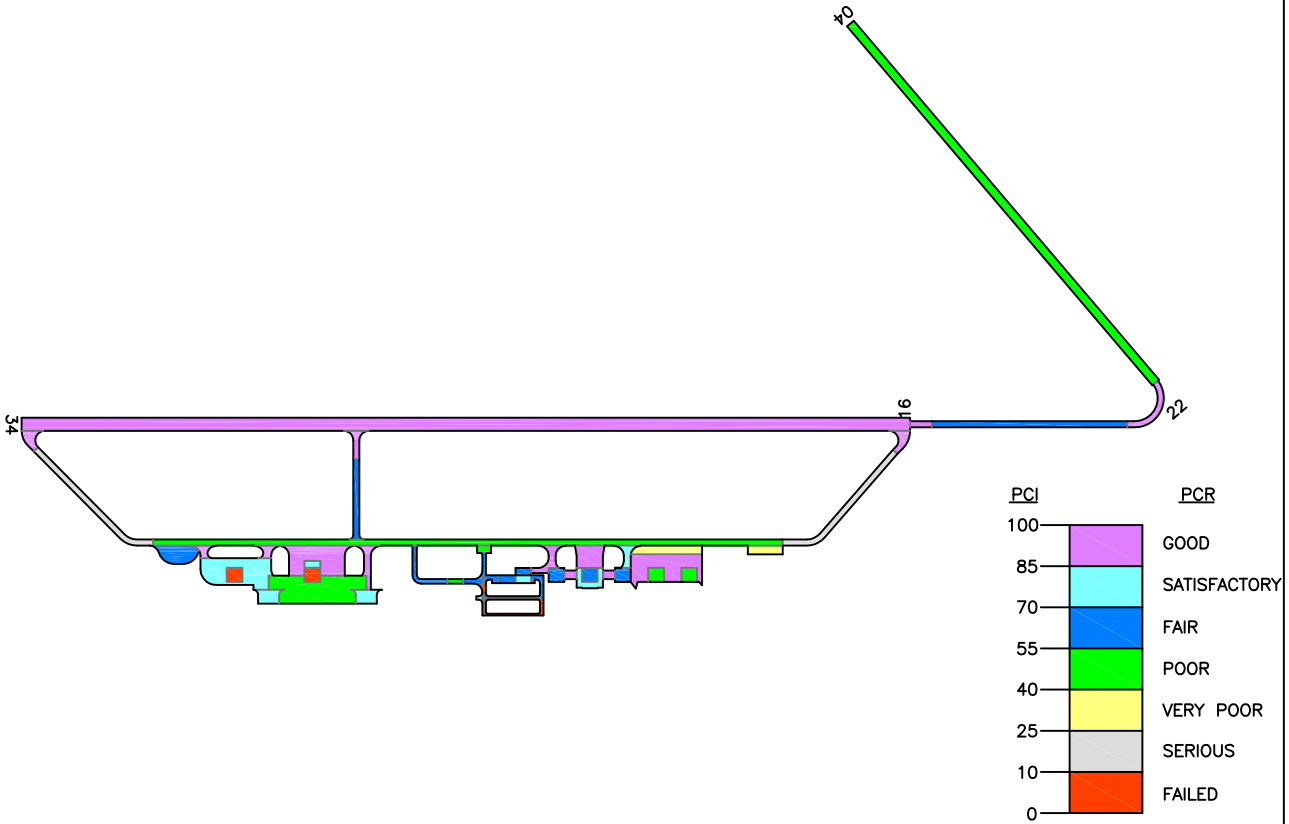
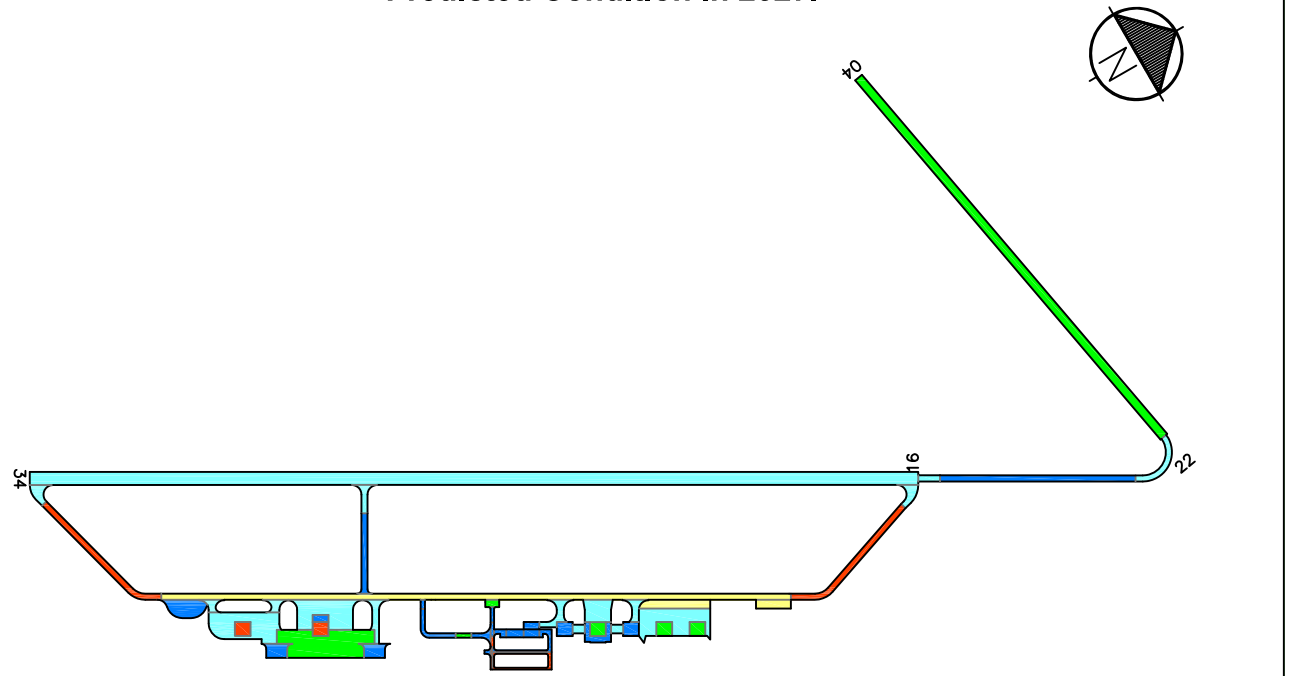
**Figure MA-5. Future Pavement Condition.**

A graphical representation of the projected PCIs listed in Table 1 is shown in Figure MA-5.
