# MONUMENT MUNICIPAL AIRPORT

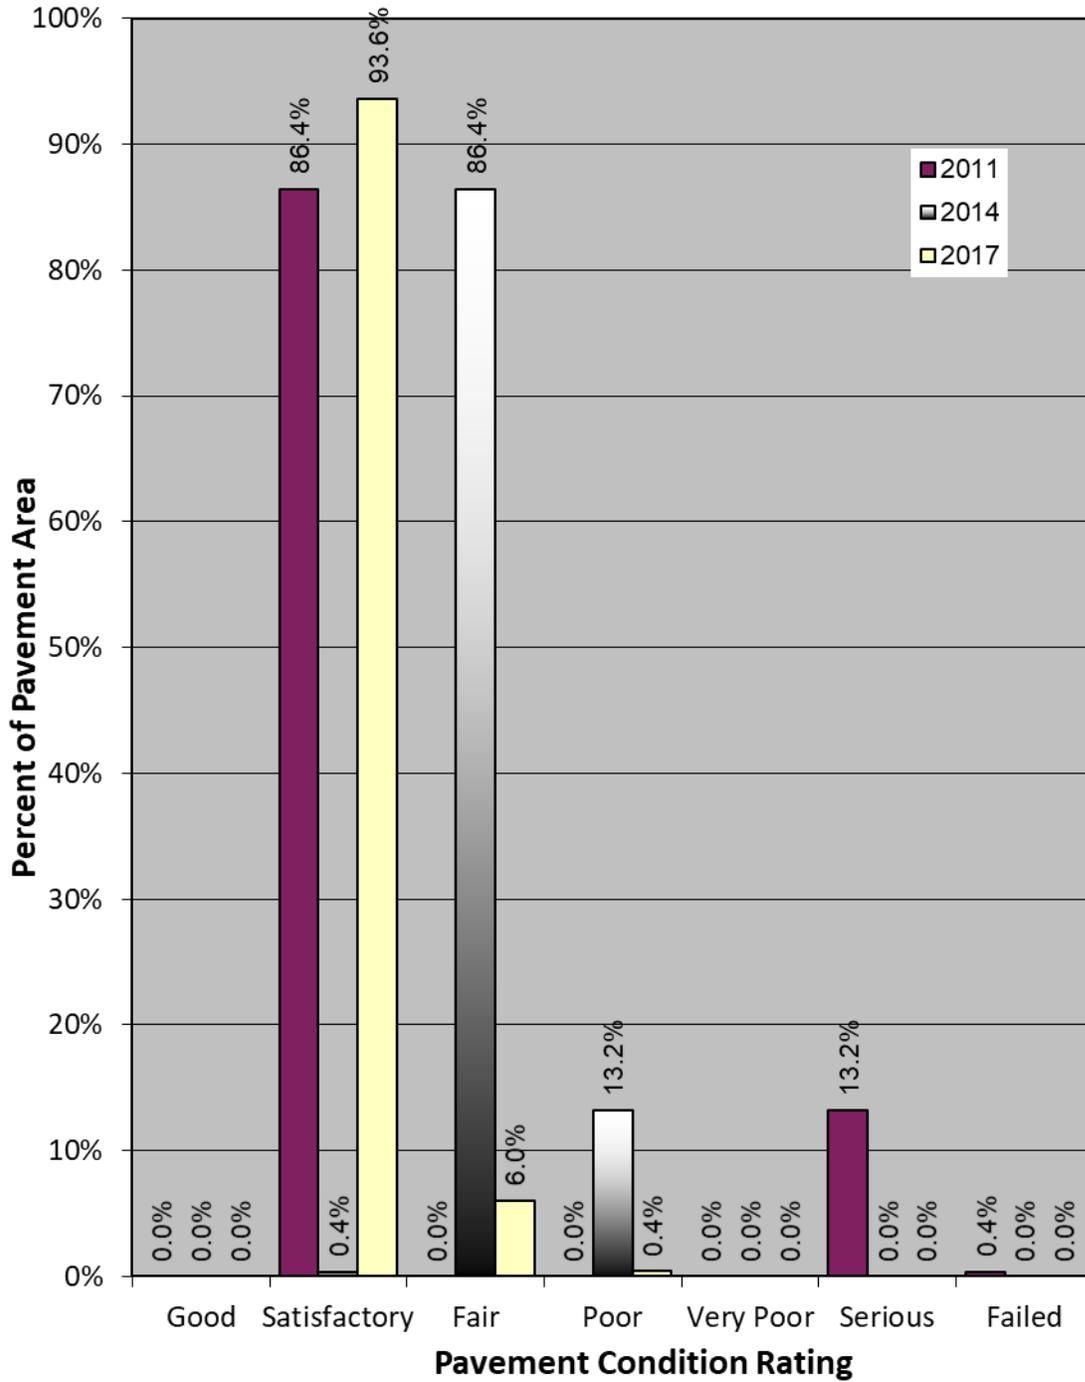
**Figure MN-4. Distribution of Pavement Condition  
Monument Municipal Airport**

Section PCIs at Monument Municipal Airport range from a low of 53 (a PCR of “Poor”) to a high of 75 (a PCR of “Satisfactory”). The area-weighted average PCI for all airport pavements is 75, corresponding to an overall PCR of “Satisfactory”. Figure MN-4 shows how much pavement area is associated with each Pavement Condition Rating category and also shows pavement condition distribution from the inspections conducted in 2011 and 2014.
