# ONTARIO MUNICIPAL AIRPORT

This report describes how your Pavement Maintenance Management Program (PMMP) was developed. Your Program was developed as part of the Oregon Continuous Aviation System Plan sponsored in part by the Oregon Department of Aviation and the Federal Aviation Administration (FAA). The information and data contained in this report ensures you comply with the requirements of FAA Grant Assurance Number 11 which states that any airport requesting federal funds for pavement improvement projects must have implemented a pavement maintenance management program.

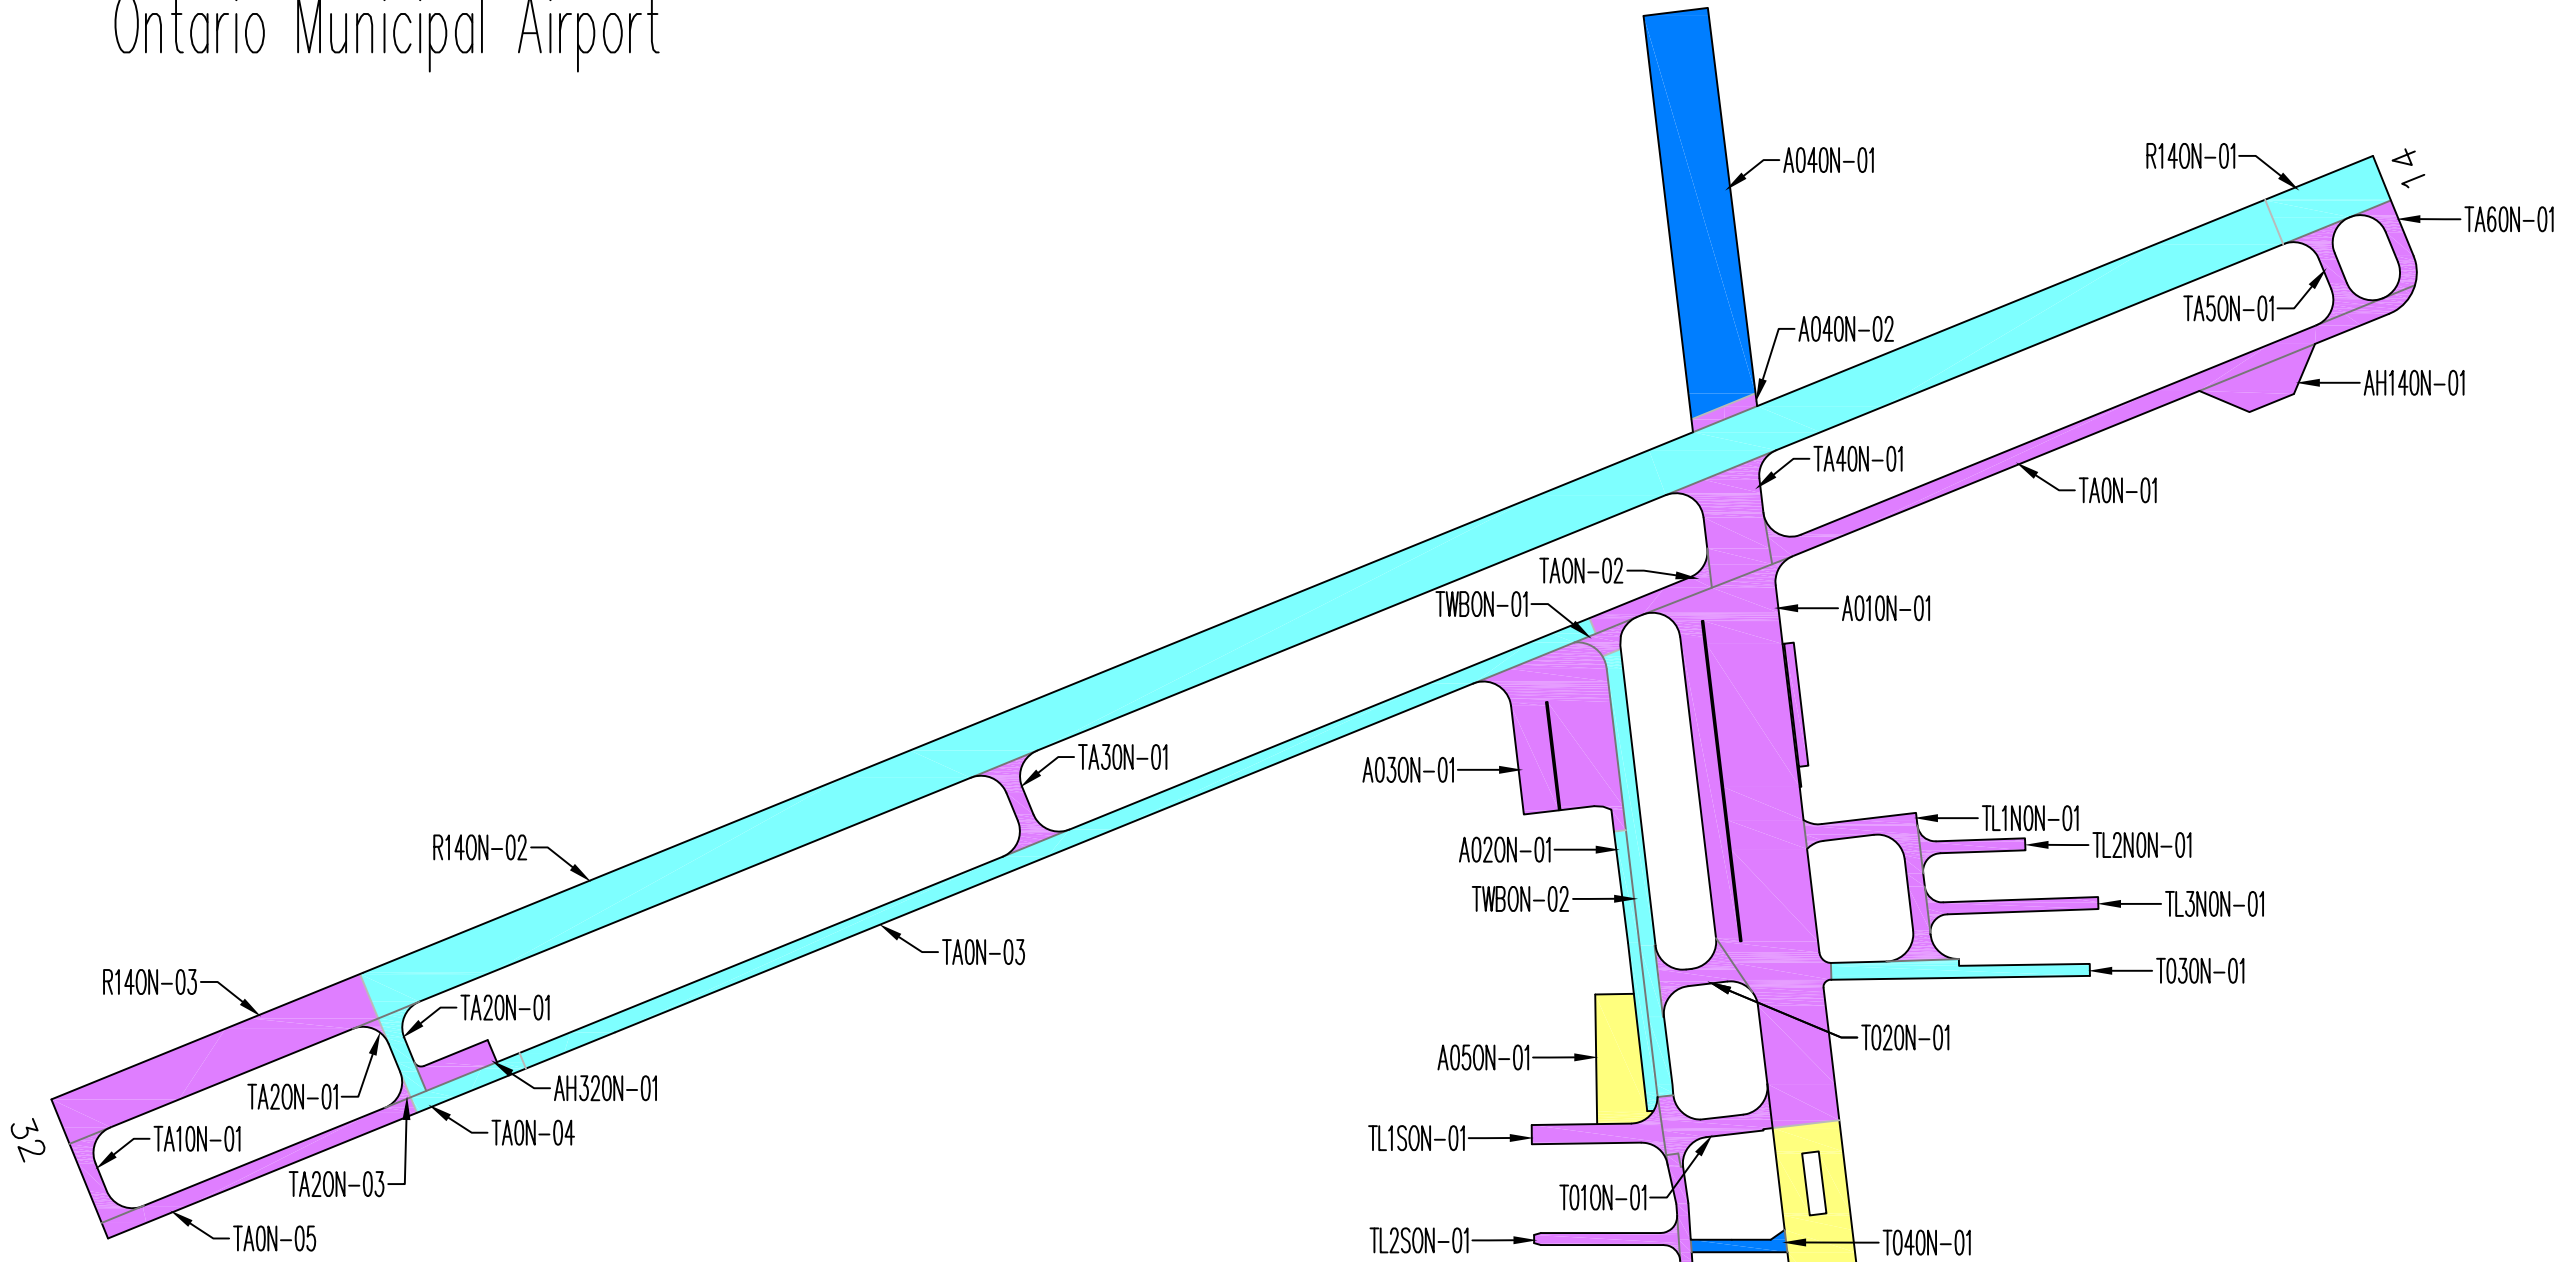
Figure ON-3. Pavement Condition in June 2017.  
Ontario Municipal Airport

Section PCIs at Ontario Municipal Airport range from a low of 28 (a PCR of “Very Poor”) to a high of 100 (a PCR of “Good”). The area-weighted average PCI for all airport pavements is 81, corresponding to an overall PCR of “Satisfactory”. Figure ON-4 shows how much pavement area is associated with each Pavement Condition Rating category and also shows pavement condition distribution from the inspections conducted in 2011 and 2014.

The primary distresses observed during the inspection were: weathering, longitudinal and transverse cracking, patching, depressions and block cracking, with isolated occurrences of alligator cracking and raveling.

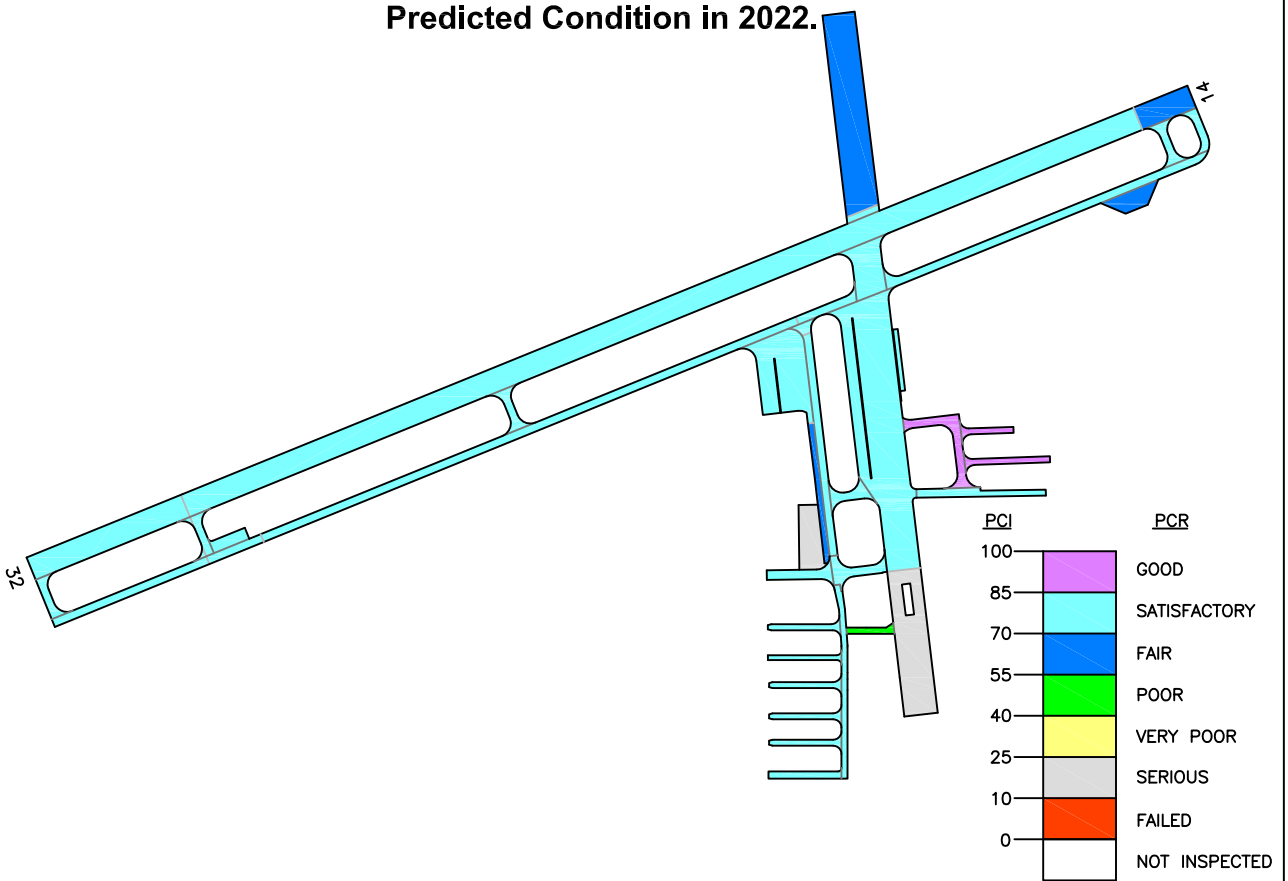
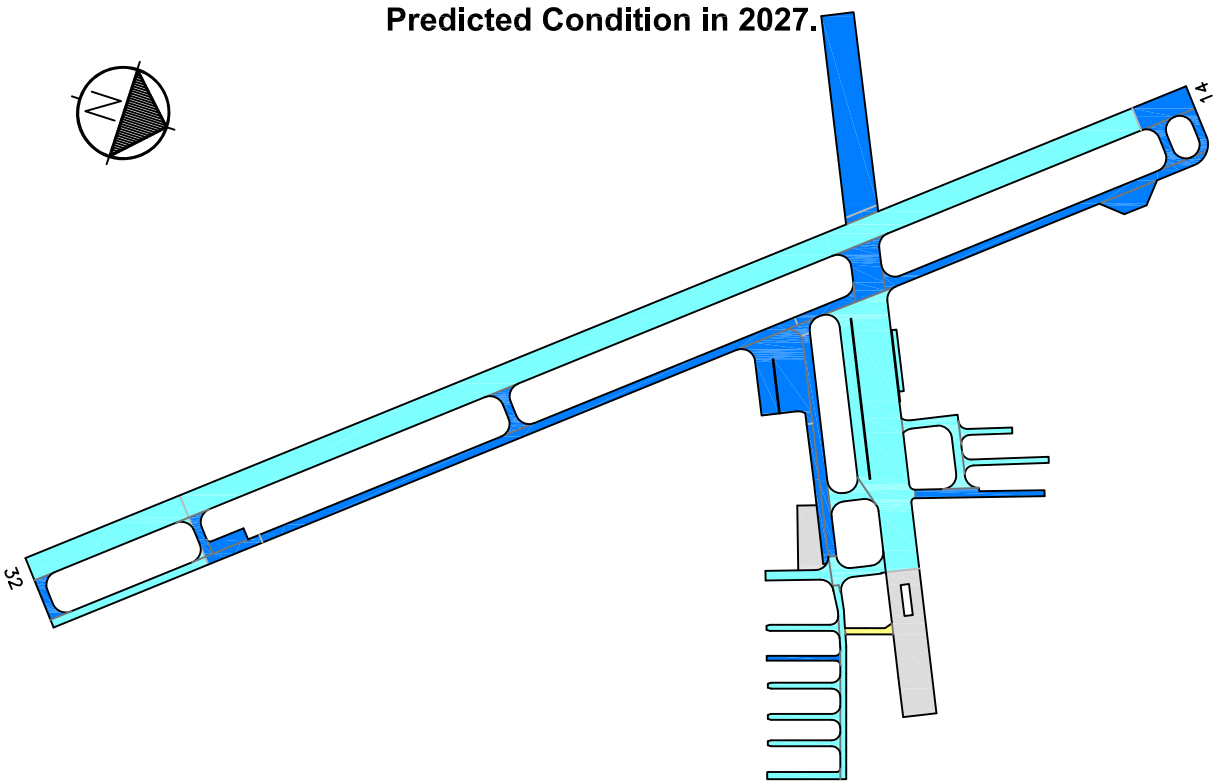
**Figure ON-5. Future Pavement Condition.**

A graphical representation of the projected PCIs listed in Table 1 is shown in Figure ON-5.
