EASTERN OREGON REGIONAL AIRPORT AT PENDLETON

Using the branch, section and sample unit divisions established, a visual condition survey was conducted at Eastern Oregon Regional Airport at Pendleton in June 2017. During the inspection, pavement defects were identified and measured in accordance with the methodology outlined in ASTM D5430. This inspection ensures your airport complies with the “detailed inspection” requirement of FAA’s PMMP guidelines. After collection, the data were entered into the PAVER software for analysis. These data are reproduced in the Re-Inspection Report attached as Appendix 4.

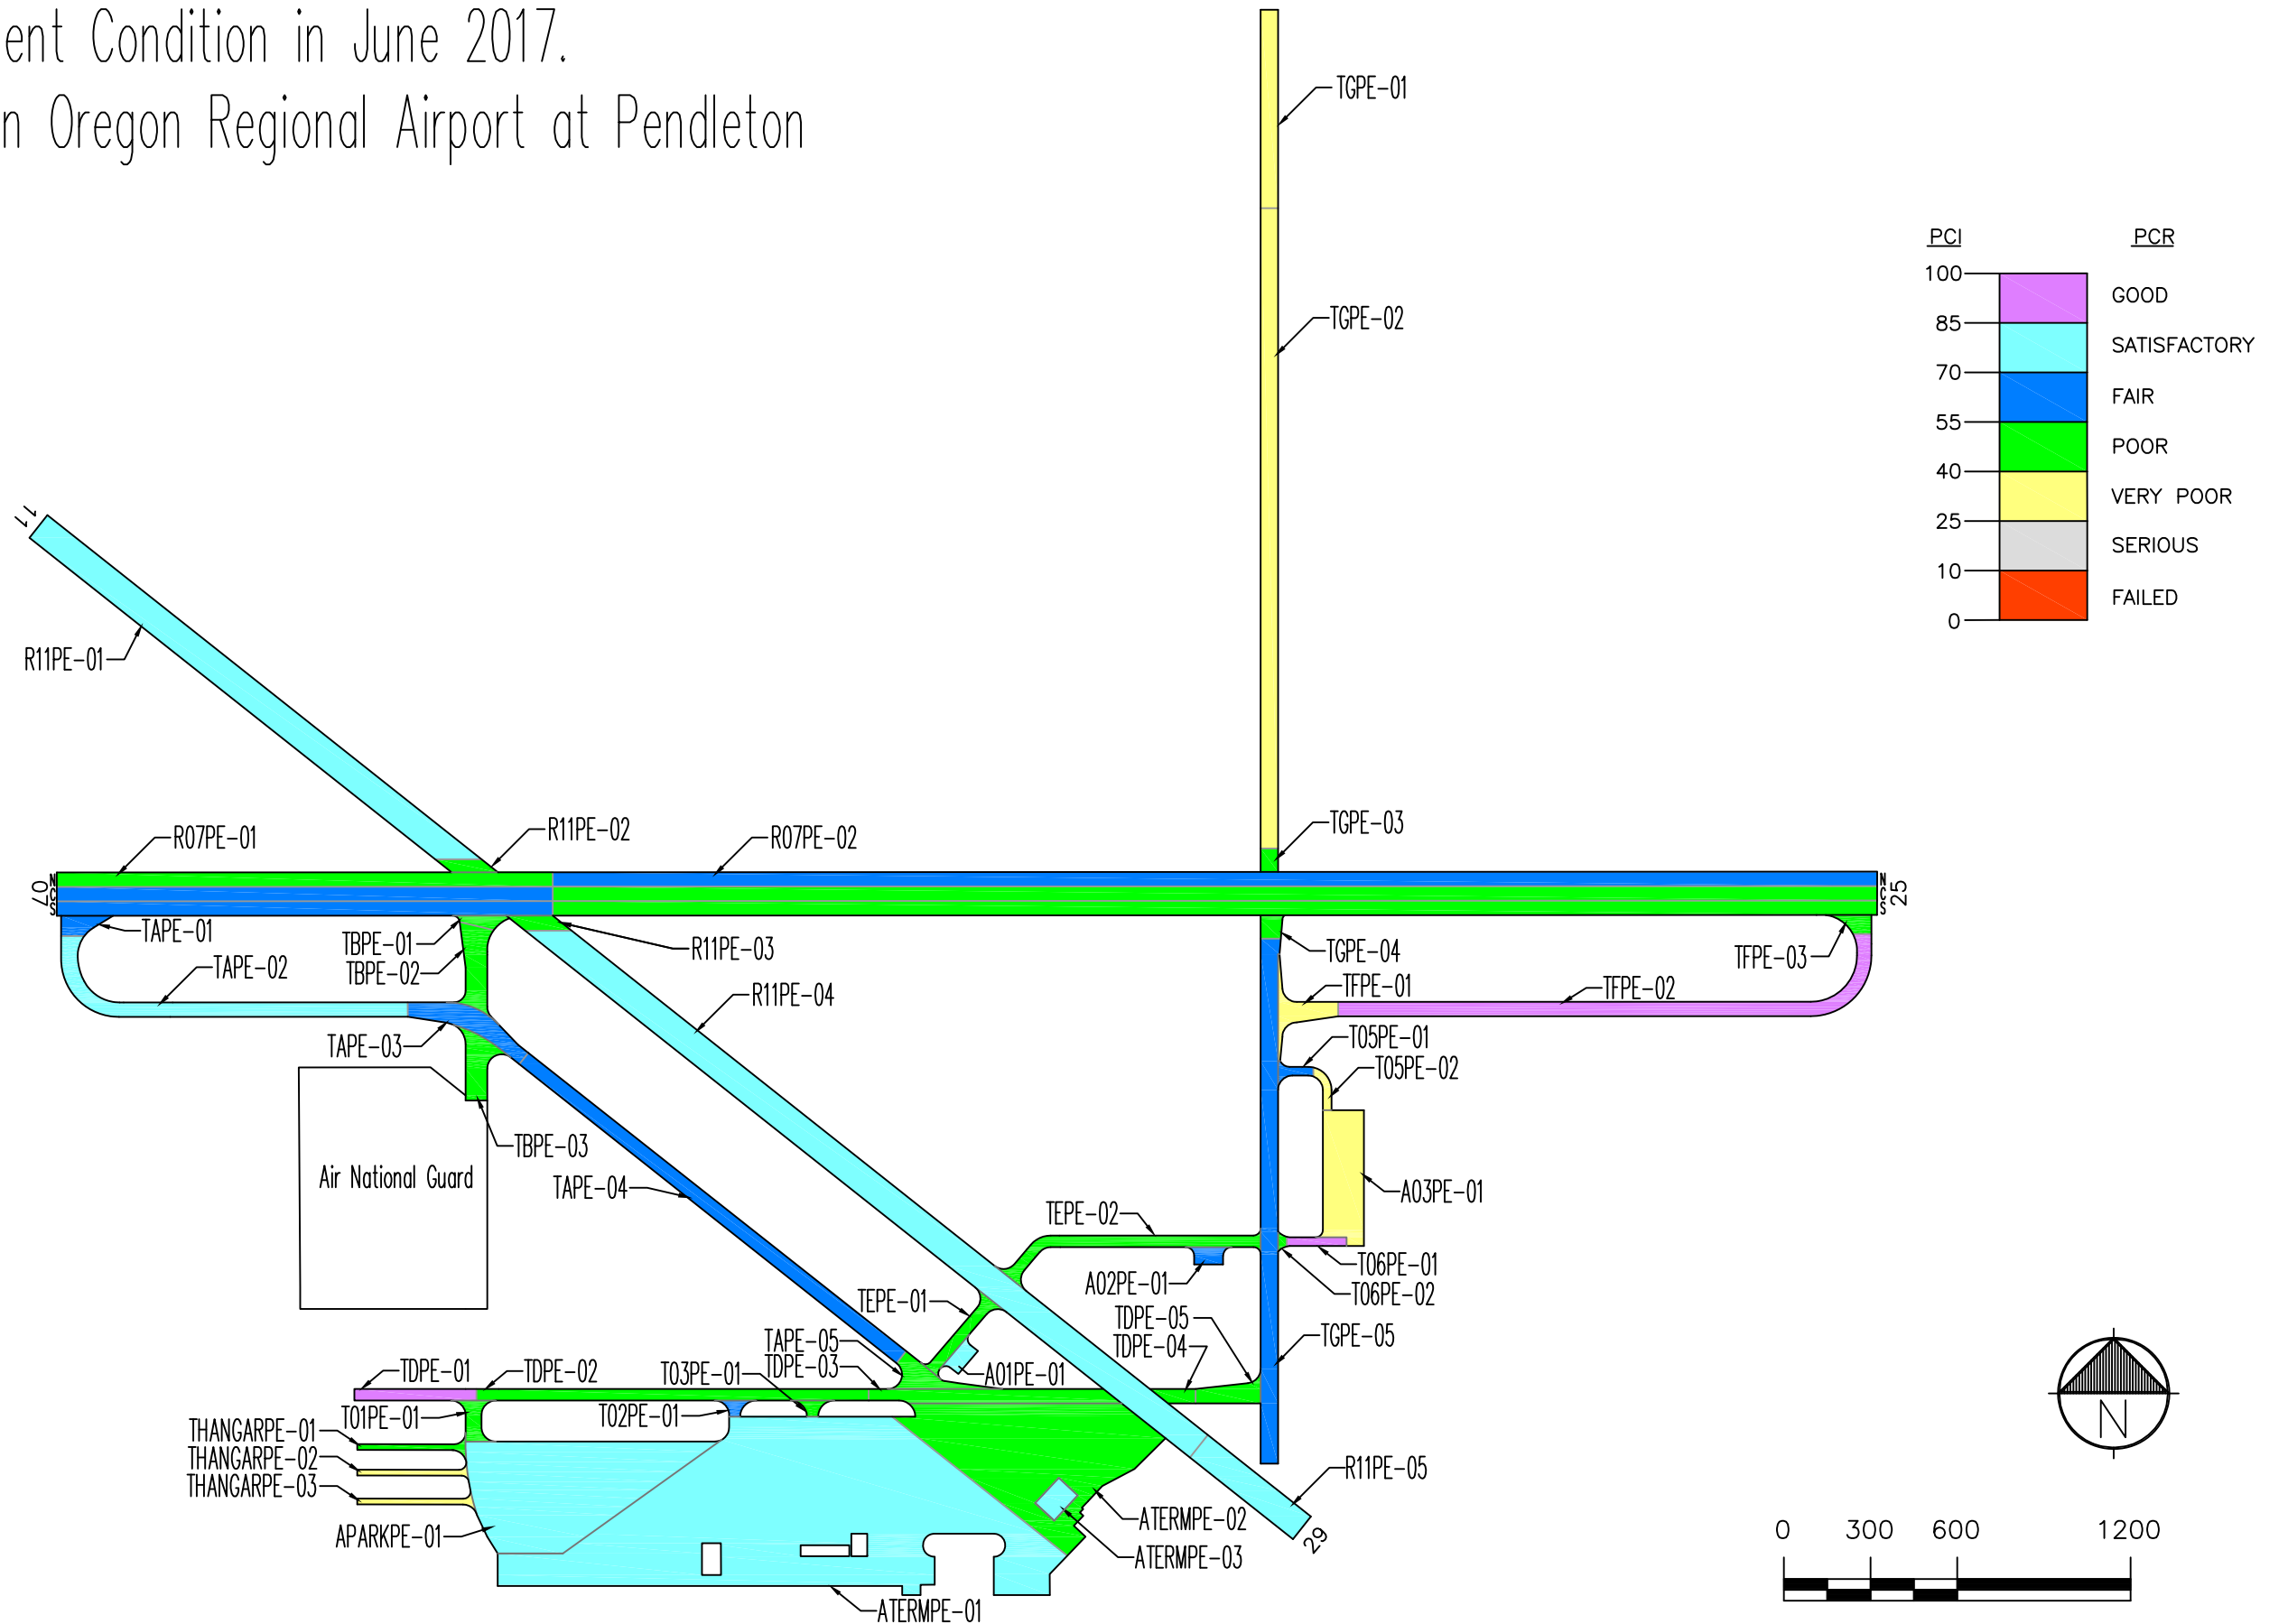
Figure PE-3. Pavement Condition in June 2017.
Eastern Oregon Regional Airport at Pendleton

The Branch Condition Report in Appendix 1 summarizes current pavement condition by branch while the Section Condition Report in Appendix 2 lists pavement condition by section. The current Pavement Condition Rating (PCR) is shown graphically in Figure PE-3.

Section PCIs at Eastern Oregon Regional Airport at Pendleton range from a low of 30 (a PCR of “Very Poor”) to a high of 95 (a PCR of “Good”). The area-weighted average PCI for all airport pavements is 64, corresponding to an overall PCR of “Fair”. Figure PE-4 shows how much pavement area is associated with each Pavement Condition Rating category. The condition distribution from the 2014 inspection is also included.
