# PRINEVILLE/CROOK COUNTY AIRPORT

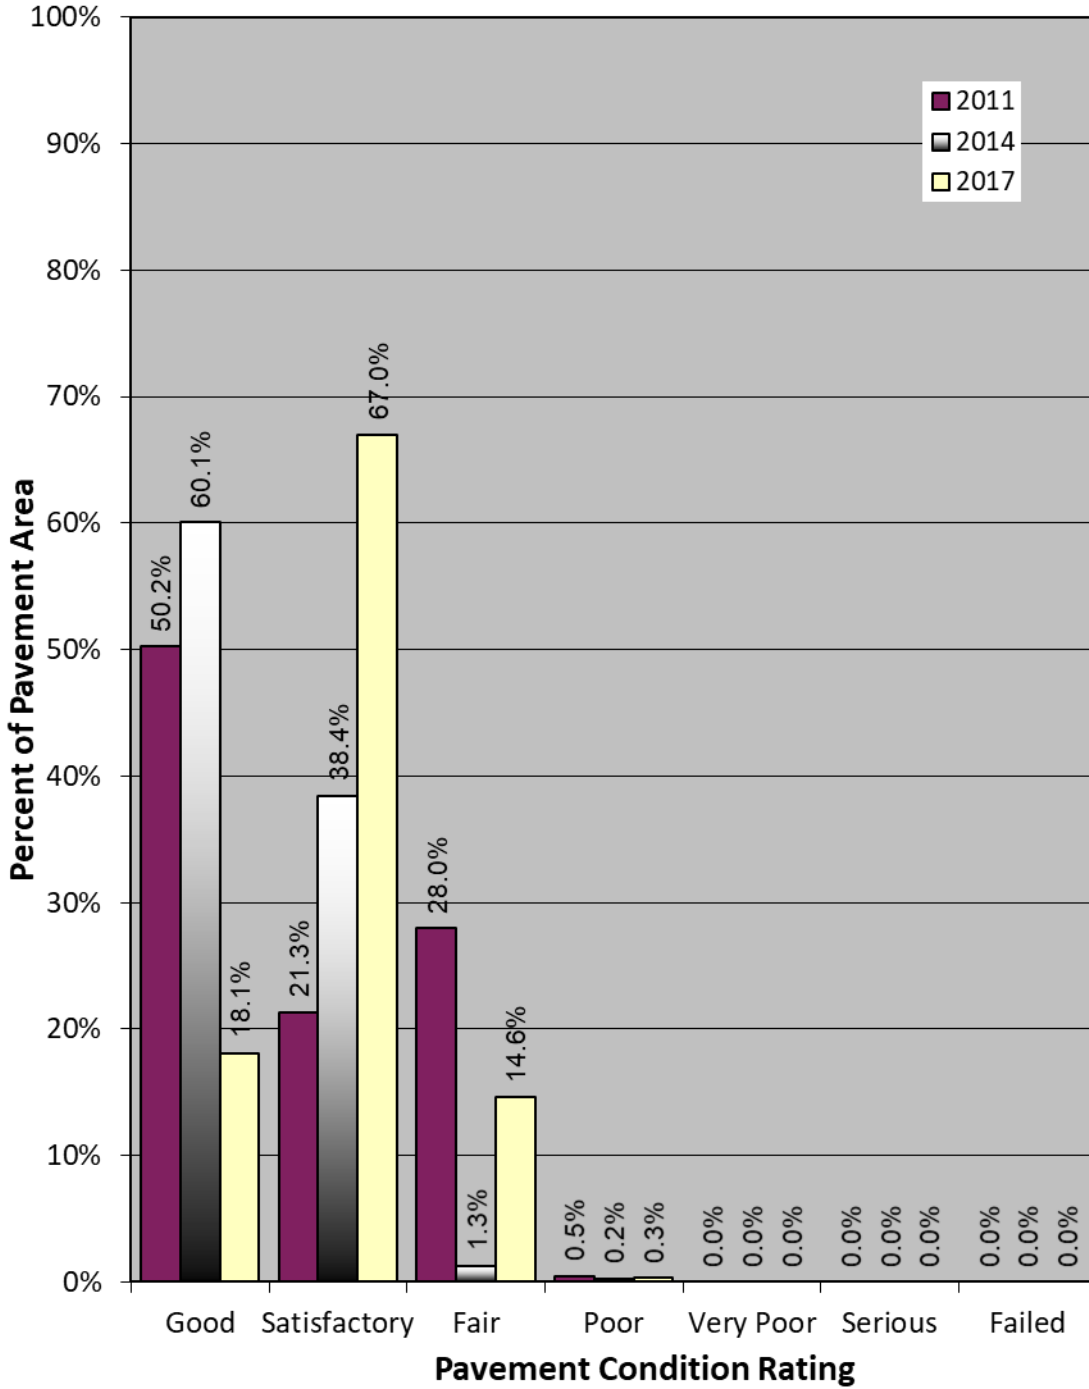
**Figure PR-4. Distribution of Pavement Condition  
Prineville/Crook County Airport**

Section PCIs at Prineville Airport range from a low of 48 (a PCR of “Poor”) to a high of 100 (a PCR of “Good”). The area-weighted average PCI for all airport pavements is 80, corresponding to an overall PCR of “Satisfactory”. Figure PR-4 shows how much pavement area is associated with each Pavement Condition Rating category and also shows pavement condition distribution from the inspections conducted in 2011 and 2014.

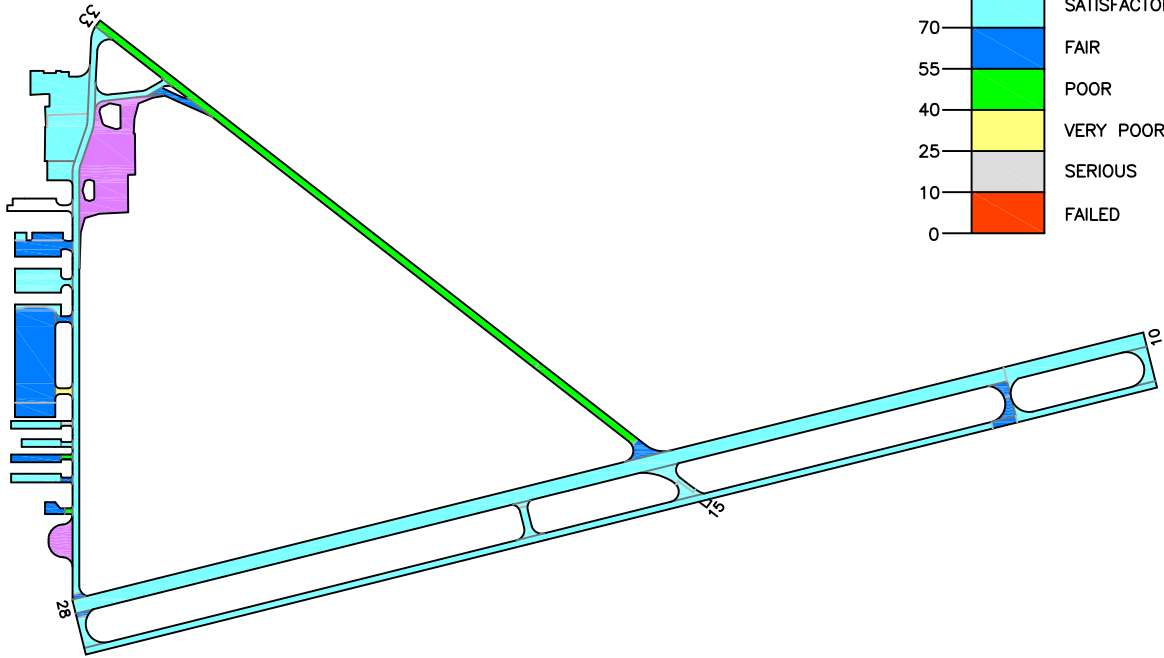
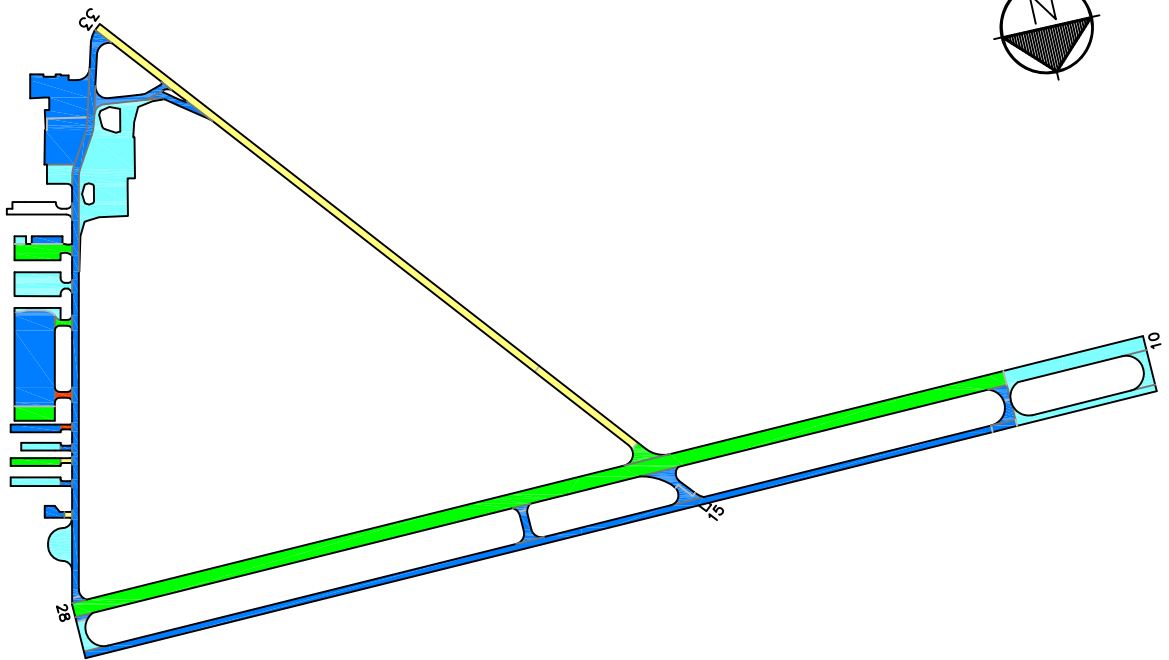
**Figure PR-5. Future Pavement Condition.**

A graphical representation of the projected PCIs listed in Table 1 is shown in Figure PR-5.
