SISTERS EAGLE AIR AIRPORT

Figure SI-1. Airport Layout, Dimensions and Pavement Cross-Sections.
Sisters Eagle Air Airport

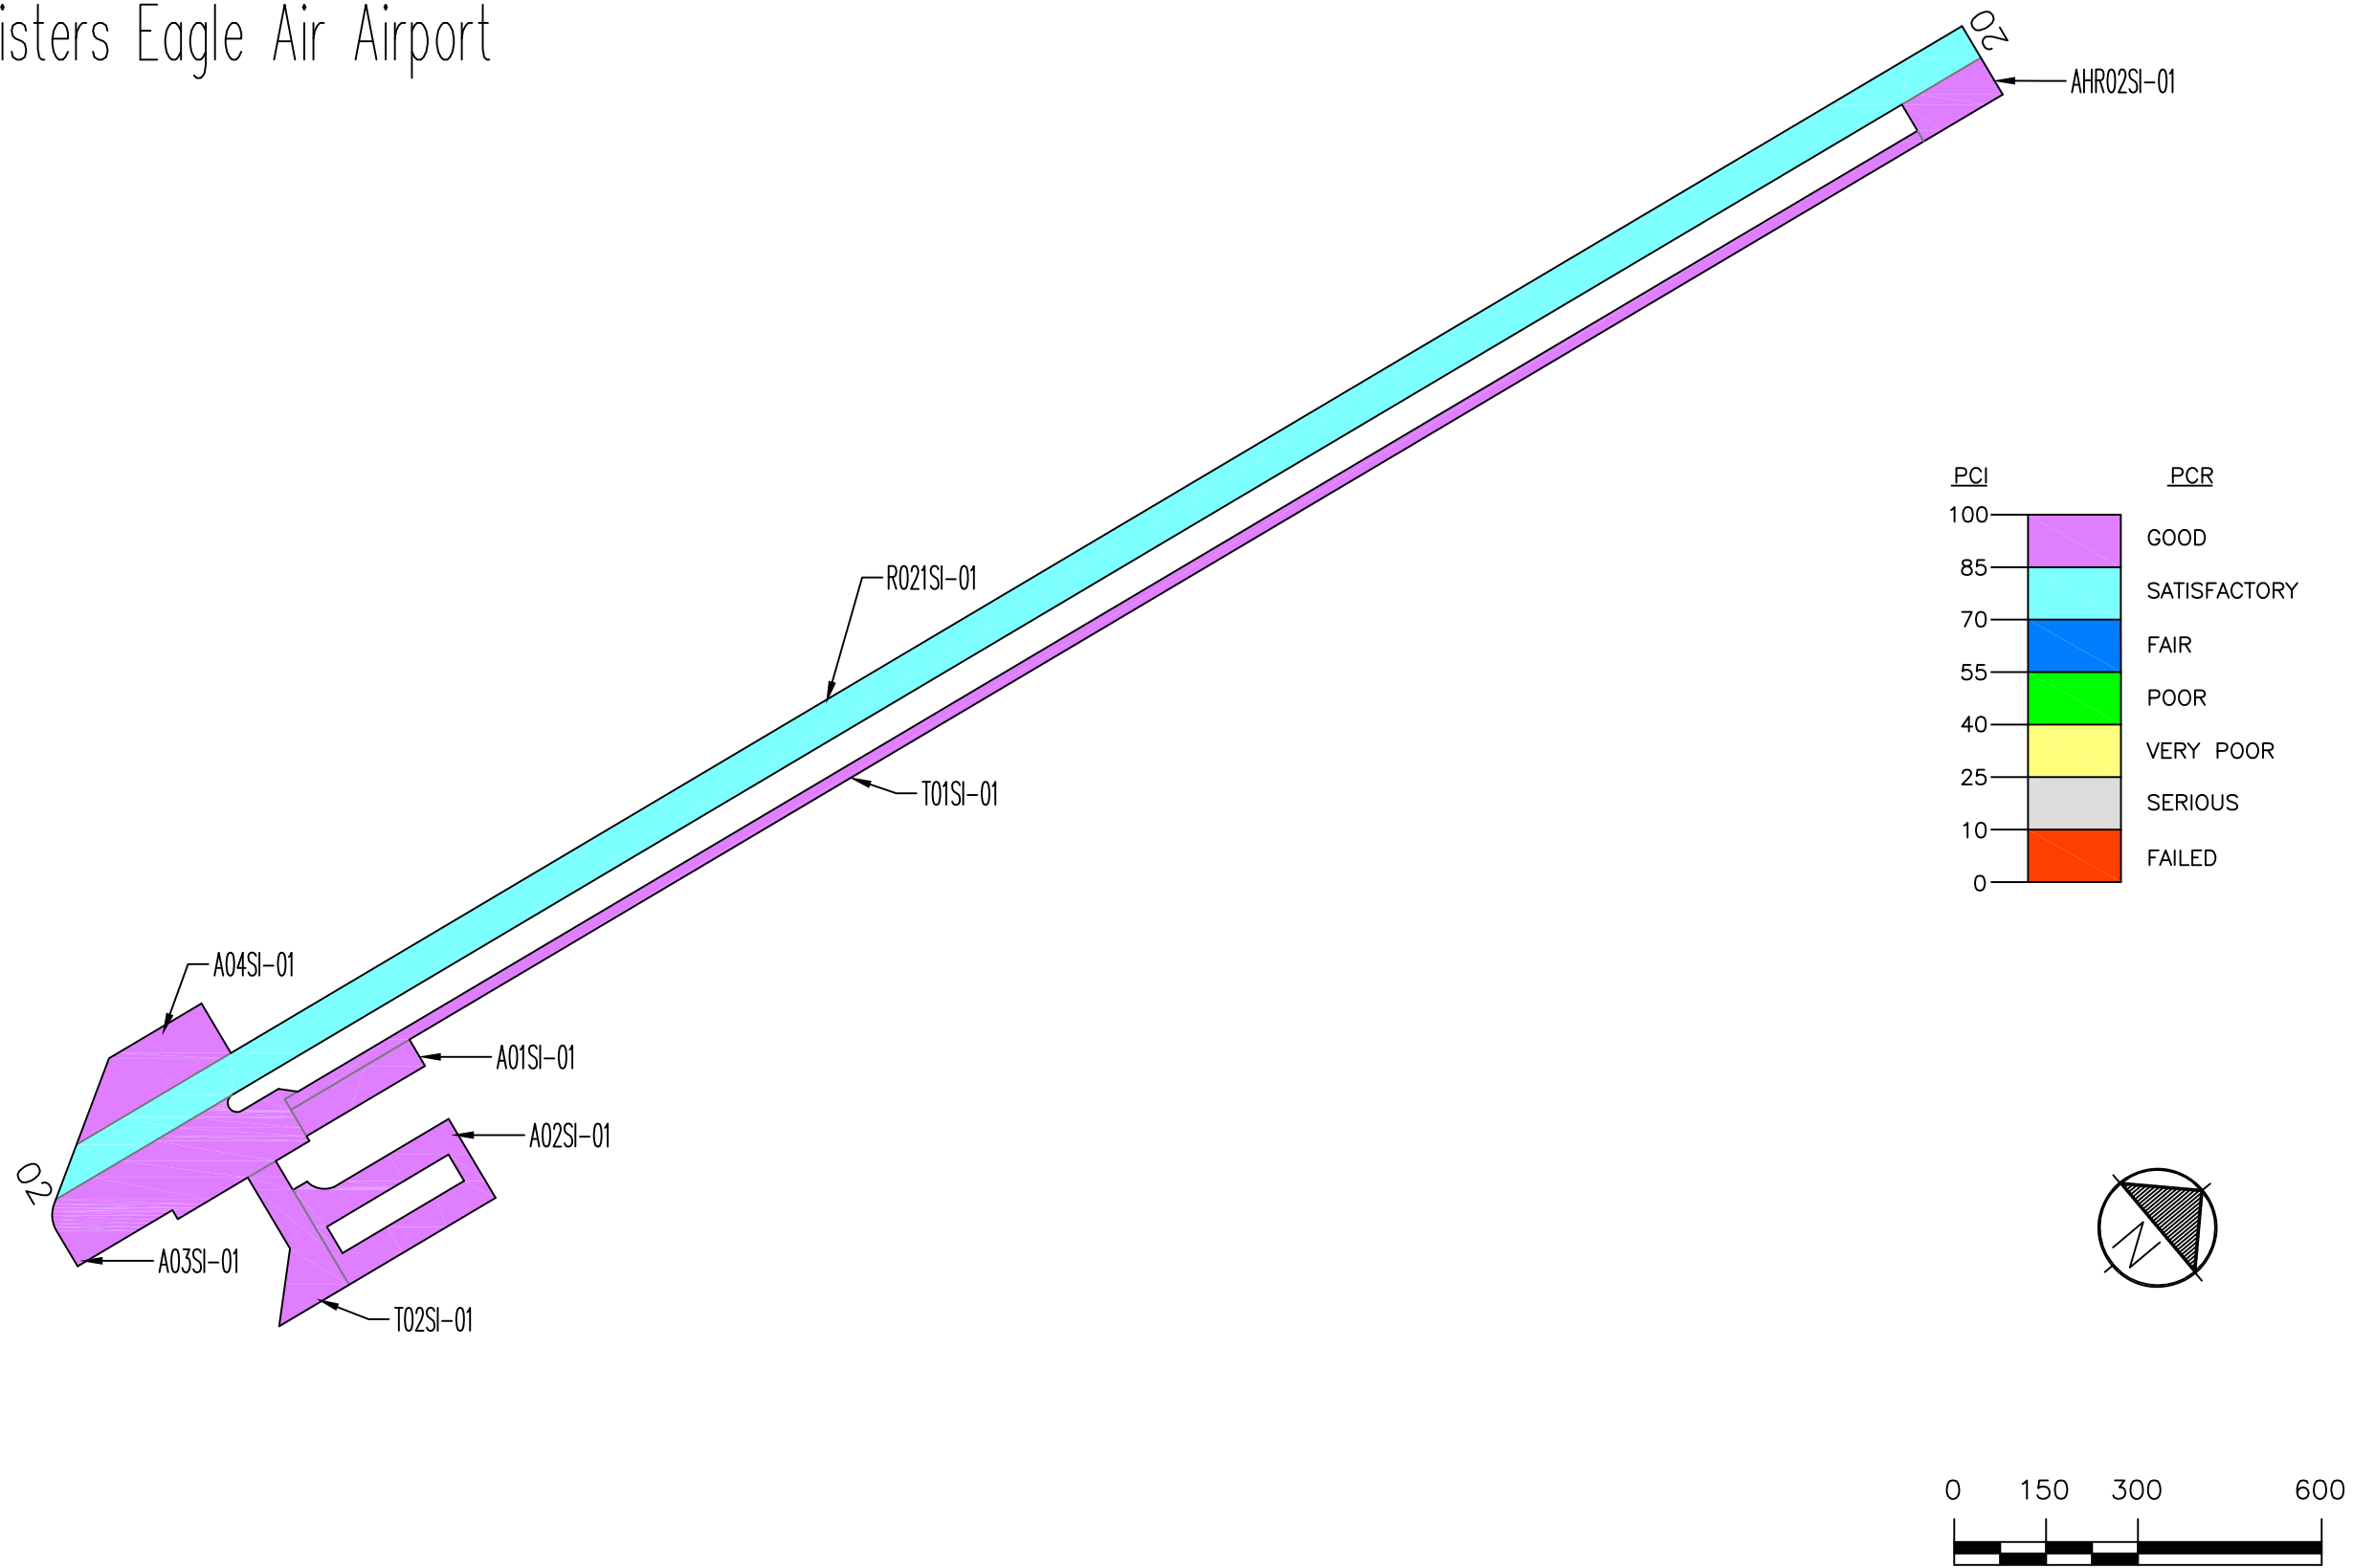
Figure SI-3. Pavement Condition in June 2017.
Sisters Eagle Air Airport

The Branch Condition Report in Appendix 1 summarizes current pavement condition by branch while the Section Condition Report in Appendix 2 lists pavement condition by section. The current Pavement Condition Rating (PCR) is shown graphically in Figure SI-3.

Section PCIs at Sisters Eagle Air Airport range from a low of 85 (a PCR of “Satisfactory”) to a high of 100 (a PCR of “Good”). The area-weighted average PCI for all airport pavements is 91, corresponding to an overall PCR of “Good”. Figure SI-4 shows how much pavement area is associated with each Pavement Condition Rating category and also shows pavement condition distribution from the inspections conducted in 2011 and 2014.

The only distress observed during the inspection was longitudinal and transverse cracking.

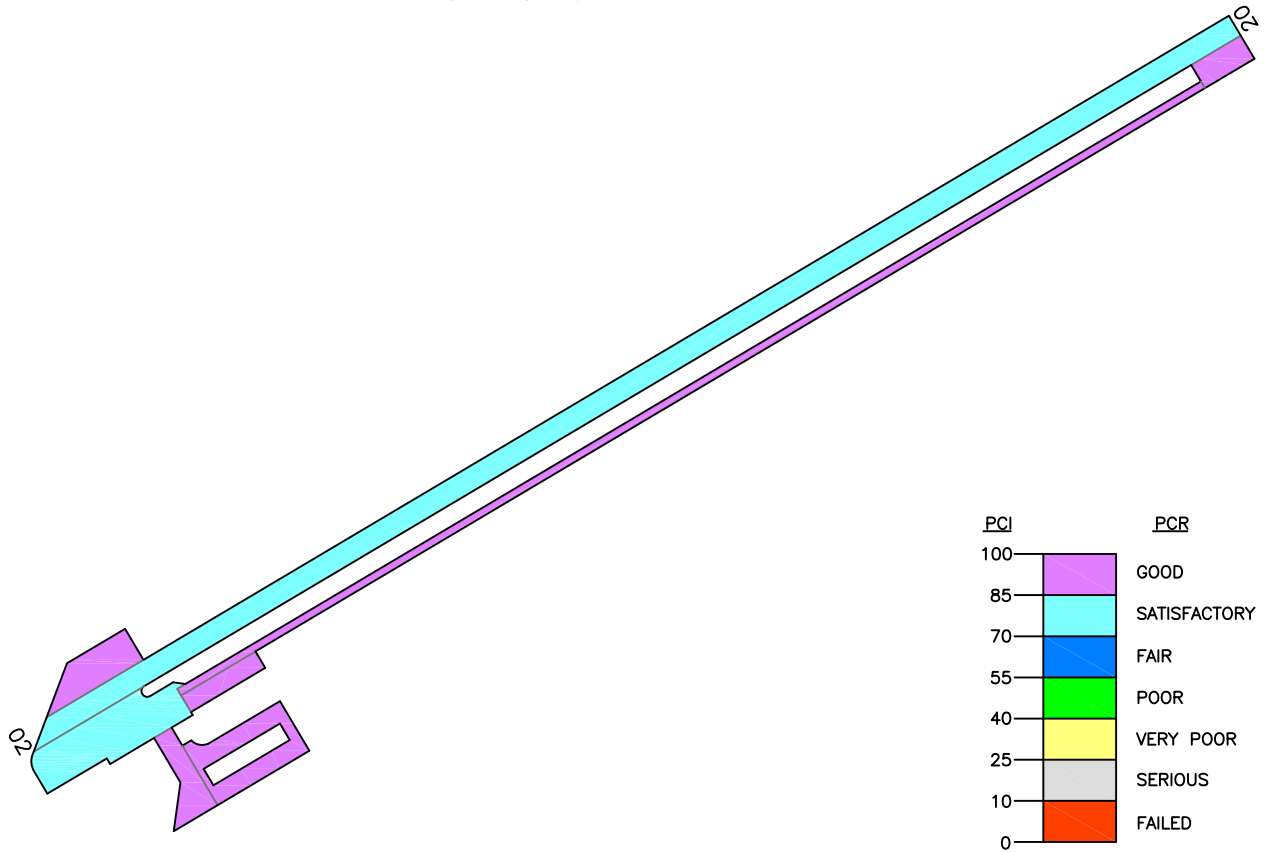
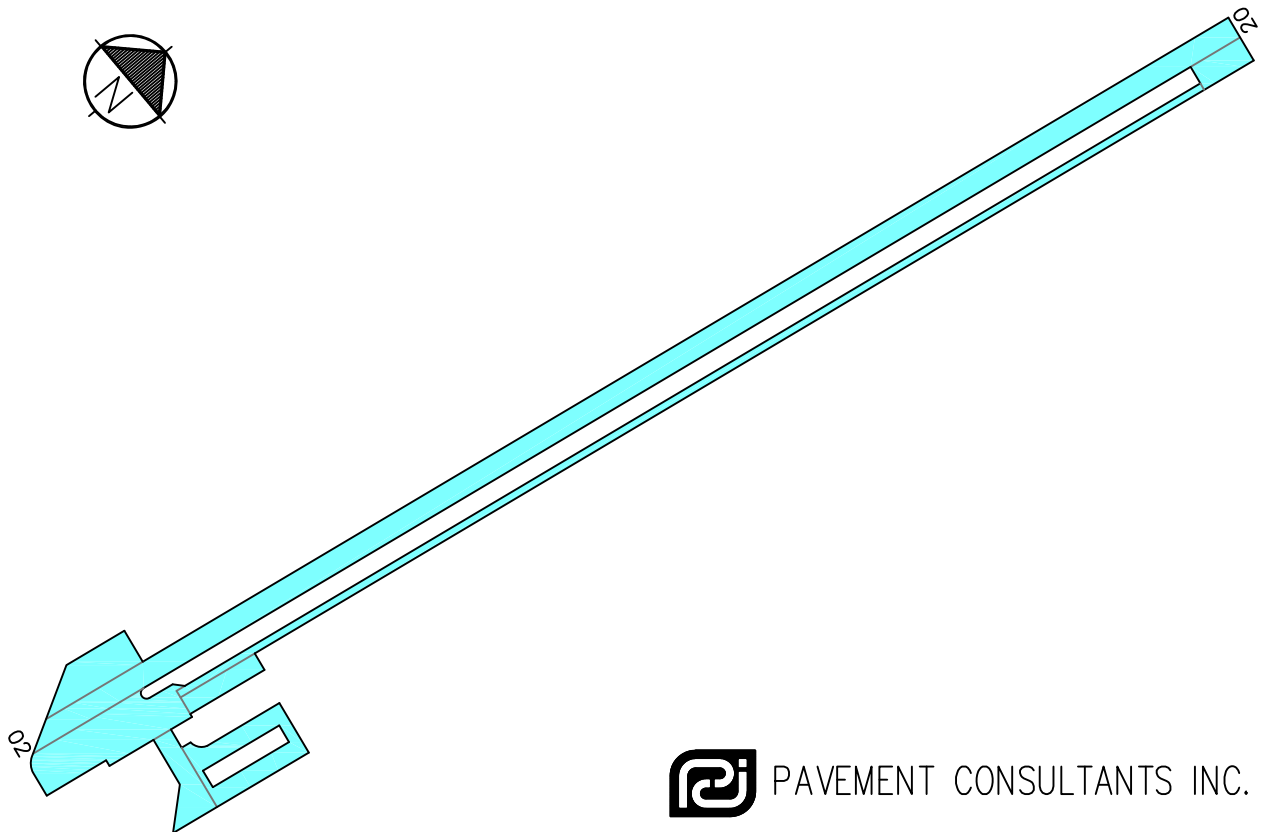
Figure SI-5. Future Pavement Condition.

A graphical representation of the projected PCIs listed in Table 1 is shown in Figure SI-5.
