SUNRIVER AIRPORT

Figure SU-1. Airport Layout, Dimensions and Pavement Cross-Sections.
Sunriver Airport

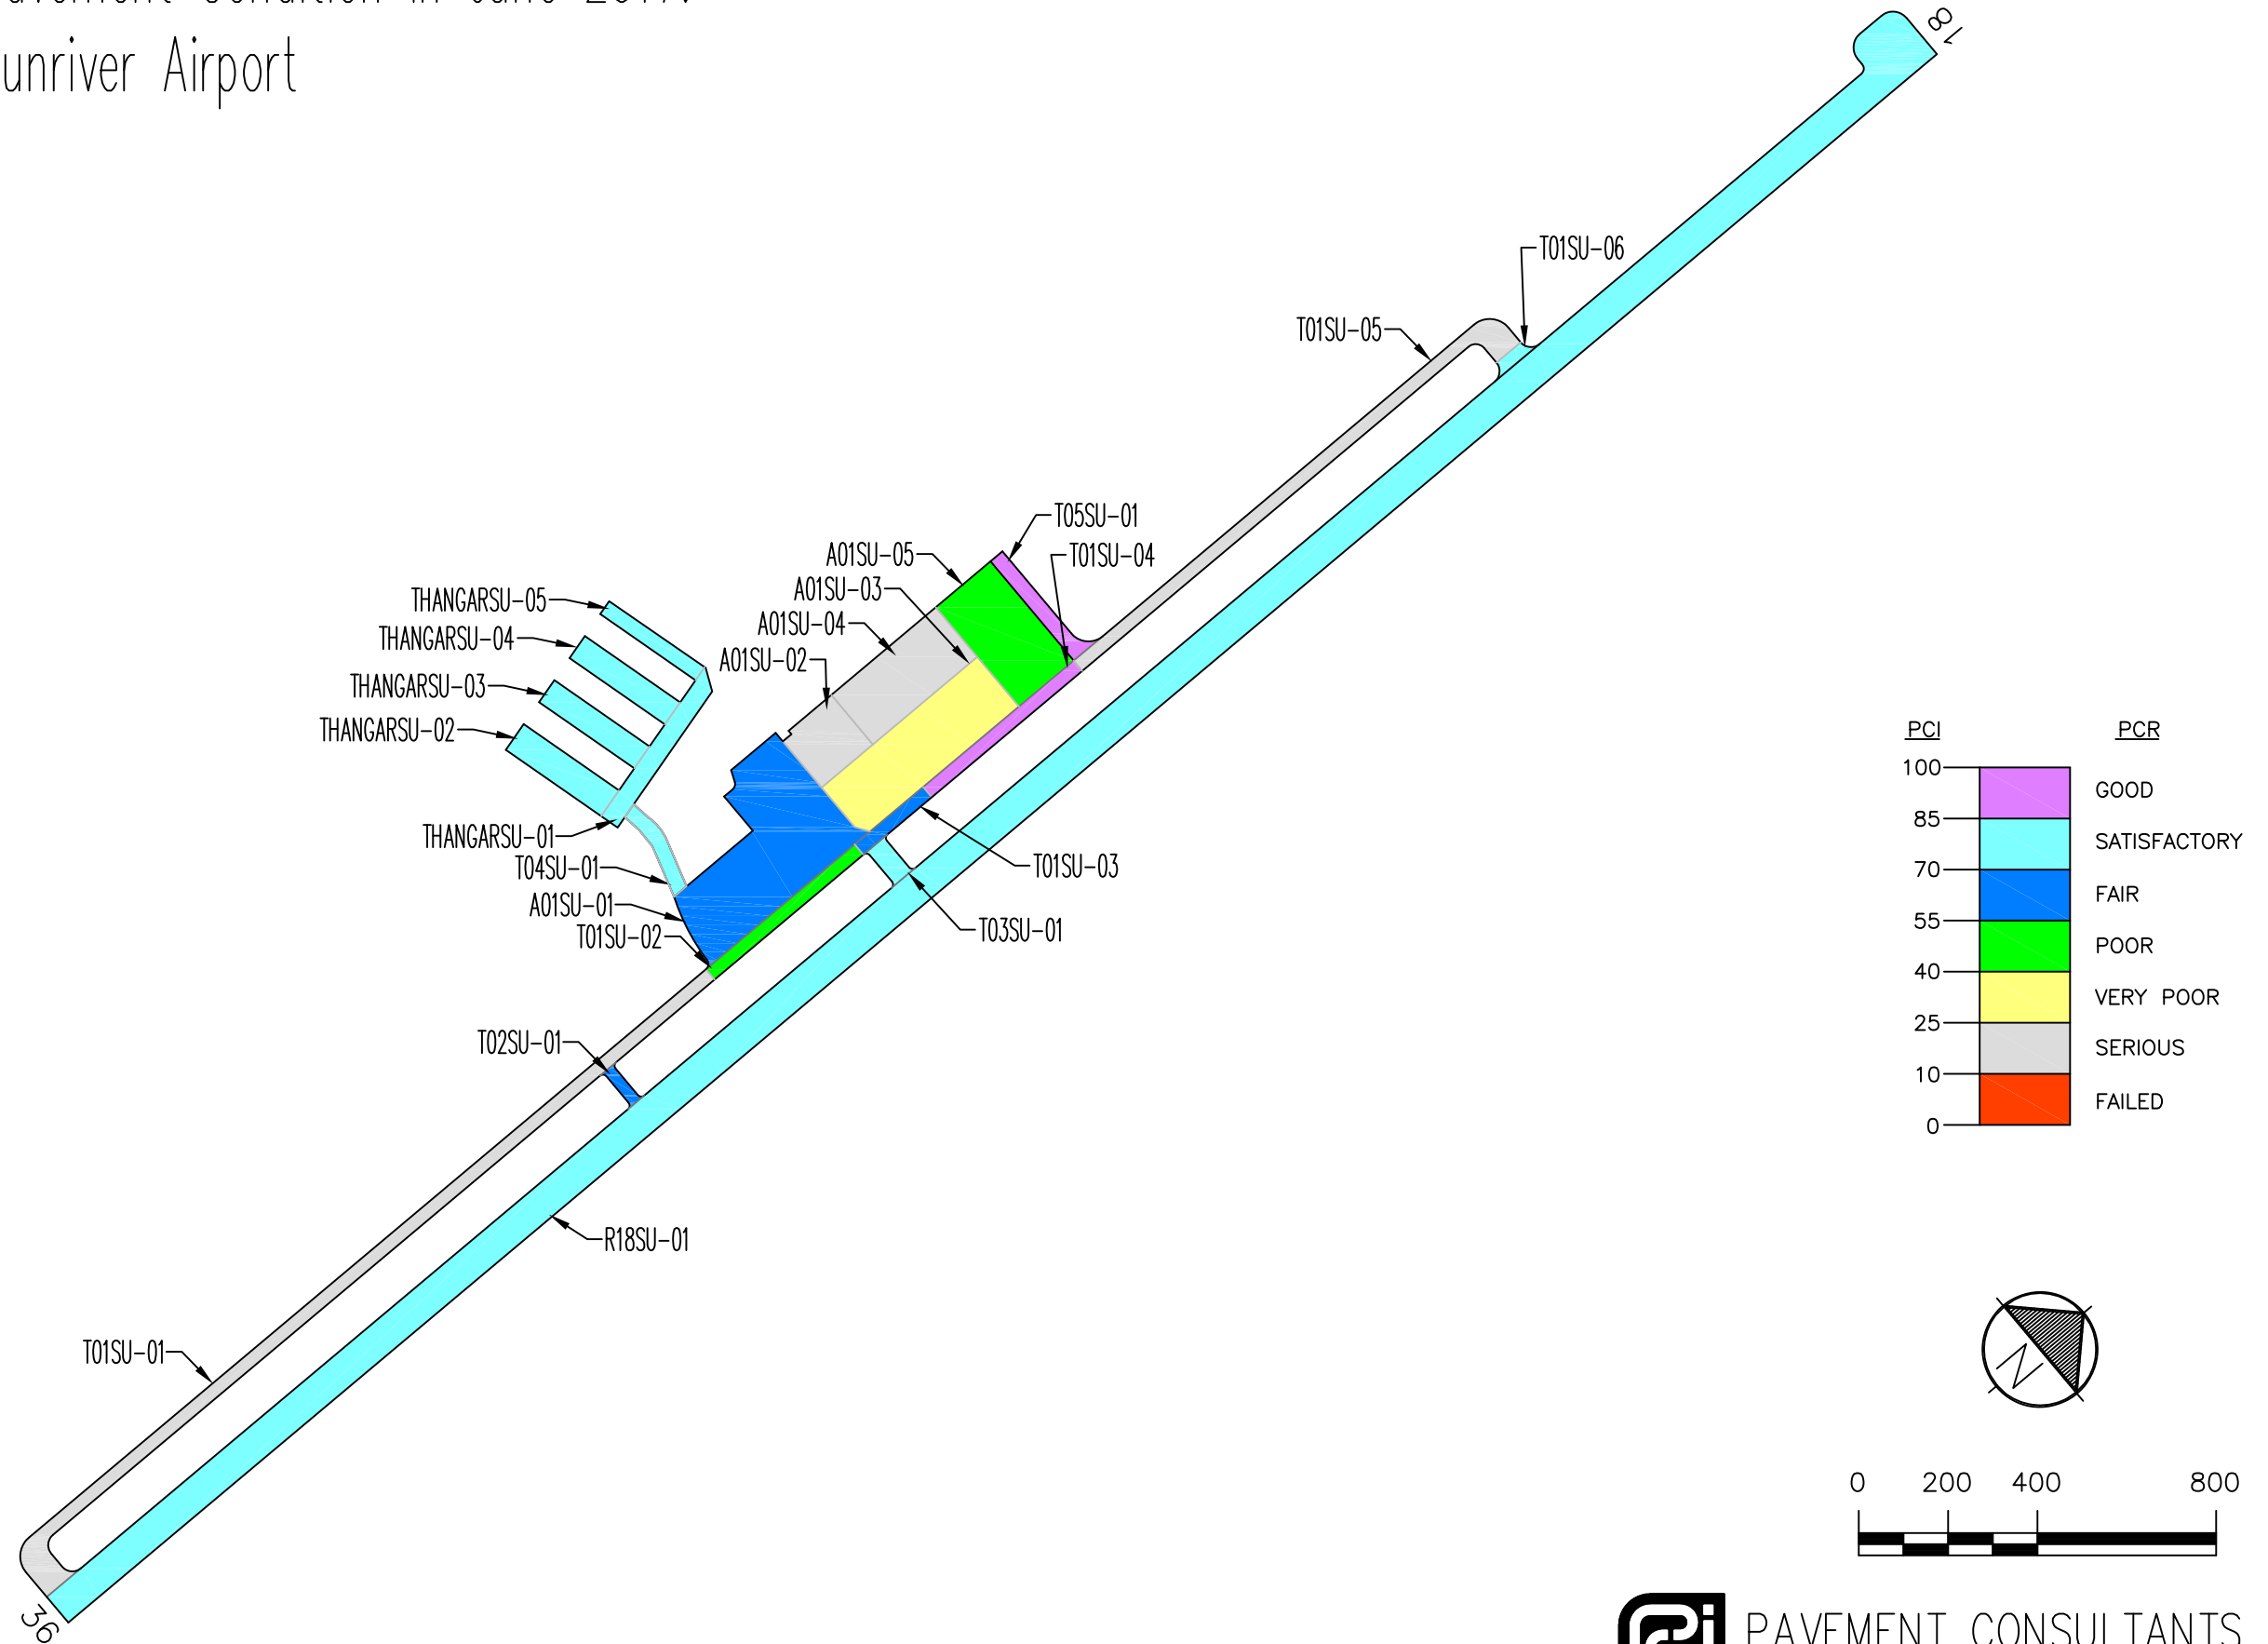
Figure SU-3. Pavement Condition in June 2017.
Sunriver Airport

Section PCIs at Sunriver Airport range from a low of 11 (a PCR of “Serious”) to a high of 95 (a PCR of “Good”). The area-weighted average PCI for all airport pavements is 62, corresponding to an overall PCR of “Fair”. Figure SU-4 shows how much pavement area is associated with each Pavement Condition Rating category and also shows pavement condition distribution from the inspections conducted in 2011 and 2014.

The primary distresses observed during the inspection were: longitudinal and transverse cracking, weathering, alligator cracking, patching, block cracking, and rutting, with an isolated occurrence of depressions.

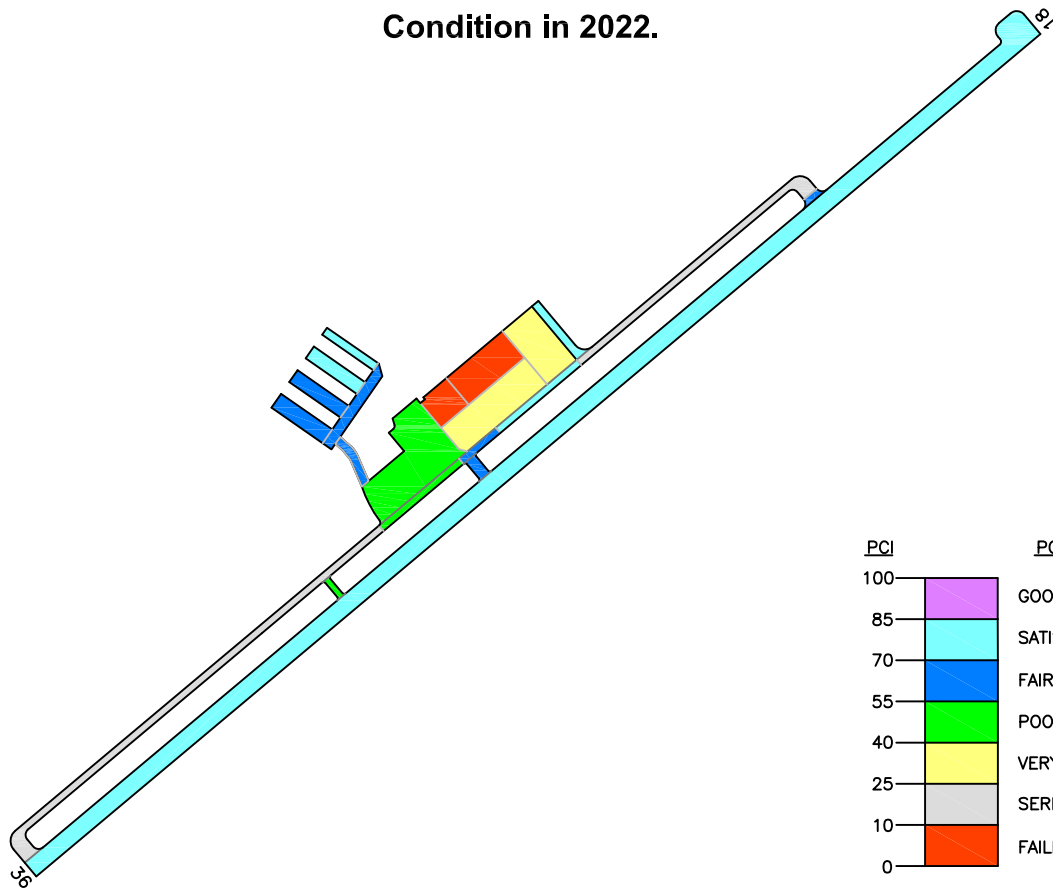
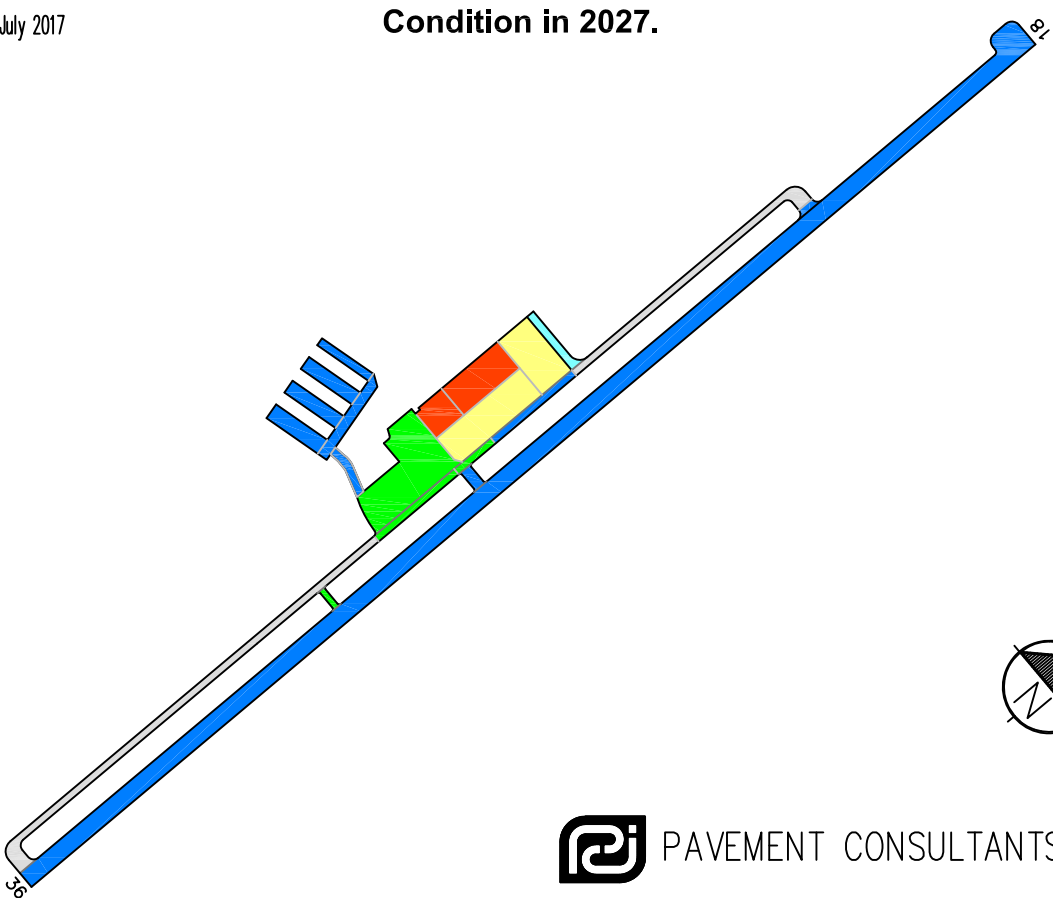
Figure SU-5. Future Pavement Condition.

A graphical representation of the projected PCIs listed in Table 1 is shown in Figure SU-5.
