# WASCO STATE AIRPORT

This report describes how your Pavement Maintenance Management Program (PMMP) was developed. Your Program was developed as part of the Oregon Continuous Aviation System Plan sponsored in part by the Oregon Department of Aviation and the Federal Aviation Administration (FAA). The information and data contained in this report ensures you comply with the requirements of FAA Grant Assurance Number 11 which states that any airport requesting federal funds for pavement improvement projects must have implemented a pavement maintenance management program.

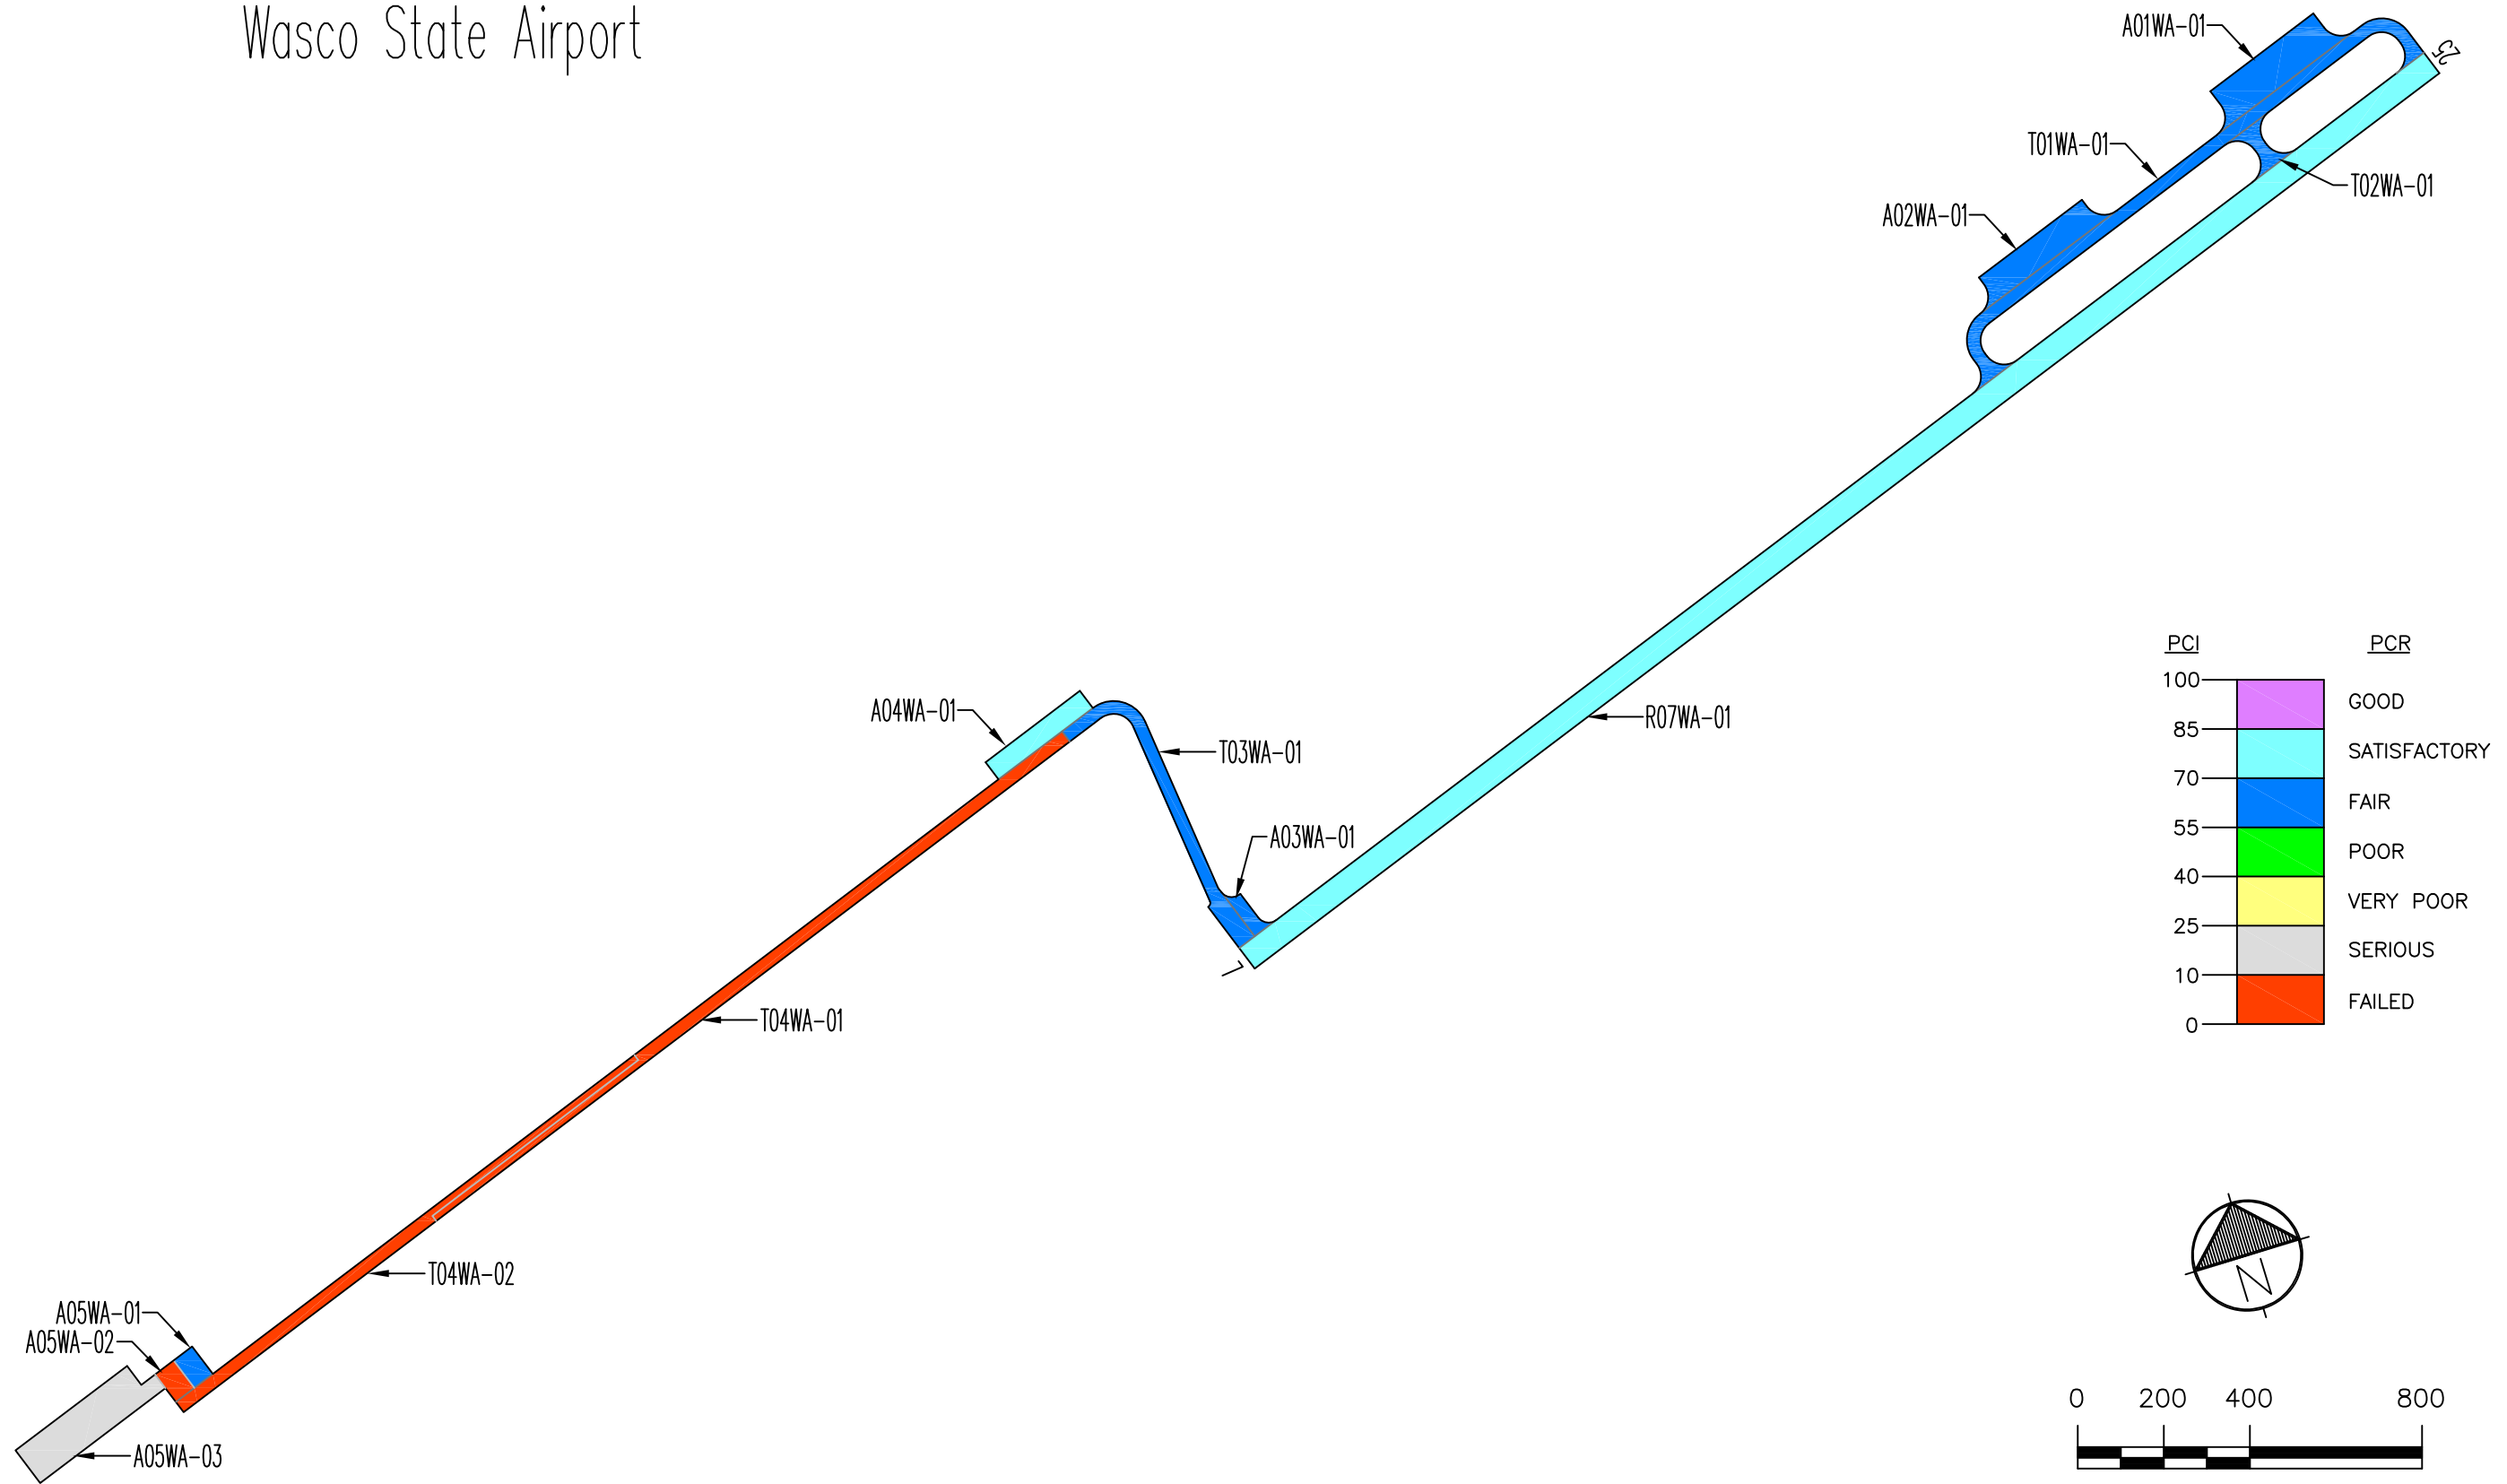
Figure WA-3. Pavement Condition in June 2017.  
Wasco State Airport

Section PCIs at Wasco State Airport range from a low of 2 (a PCR of "Failed") to a high of 77 (a PCR of "Satisfactory"). The area-weighted average PCI for all airport pavements is 53, corresponding to an overall PCR of "Poor". Figure WA-4 shows how much pavement area is associated with each Pavement Condition Rating category and also shows pavement condition distribution from the inspections conducted in 2011 and 2014.

The primary distresses observed during the inspection were: block cracking, raveling, alligator cracking, and longitudinal and transverse cracking, with an isolated occurrence of depressions.

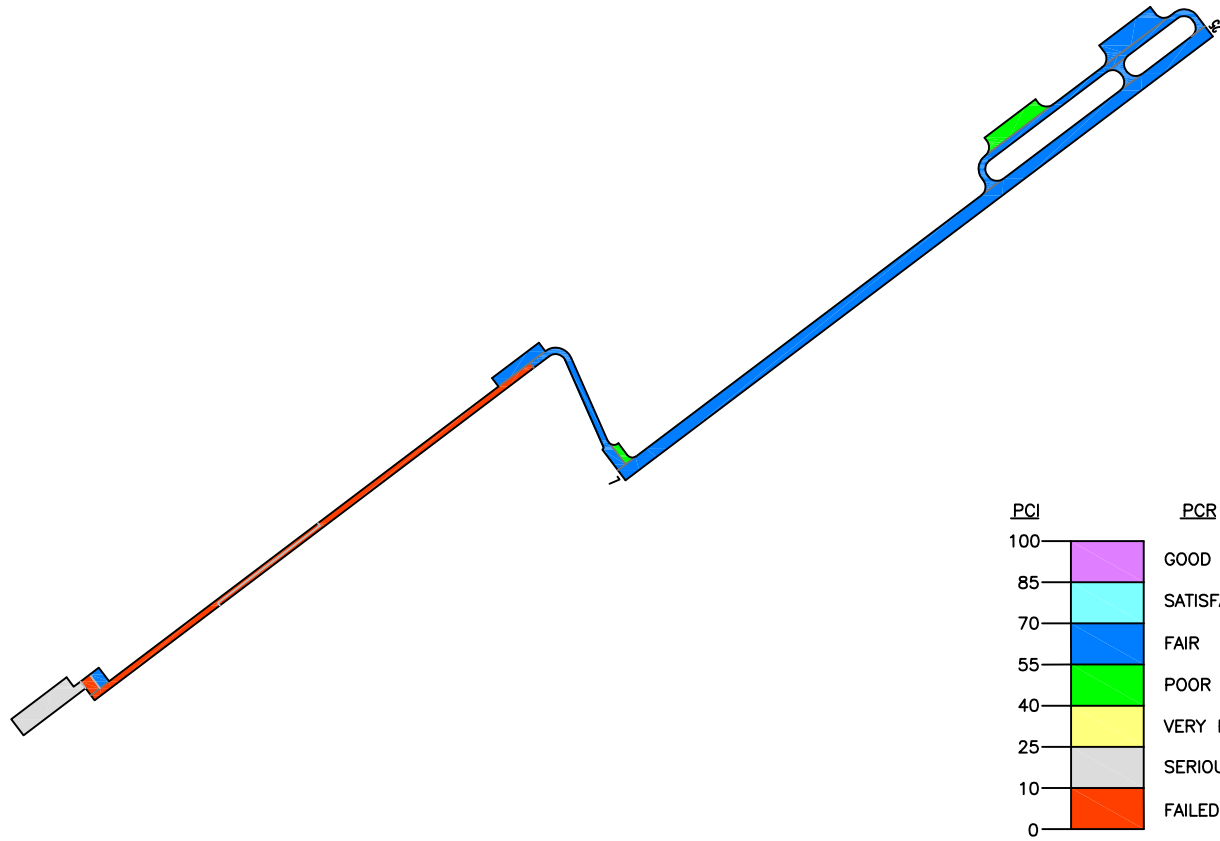
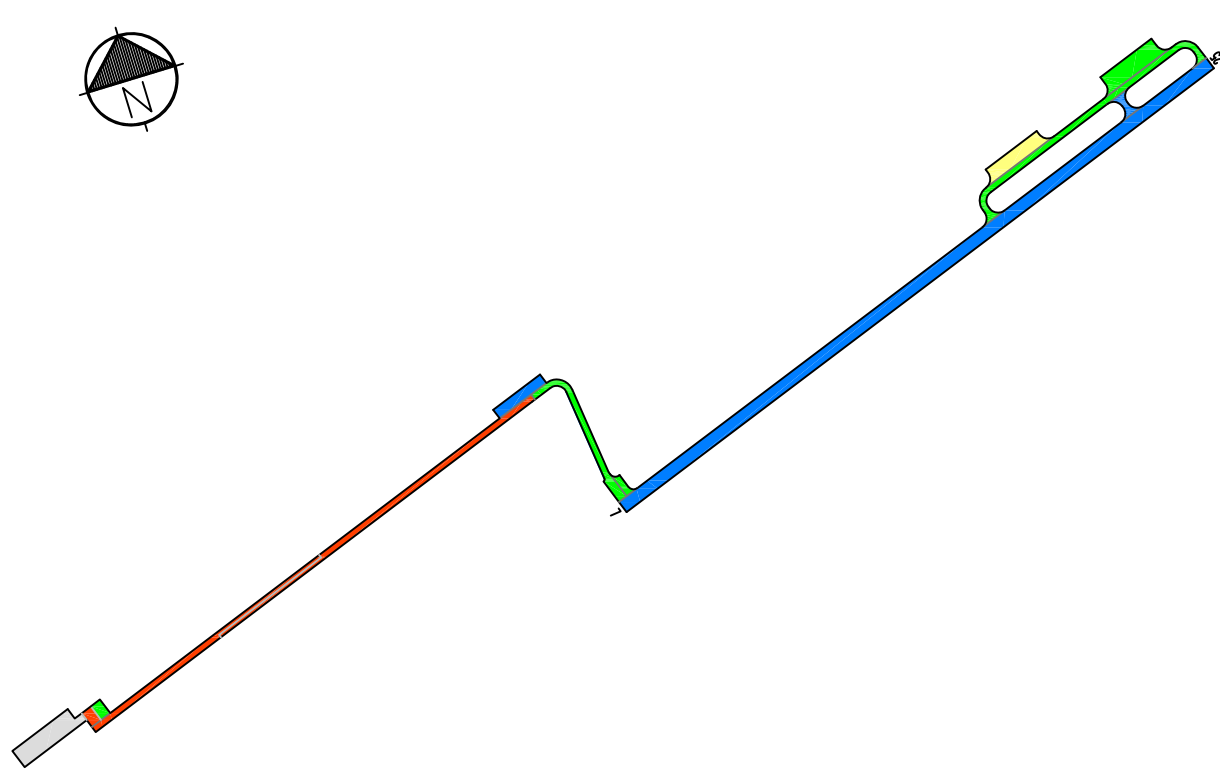
Figure WA-5. Future Pavement Condition.

A graphical representation of the projected PCIs listed in Table 1 is shown in Figure WA-5.
