WARRENTON-ASTORIA REGIONAL AIRPORT

This report describes how your Pavement Maintenance Management Program (PMMP) was developed. Your Program was developed as part of the Oregon Continuous Aviation System Plan sponsored in part by the Oregon Department of Aviation and the Federal Aviation Administration (FAA). The information and data contained in this report ensures you comply with the requirements of FAA Grant Assurance Number 11 which states that any airport requesting federal funds for pavement improvement projects must have implemented a pavement maintenance management program.

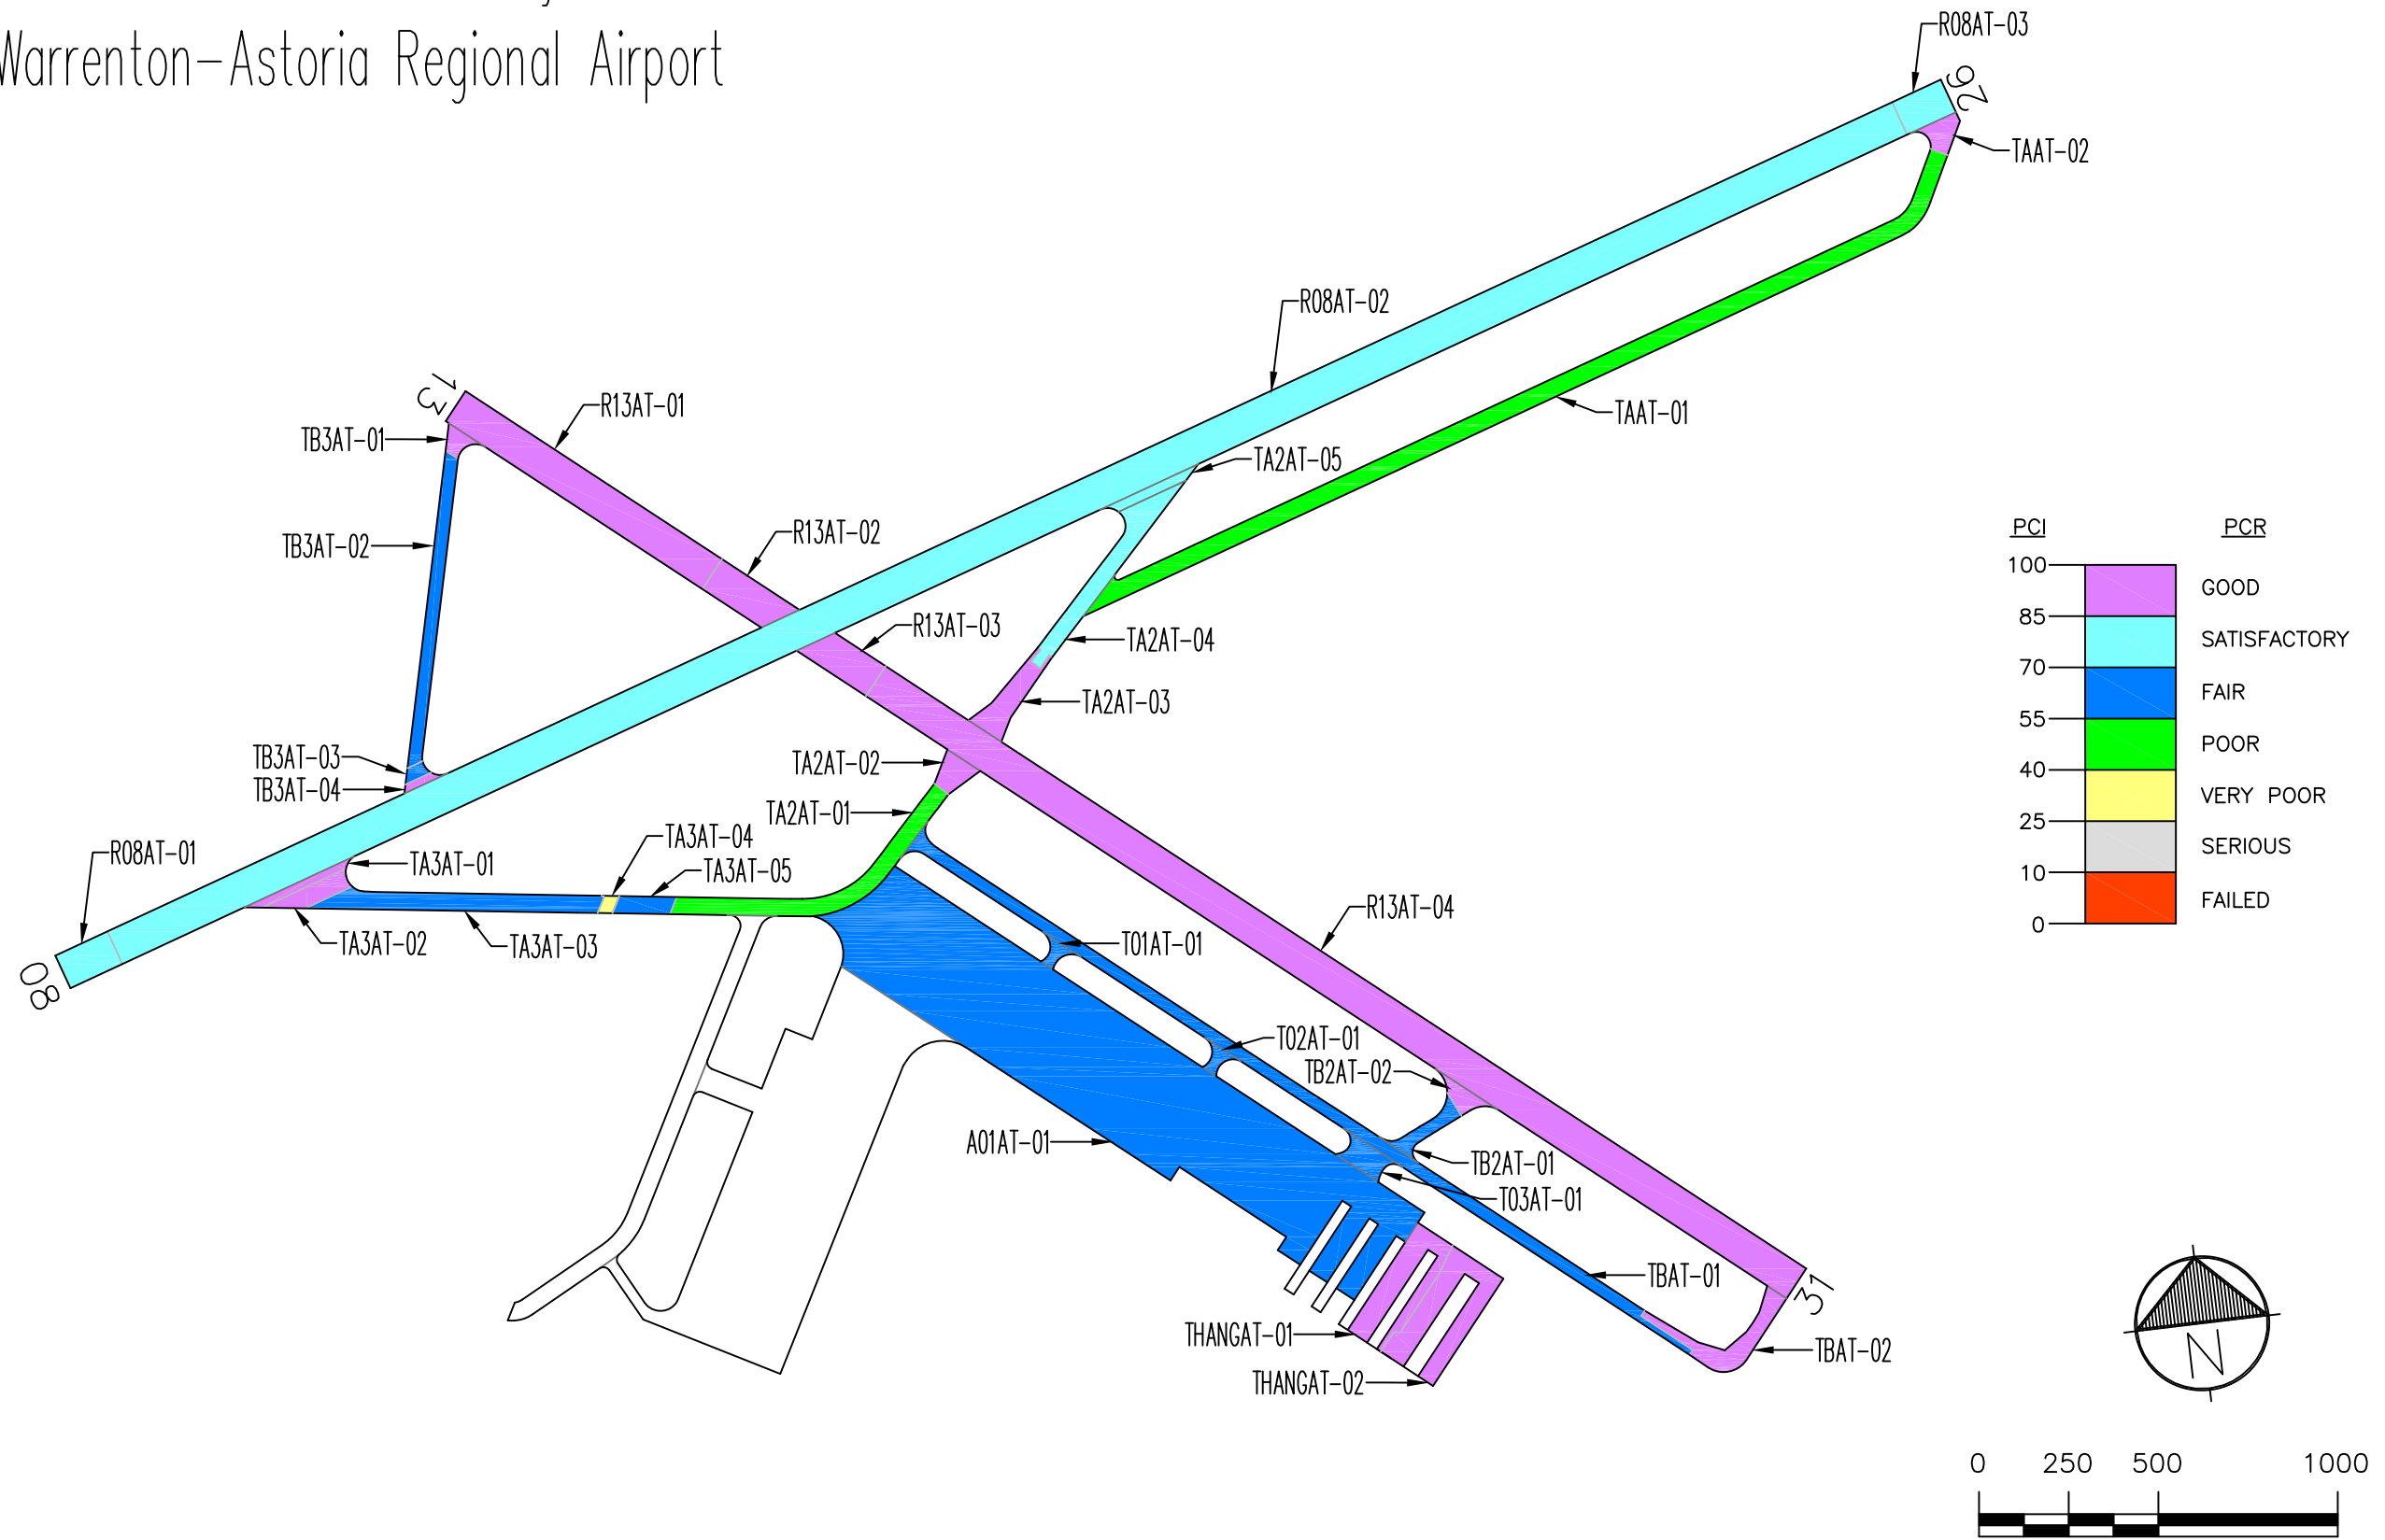
Figure AT-3. Pavement Condition in May 2018.
Warrenton-Astoria Regional Airport

The Branch Condition Report in Appendix 1 summarizes current pavement condition by branch while the Section Condition Report in Appendix 2 lists pavement condition by section. The current Pavement Condition Rating (PCR) is shown graphically in Figure AT-3.

Section PCIs at Astoria Regional Airport range from a low of 36 (a PCR of “Very Poor”) to a high of 100 (a PCR of “Good”). The area-weighted average PCI for all airport pavements is 78, corresponding to an overall PCR of “Satisfactory”. Figure AT-4 shows how much pavement area is associated with each Pavement Condition Rating category and also shows pavement condition distribution from the inspections conducted in 2012 and 2015.

The primary distresses observed during the inspection in the asphalt pavements were: weathering, longitudinal and transverse cracking, block cracking, and patching, with an isolated occurrence of depressions. The primary distresses observed in the concrete pavements were: linear cracking, joint seal damage, and shattered slabs, with isolated occurrences of corner spalls, joint spalls, small patches, and corner breaks.

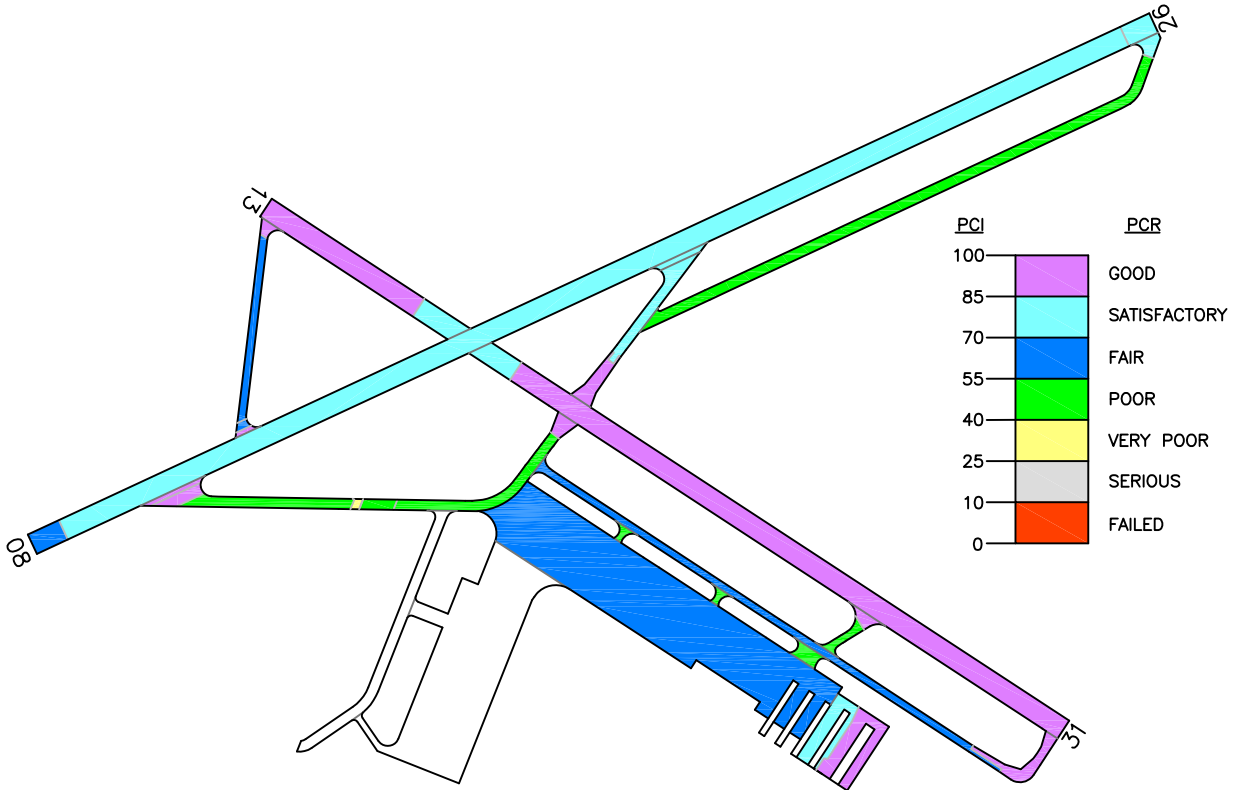
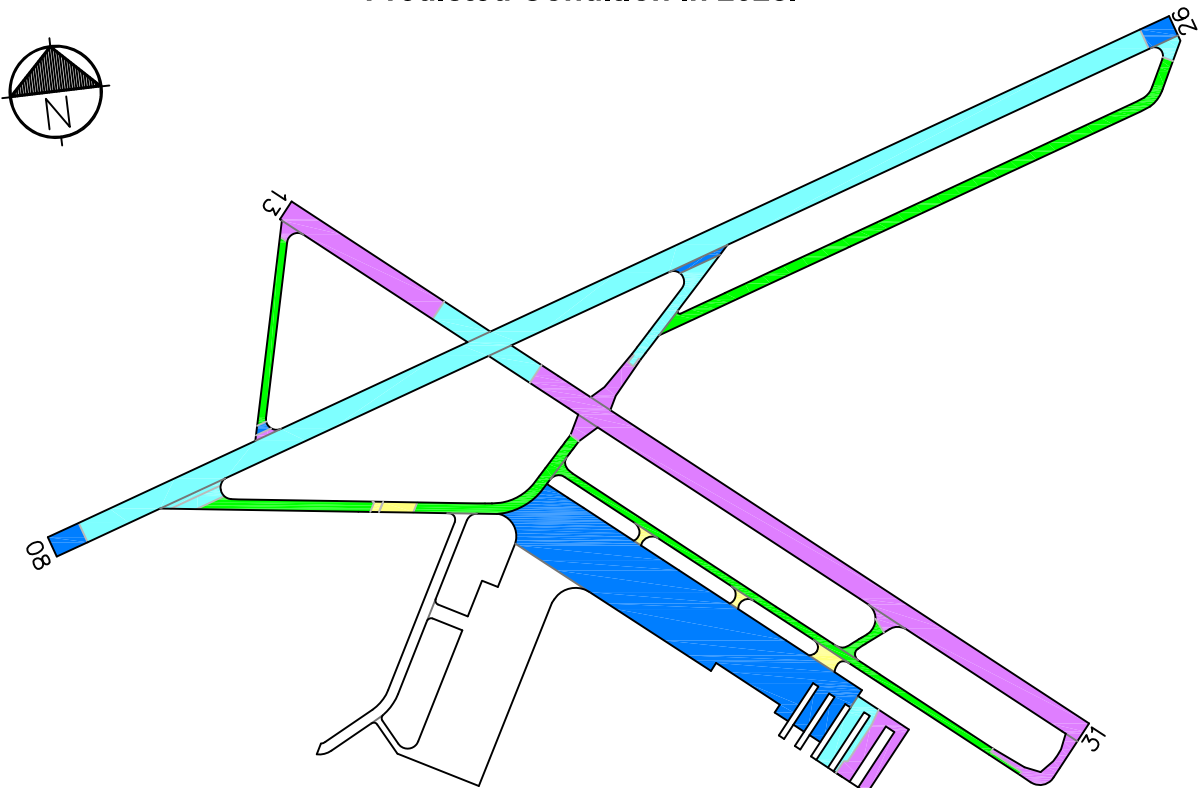
Figure AT-5. Future Pavement Condition.

A graphical representation of the projected PCIs listed in Table 1 is shown in Figure AT-5.
