AURORA STATE AIRPORT

This report describes how your Pavement Maintenance Management Program (PMMP) was developed. Your Program was developed as part of the Oregon Continuous Aviation System Plan sponsored in part by the Oregon Department of Aviation and the Federal Aviation Administration (FAA). The information and data contained in this report ensures you comply with the requirements of FAA Grant Assurance Number 11 which states that any airport requesting federal funds for pavement improvement projects must have implemented a pavement maintenance management program.

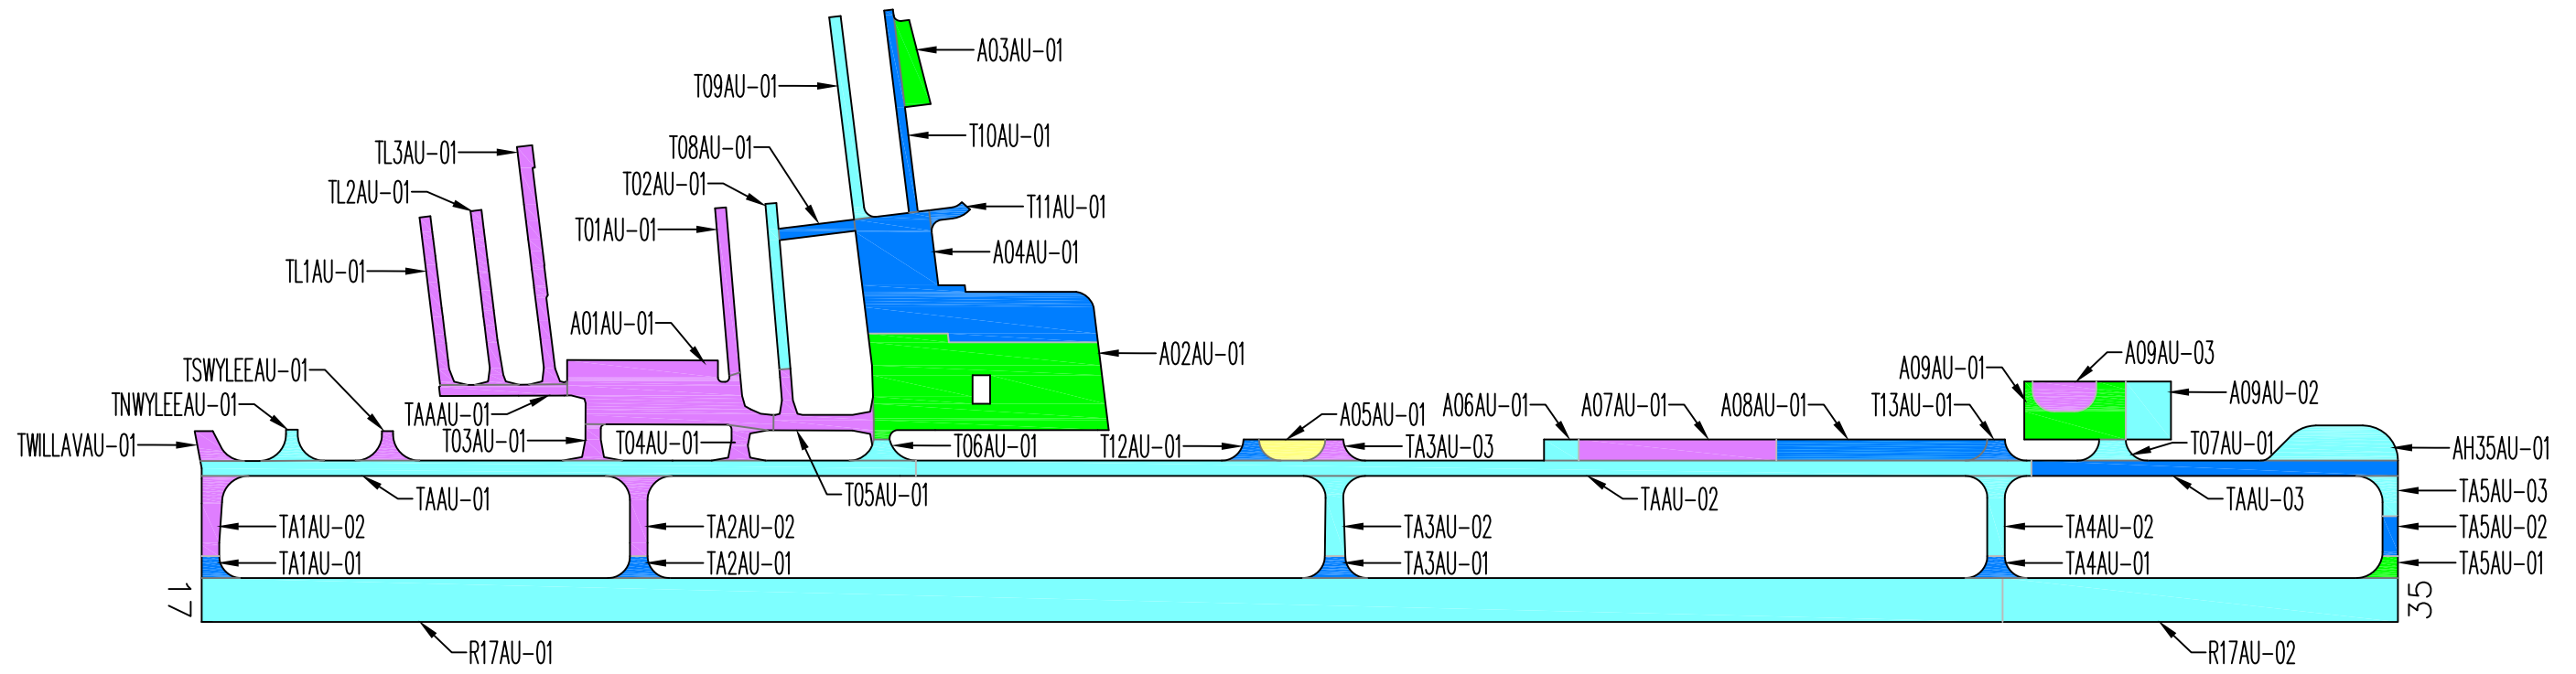
Figure AU-3. Pavement Condition in July 2018.
Aurora State Airport

The Branch Condition Report in Appendix 1 summarizes current pavement condition by branch while the Section Condition Report in Appendix 2 lists pavement condition by section. The current Pavement Condition Rating (PCR) is shown graphically in Figure AU-3.

Section PCIs at Aurora State Airport range from a low of 40 (a PCR of “Very Poor”) to a high of 100 (a PCR of “Good”). The area-weighted average PCI for all airport pavements is 77, corresponding to an overall PCR of “Satisfactory”. Figure AU-4 shows how much pavement area is associated with each Pavement Condition Rating category and also shows pavement condition distribution from the inspections conducted in 2012 and 2015.

The primary distresses observed during the inspection were: longitudinal and transverse cracking, weathering, patching, block cracking, alligator cracking, raveling and depressions. The primary distress observed in the concrete pavement was joint spalls, with isolated occurrences of linear cracking.
