CORVALLIS MUNICIPAL AIRPORT

Figure CR-1A. Airport Layout, Dimensions and Pavement Cross-Sections.
Runways and Aprons
Corvallis Municipal Airport

Figure CR-2. Pavement Branch, Section and Sample Unit Layout.
Corvallis Municipal Airport

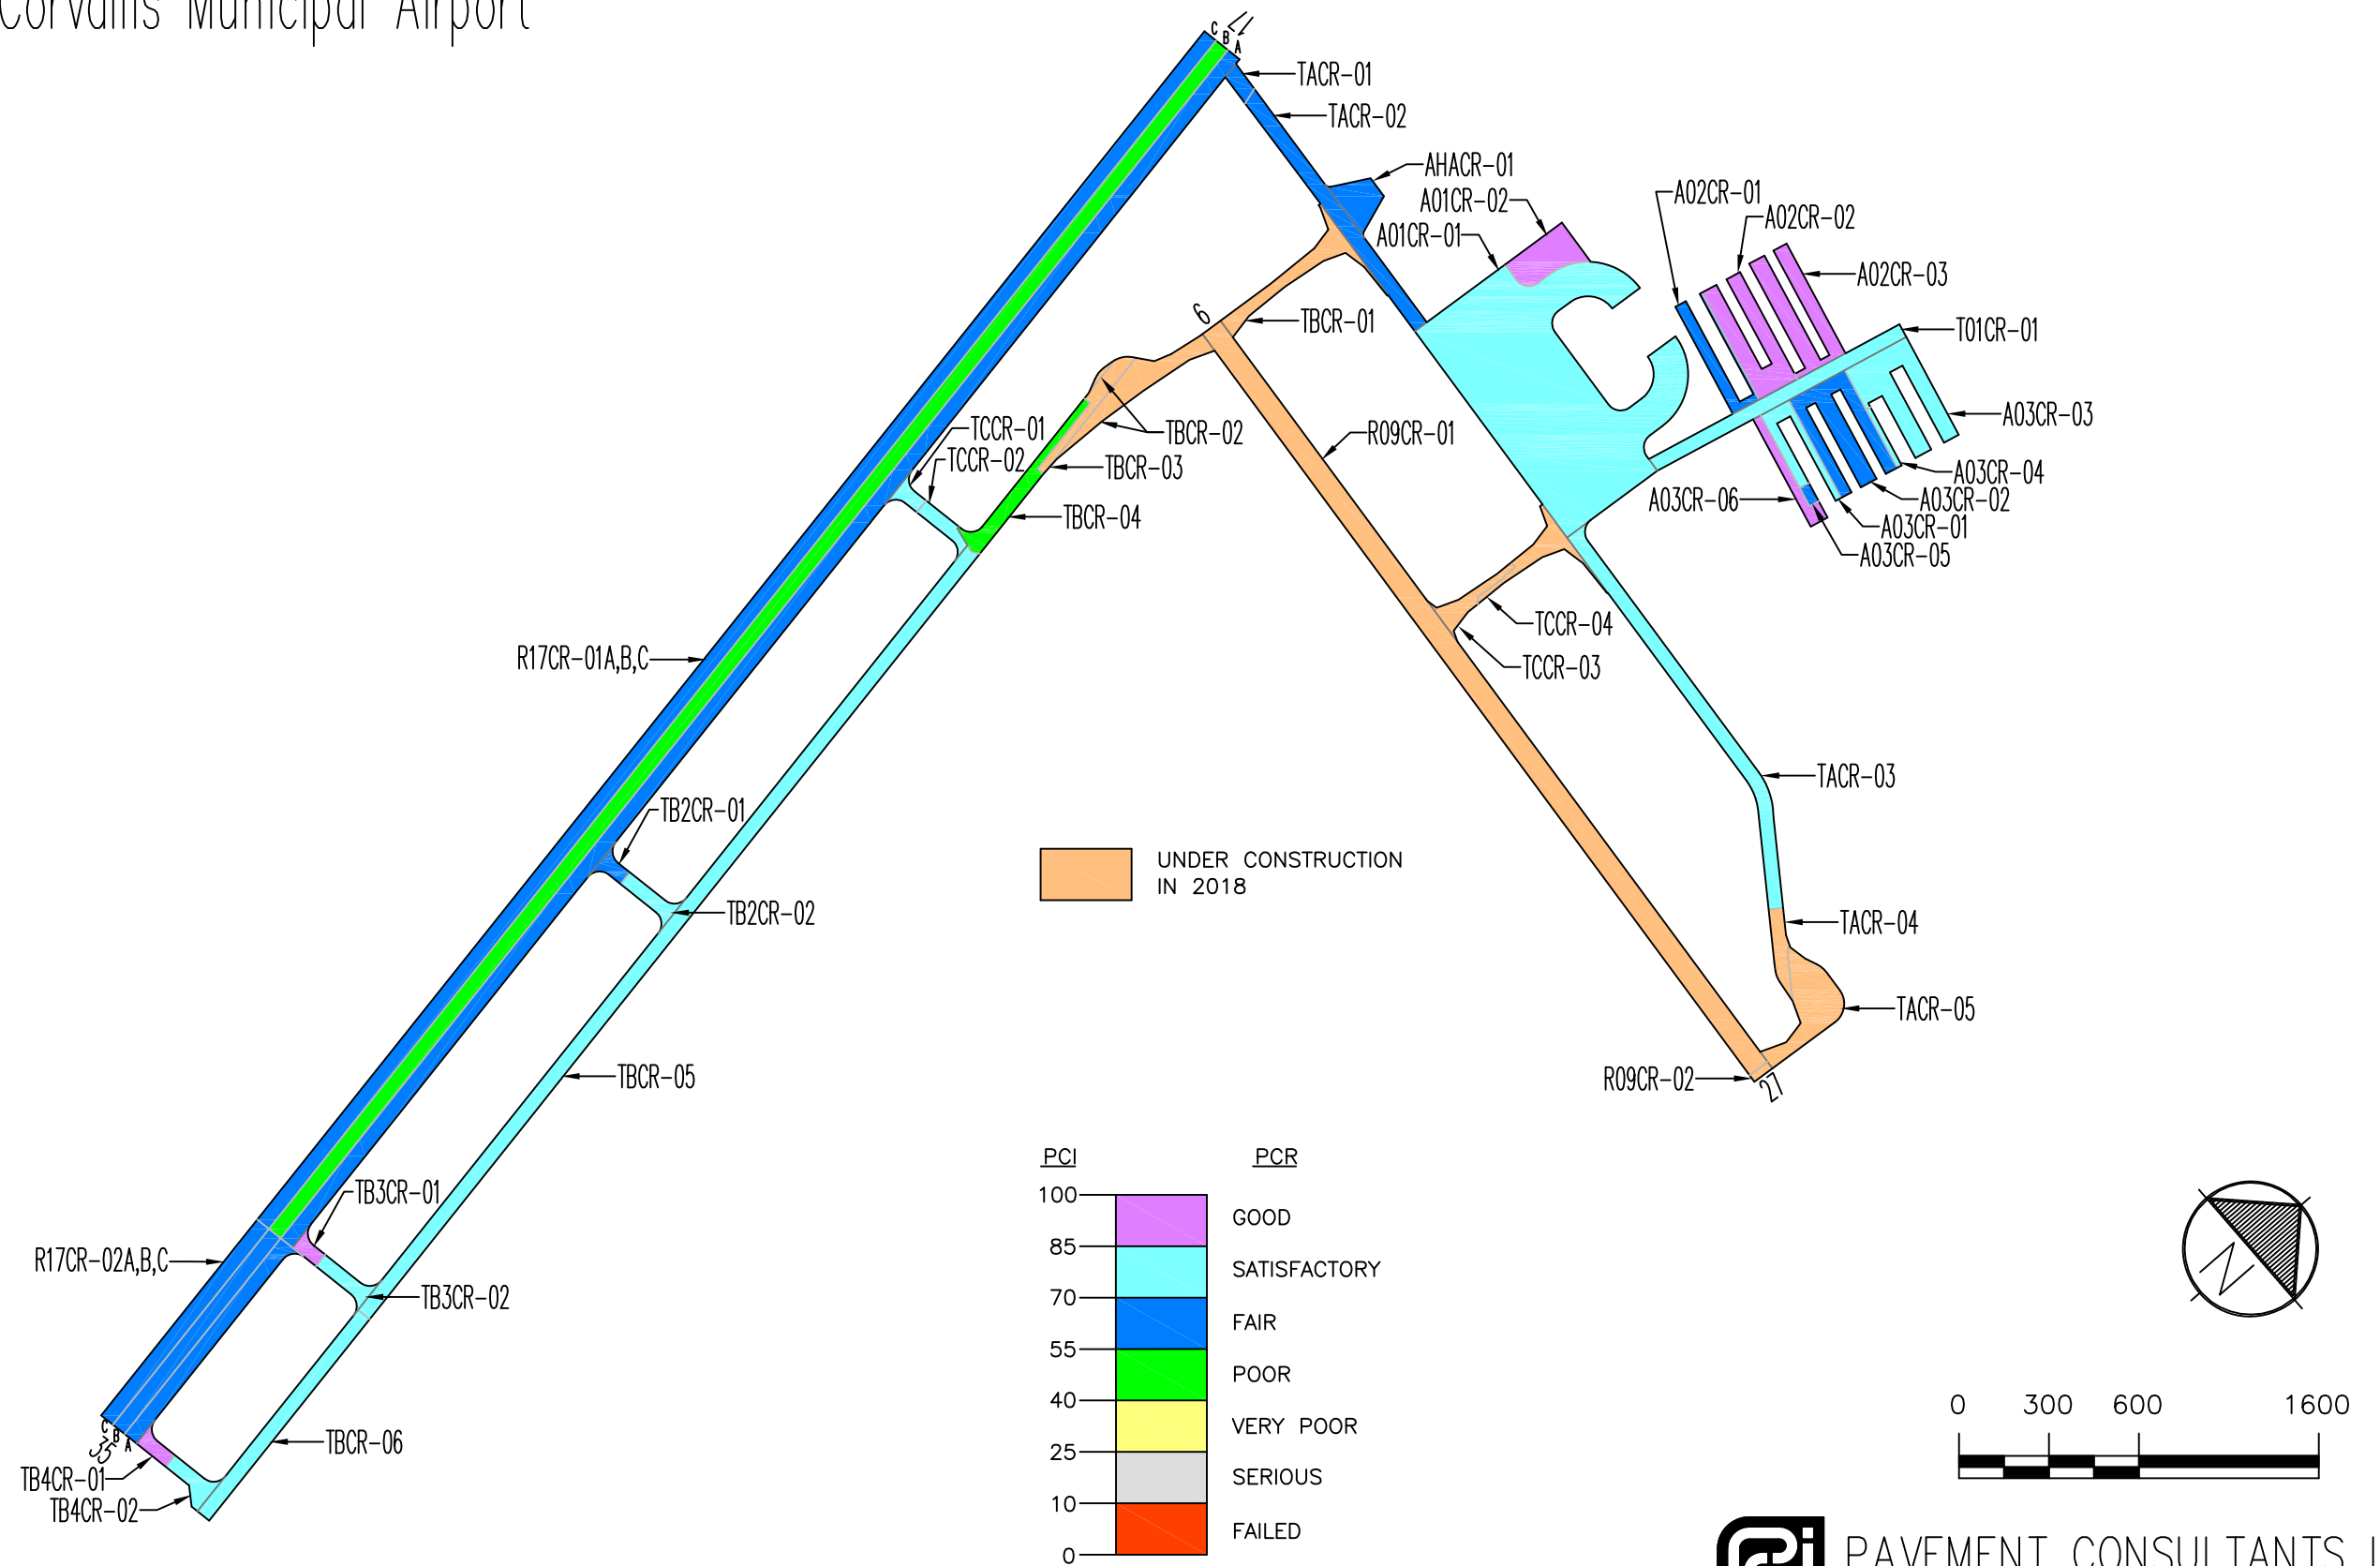
Figure CR-3. Pavement Condition in June 2018.
Corvallis Municipal Airport

Section PCIs at Corvallis Municipal Airport range from a low of 49 (a PCR of “Poor”) to a high of 100 (a PCR of “Good”). The area-weighted average PCI for all airport pavements is 76, corresponding to an overall PCR of “Satisfactory”. Figure CR-4 shows how much pavement area is associated with each Pavement Condition Rating category and also shows pavement condition distribution from the inspections conducted in 2012 and 2015.

The primary distresses observed in the asphalt pavements during the inspection were longitudinal and transverse cracking, weathering, depressions, alligator cracking, and patching, with an isolated occurrences of block cracking. The primary distresses observed in the concrete pavements were corner breaks, linear cracking and shrinkage cracking, with isolated occurrences of corner spalls, joint spalls, shattered slabs and small patches.
