# INDEPENDENCE STATE AIRPORT

This report describes how your Pavement Maintenance Management Program (PMMP) was developed. Your Program was developed as part of the Oregon Continuous Aviation System Plan sponsored in part by the Oregon Department of Aviation and the Federal Aviation Administration (FAA). The information and data contained in this report ensures you comply with the requirements of FAA Grant Assurance Number 11 which states that any airport requesting federal funds for pavement improvement projects must have implemented a pavement maintenance management program.

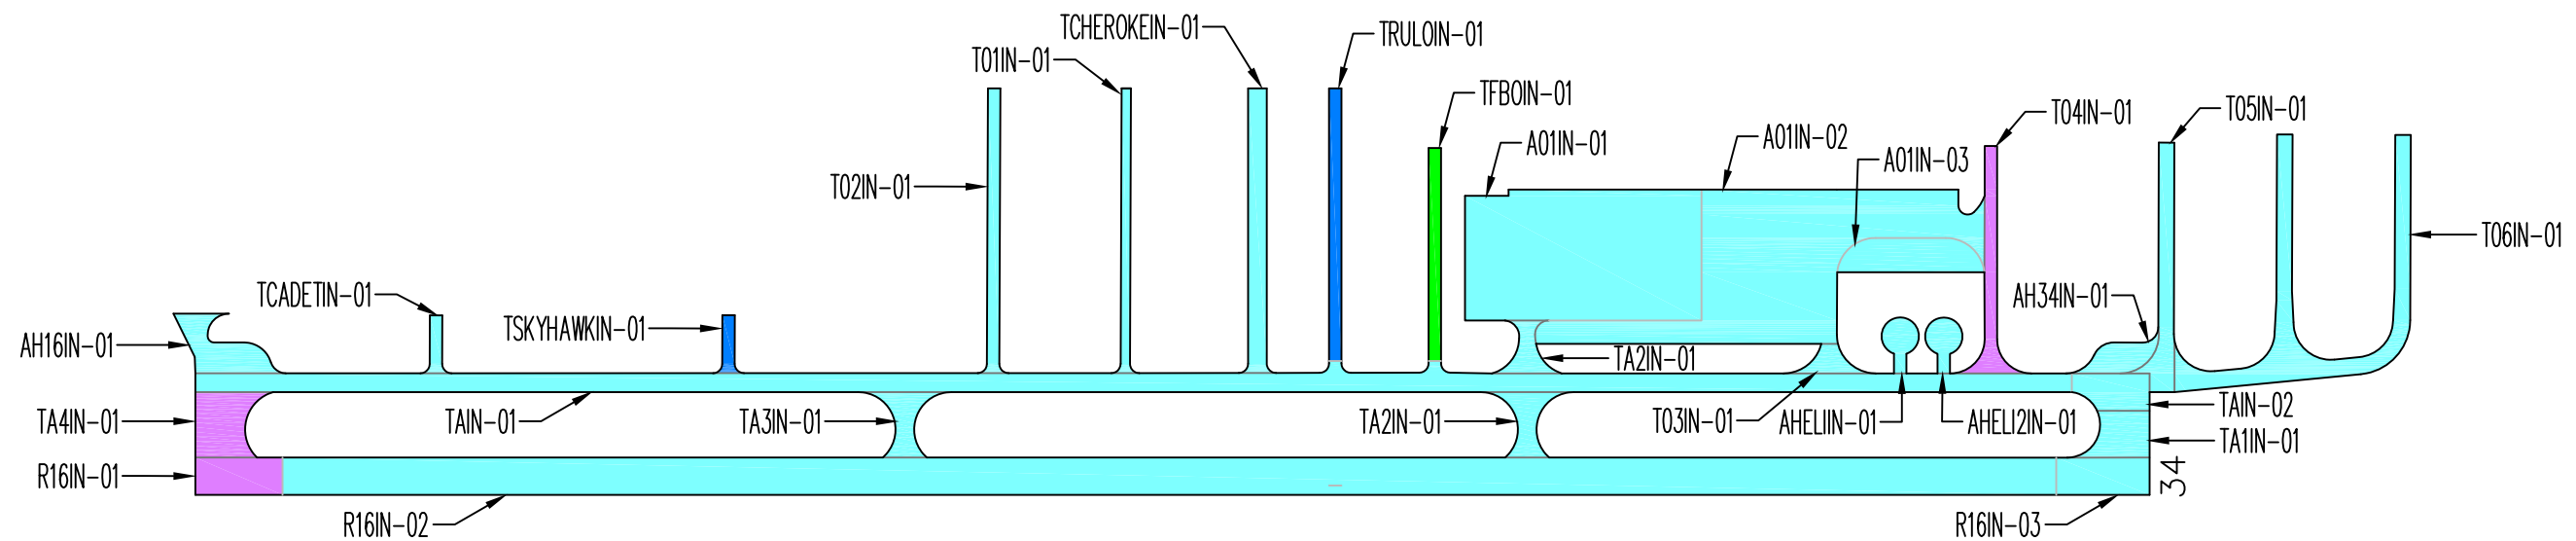
Figure IN-3. Pavement Condition in May 2018.  
Independence State Airport

Section PCIs at Independence State Airport range from a low of 47 (a PCR of “Poor”) to a high of 92 (a PCR of “Good”). The area-weighted average PCI for all airport pavements is 78, corresponding to an overall PCR of “Satisfactory”. Figure IN-4 shows how much pavement area is associated with each Pavement Condition Rating category and also shows pavement condition distribution from the inspections conducted in 2012 and 2015.

The primary distresses observed during the inspection were: longitudinal and transverse cracking, weathering, patching, alligator cracking, depressions, and block cracking, and an isolated occurrence of raveling.

Data collected during the visual condition survey were used by the PAVER software to generate the Network Maintenance Report contained in Appendix 3. This report identifies, for each pavement section, the recommended localized maintenance activities (i.e.-crack sealing, patching) that should be completed to repair the defects observed during the visual inspection. The repair quantities identified in the report were extrapolated to cover the entire pavement section, based on the distresses measured in the inspected sample units. If the repair activities identified are completed, the pavement deterioration rate will be slowed.

- 14,389 linear feet of asphalt concrete crack sealing
- 66 linear feet of asphalt concrete wide crack sealing/repair.

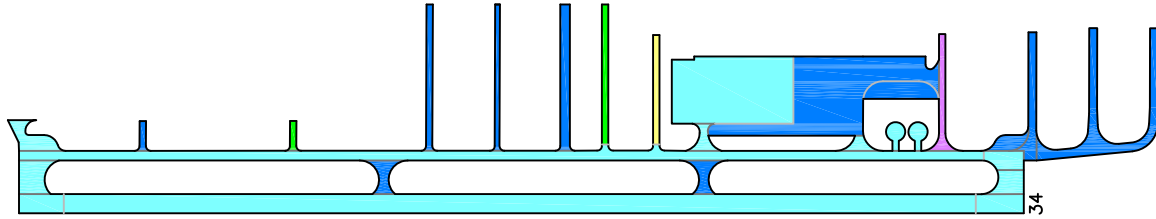
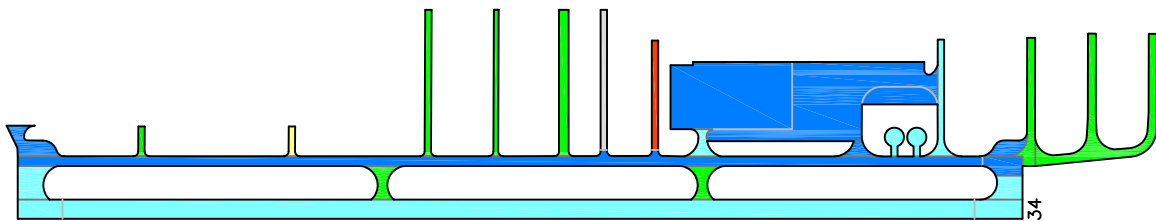
**Figure IN-5. Future Pavement Condition.**

A graphical representation of the projected PCIs listed in Table 1 is shown in Figure IN-5.
