LENHARDT AIRPARK

This report describes how your Pavement Maintenance Management Program (PMMP) was developed. Your Program was developed as part of the Oregon Continuous Aviation System Plan sponsored in part by the Oregon Department of Aviation and the Federal Aviation Administration (FAA). The information and data contained in this report ensures you comply with the requirements of FAA Grant Assurance Number 11 which states that any airport requesting federal funds for pavement improvement projects must have implemented a pavement maintenance management program.

Using the branch, section and sample unit divisions established, a visual condition survey was conducted at Lenhardt Airpark in May 2018. During the inspection, pavement defects were identified and measured in accordance with the methodology outlined in ASTM D5430. This inspection ensures your airport complies with the “detailed inspection” requirement of FAA’s PMMP guidelines. After collection, the data were entered into the PAVER software for analysis. These data are reproduced in the Re-Inspection Report attached as Appendix 4.

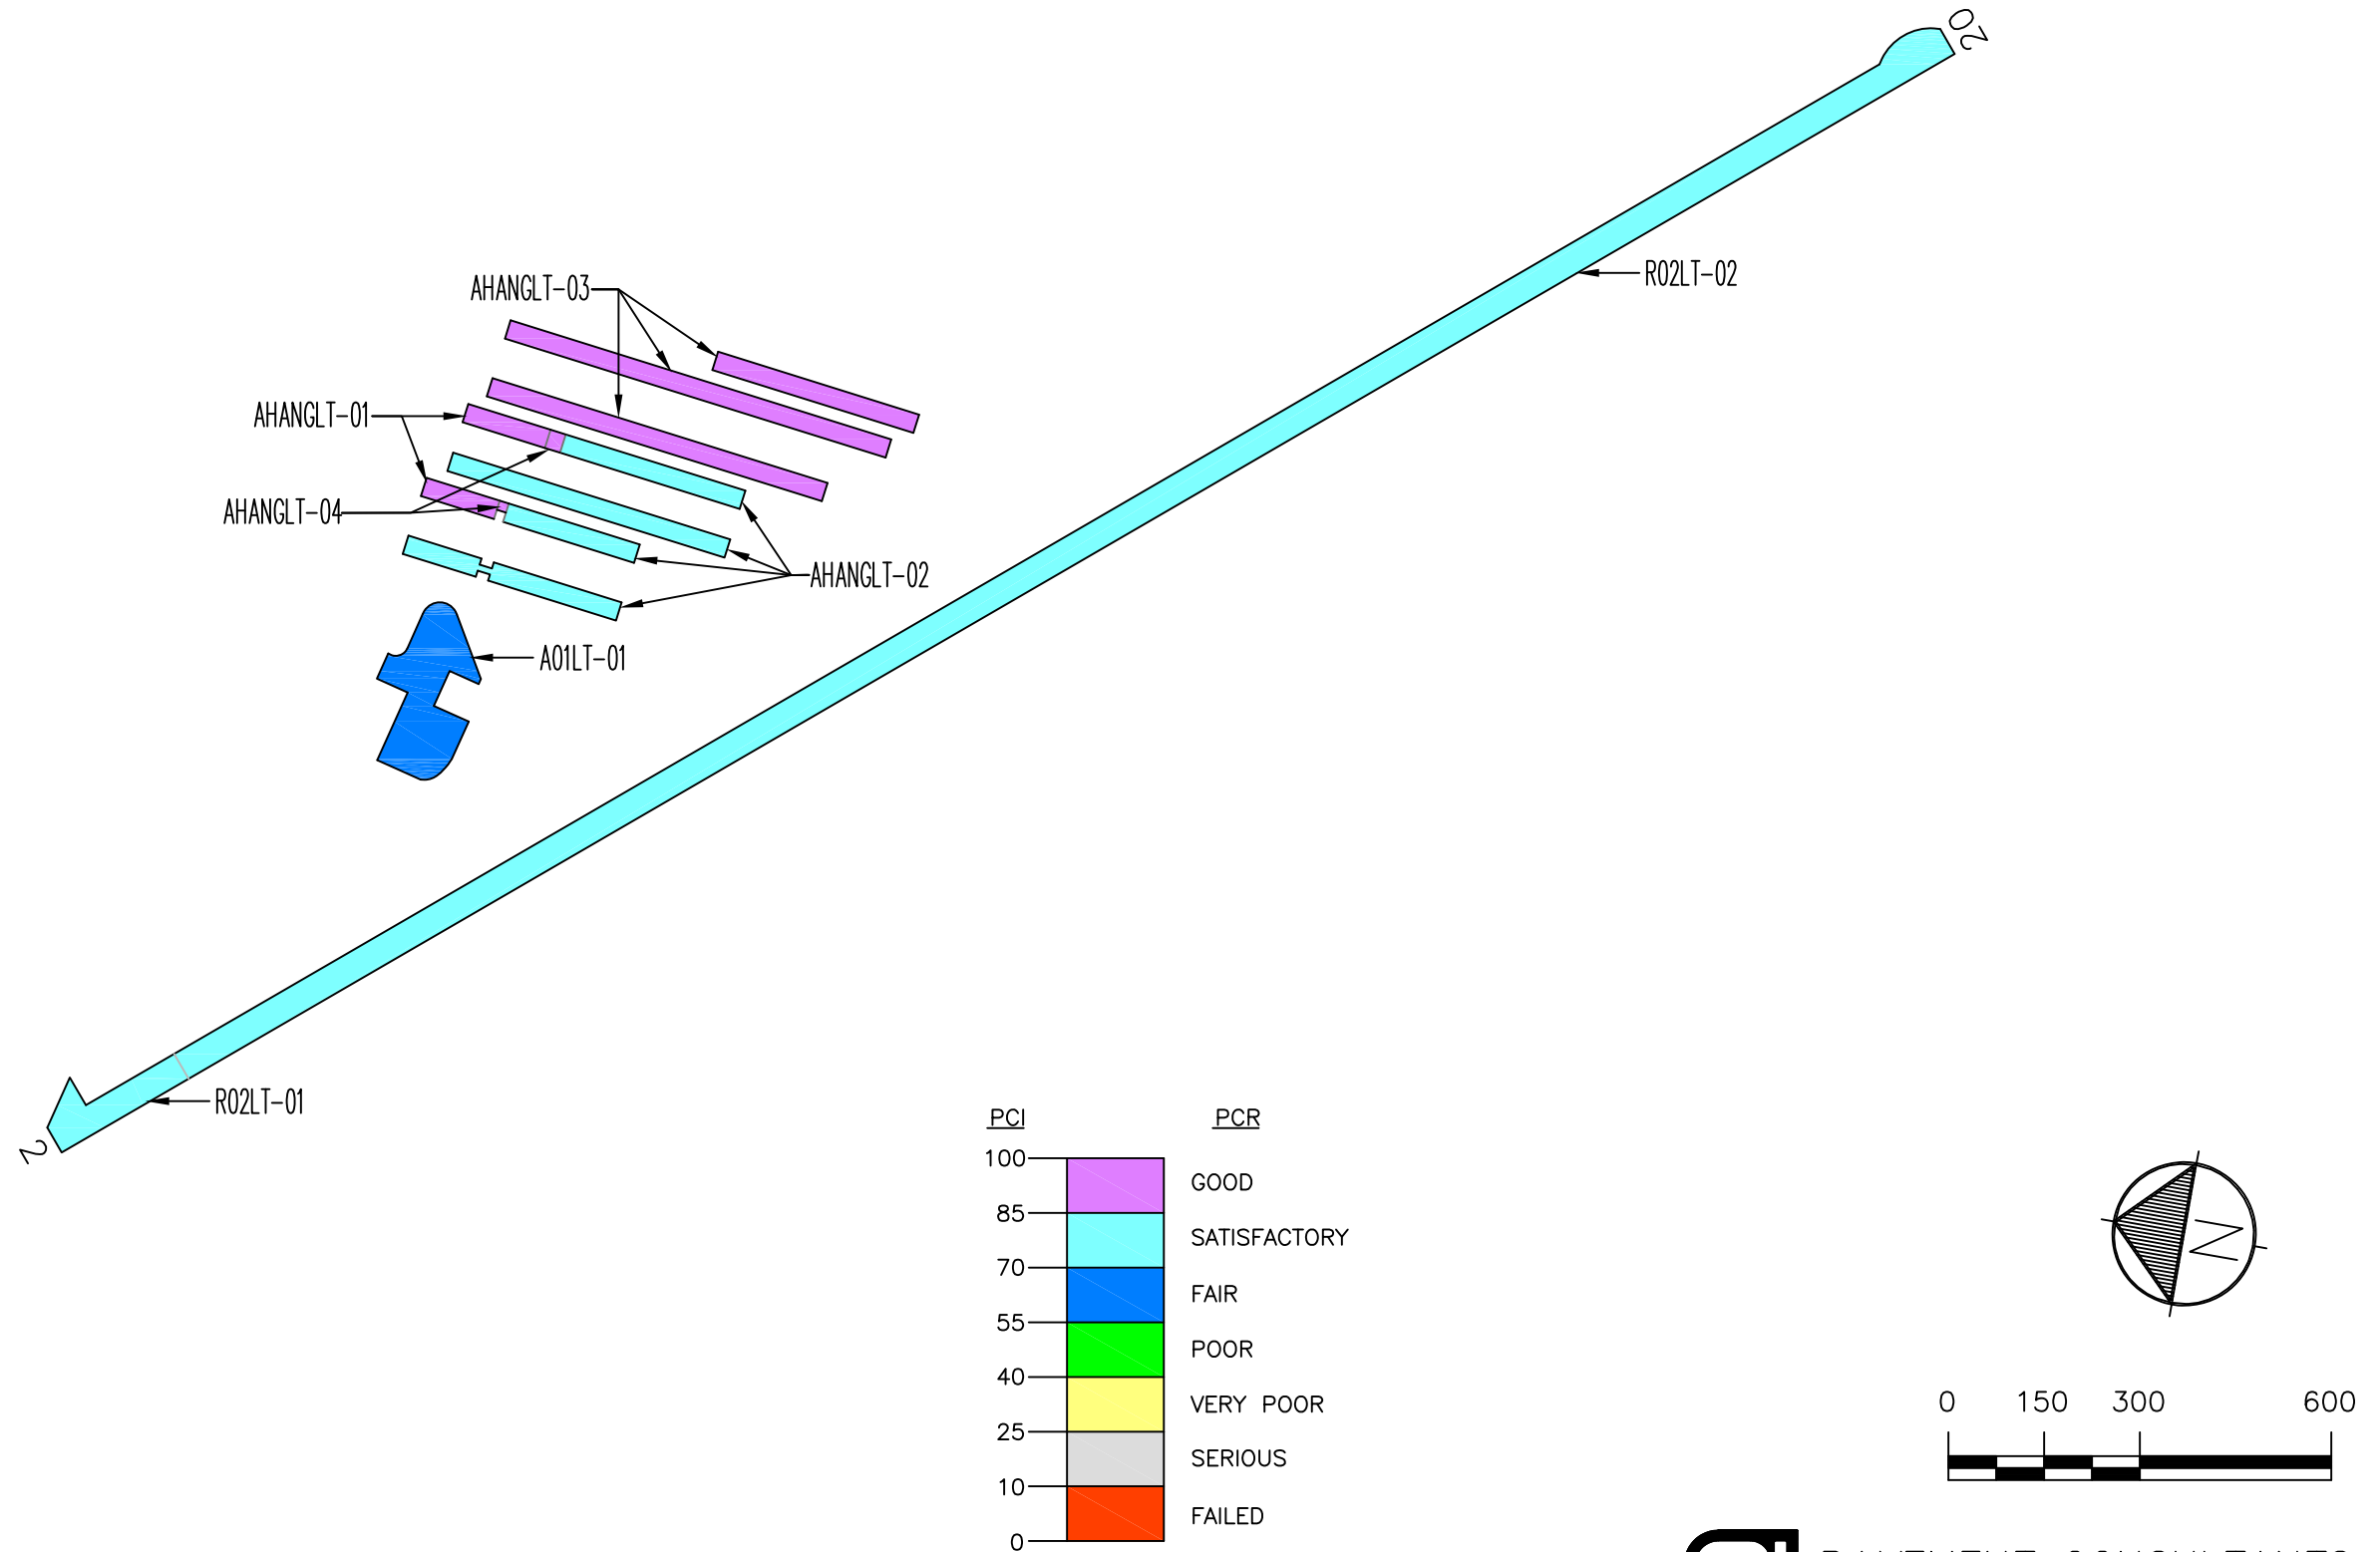
Figure LT-3. Pavement Condition in May 2018.
Lenhardt Airpark

Section PCIs at Lenhardt Airpark range from a low of 64 (a PCR of “Fair”) to a high of 99 (a PCR of “Good”). The area-weighted average PCI for all airport pavements is 80, corresponding to an overall PCR of “Satisfactory”. Figure LT-4 shows how much pavement area is associated with each Pavement Condition Rating category and also shows pavement condition distribution from the inspections conducted in 2012 and 2015.

The primary distresses observed during the inspection were longitudinal and transverse cracking and block cracking, with an isolated occurrence of depressions.

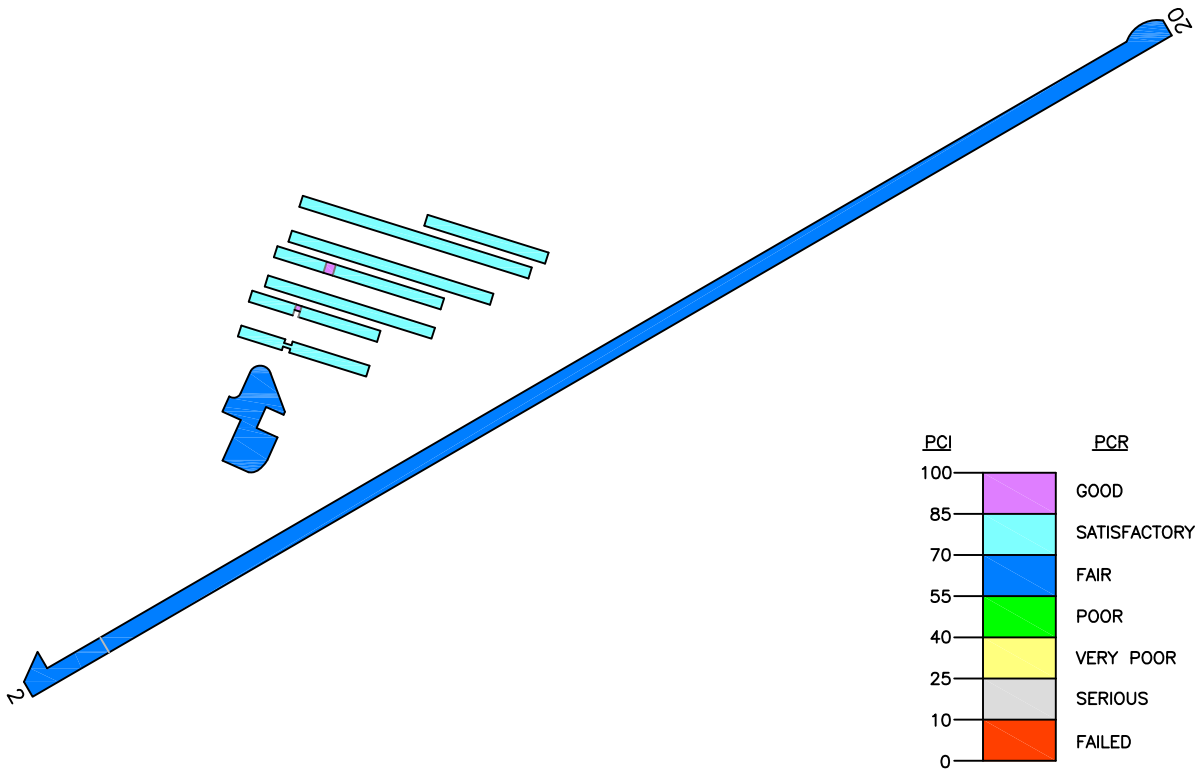
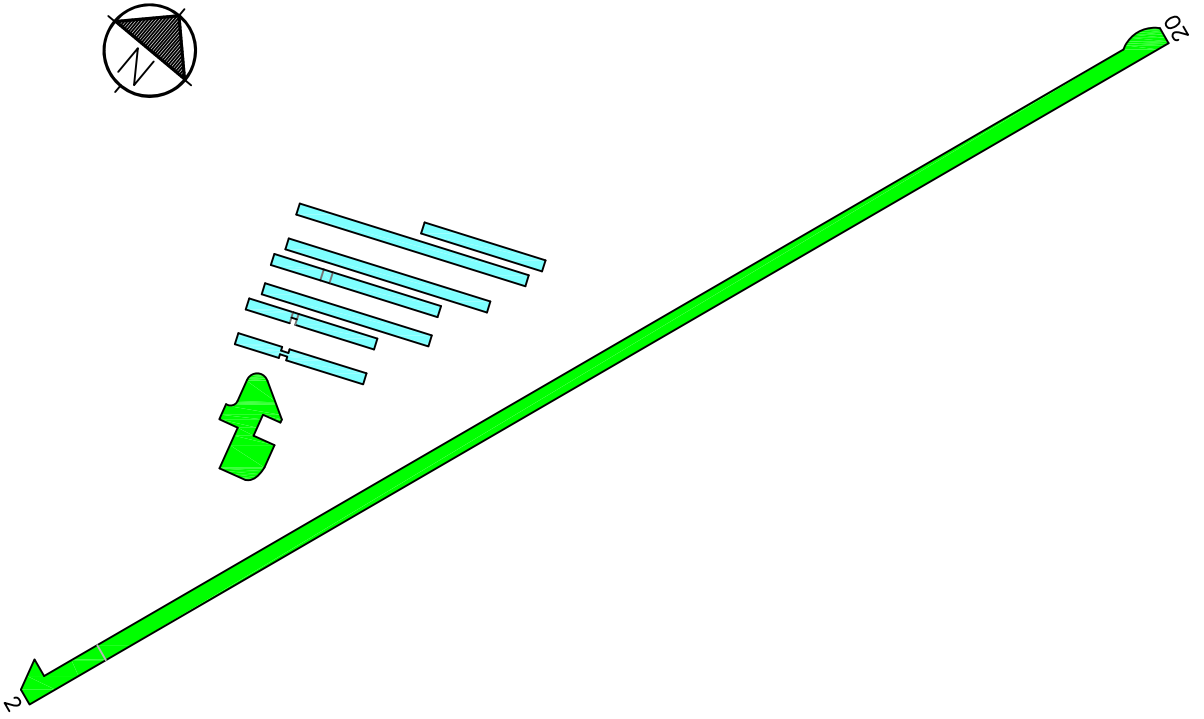
Figure LT-5. Future Pavement Condition.

A graphical representation of the projected PCIs listed in Table 1 is shown in Figure LT-5.
