# McMINNVILLE MUNICIPAL AIRPORT

This report describes how your Pavement Maintenance Management Program (PMMP) was developed. Your Program was developed as part of the Oregon Continuous Aviation System Plan sponsored in part by the Oregon Department of Aviation and the Federal Aviation Administration (FAA). The information and data contained in this report ensures you comply with the requirements of FAA Grant Assurance Number 11 which states that any airport requesting federal funds for pavement improvement projects must have implemented a pavement maintenance management program.

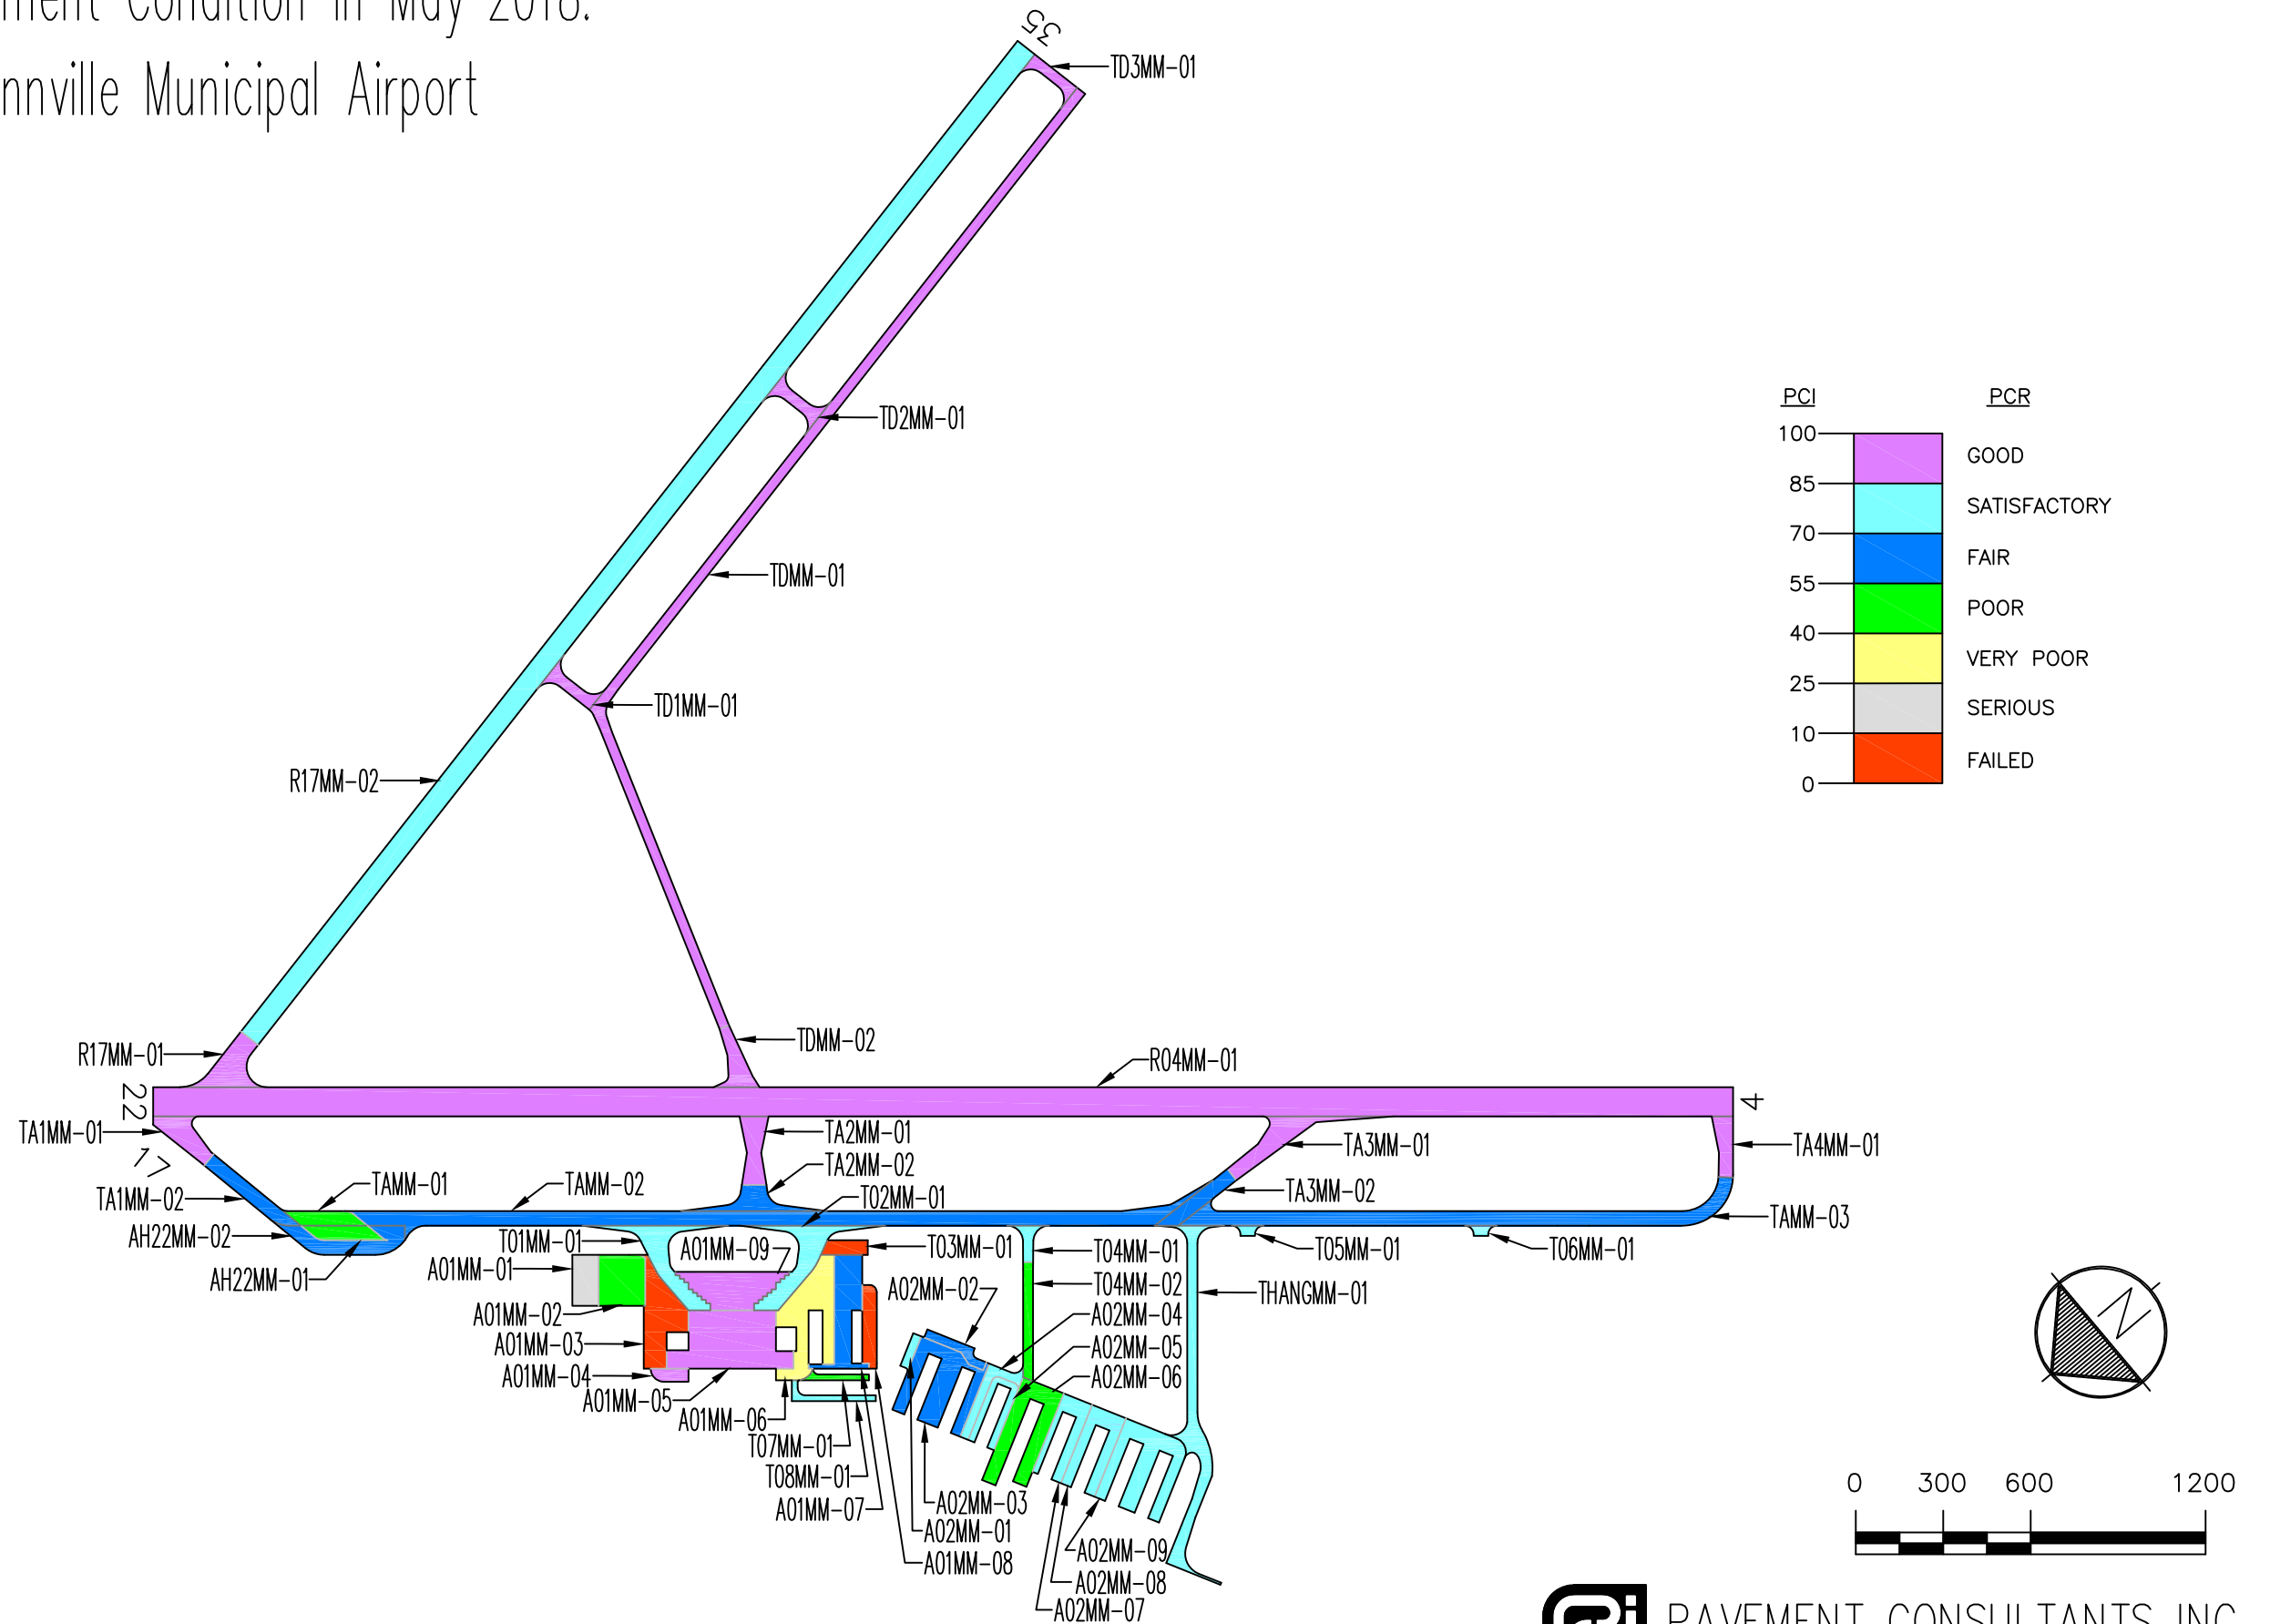
Figure MM-3. Pavement Condition in May 2018.  
McMinnville Municipal Airport

The Branch Condition Report in Appendix 1 summarizes current pavement condition by branch while the Section Condition Report in Appendix 2 lists pavement condition by section. The current Pavement Condition Rating (PCR) is shown graphically in Figure MM-3.

Section PCIs at McMinnville Municipal Airport range from a low of 3 (a PCR of “Failed”) to a high of 100 (a PCR of “Good”). The area-weighted average PCI for all airport pavements is 79, corresponding to an overall PCR of “Satisfactory”. Figure MM-4 shows how much pavement area is associated with each Pavement Condition Rating category and also shows pavement condition distribution from the inspections conducted in 2012 and 2015.

The primary distresses observed in the asphalt pavements during the inspection were: weathering, longitudinal and transverse cracking, block cracking, alligator cracking, depressions, raveling and patching. The distresses observed in the concrete pavement were: linear cracking, small patch, large patch, joint spall, and shrinkage cracks.

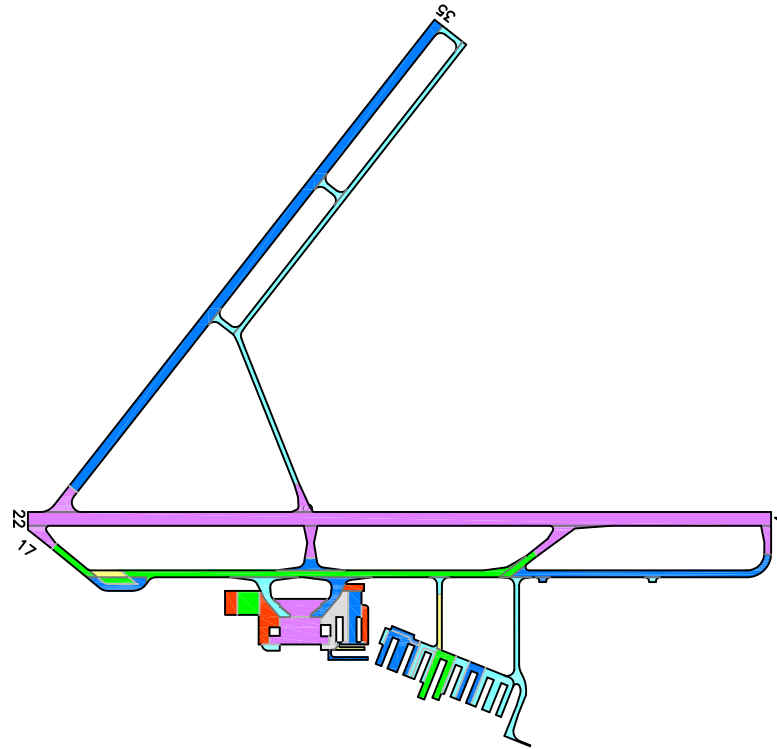
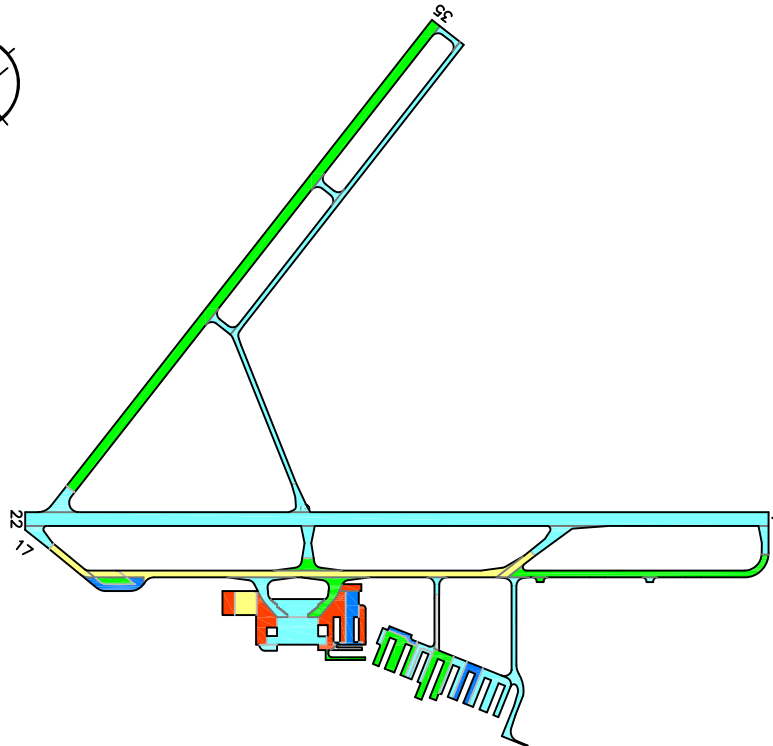
**Figure MM-5. Future Pavement Condition.**

A graphical representation of the projected PCIs listed in Table 1 is shown in Figure MM-5.
