MULINO STATE AIRPORT

DATA COLLECTION

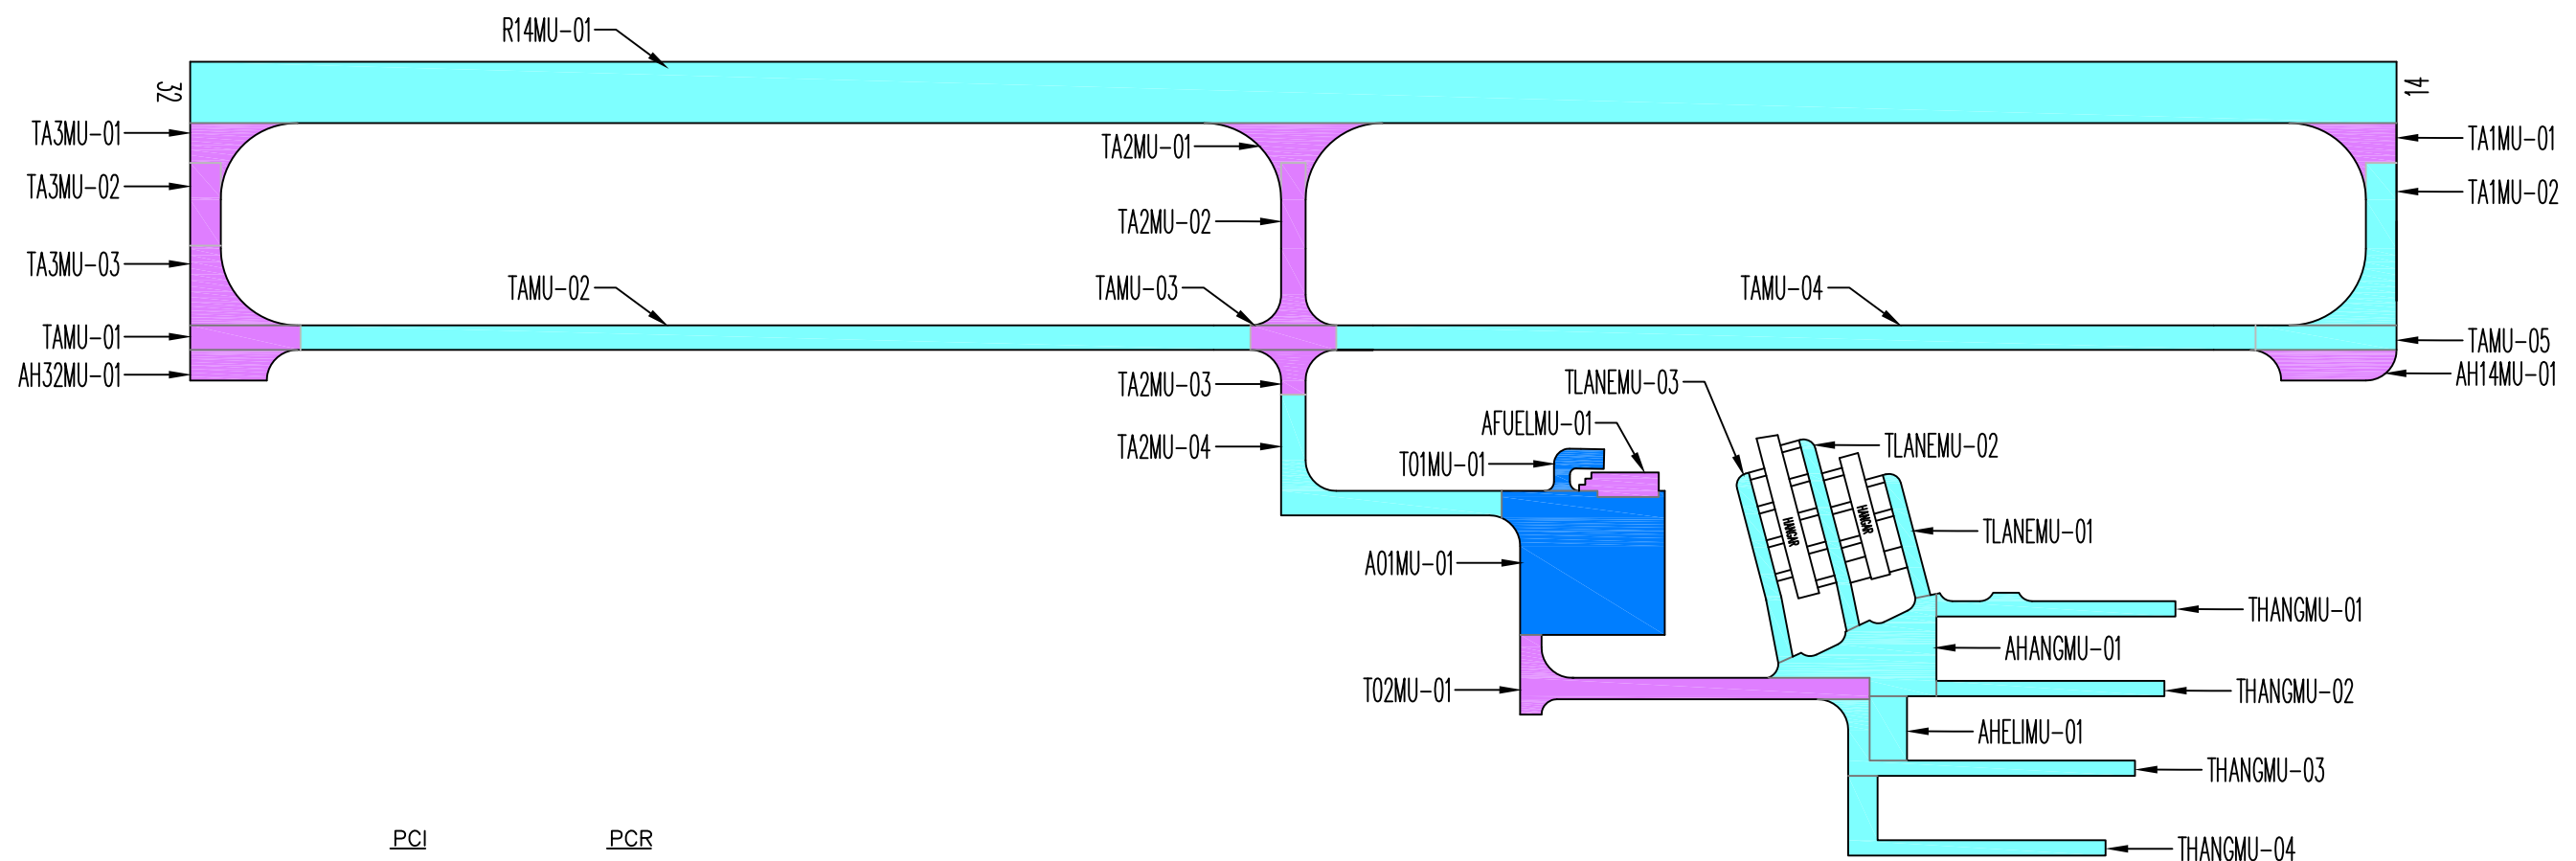
Figure MU-3. Pavement Condition in May 2018.
Mulino State Airport

Section PCIs at Mulino State Airport range from a low of 66 (a PCR of “Fair”) to a high of 100 (a PCR of “Good”). The area-weighted average PCI for all airport pavements is 81, corresponding to an overall PCR of “Satisfactory”. Figure MU-4 shows how much pavement area is associated with each Pavement Condition Rating category and also shows pavement condition distribution from the inspections conducted in 2012 and 2015.

The primary distress observed during the inspection was longitudinal and transverse cracking with isolated occurrences of raveling and patching.

Data collected during the visual condition survey were used by the PAVER software to generate the Network Maintenance Report contained in Appendix 3. This report identifies, for each pavement section, the recommended localized maintenance activities (i.e.-crack sealing, patching) that should be completed to repair the defects observed during the visual inspection. The repair quantities identified in the report were extrapolated to cover the entire pavement section, based on the distresses measured in the inspected sample units. If the repair activities identified are completed, the pavement deterioration rate will be slowed.

The recommended localized maintenance activities to be applied are selected by the PAVER software based on a Distress Maintenance Policy established for the Oregon airport system. The report results indicate that, over your entire airport, the following quantities of localized maintenance are needed:

- 20,296 linear feet of asphalt concrete crack sealing
- 4 linear feet of asphalt concrete wide crack sealing/repair.

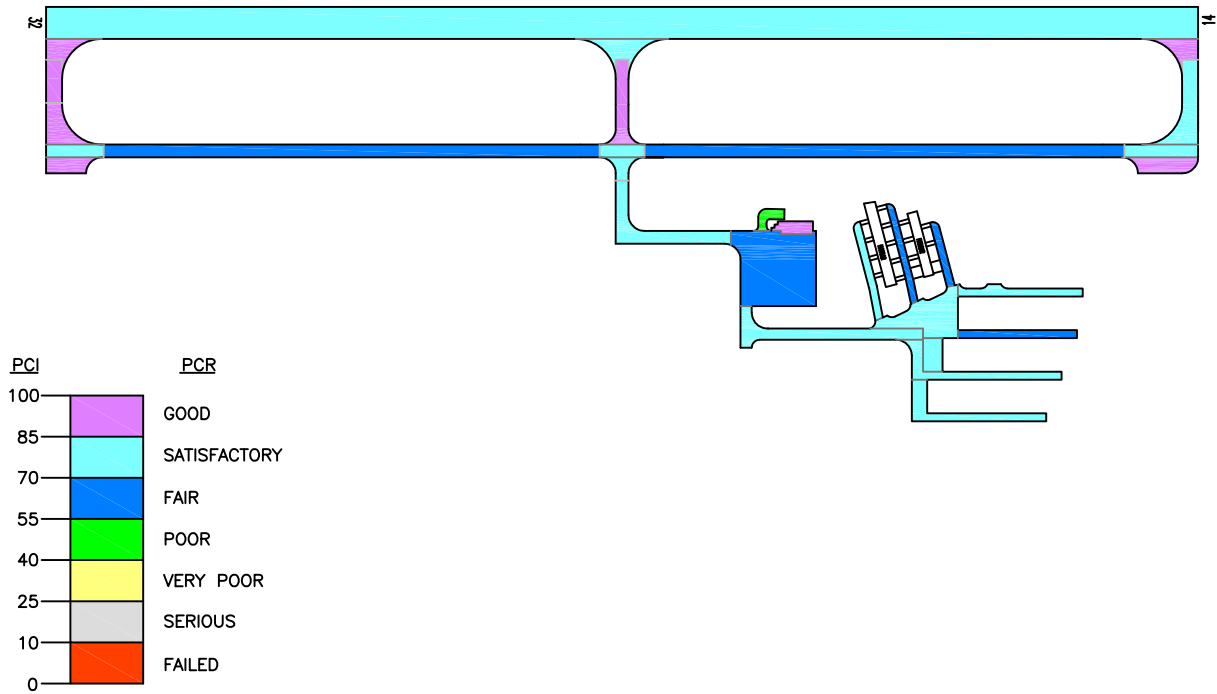
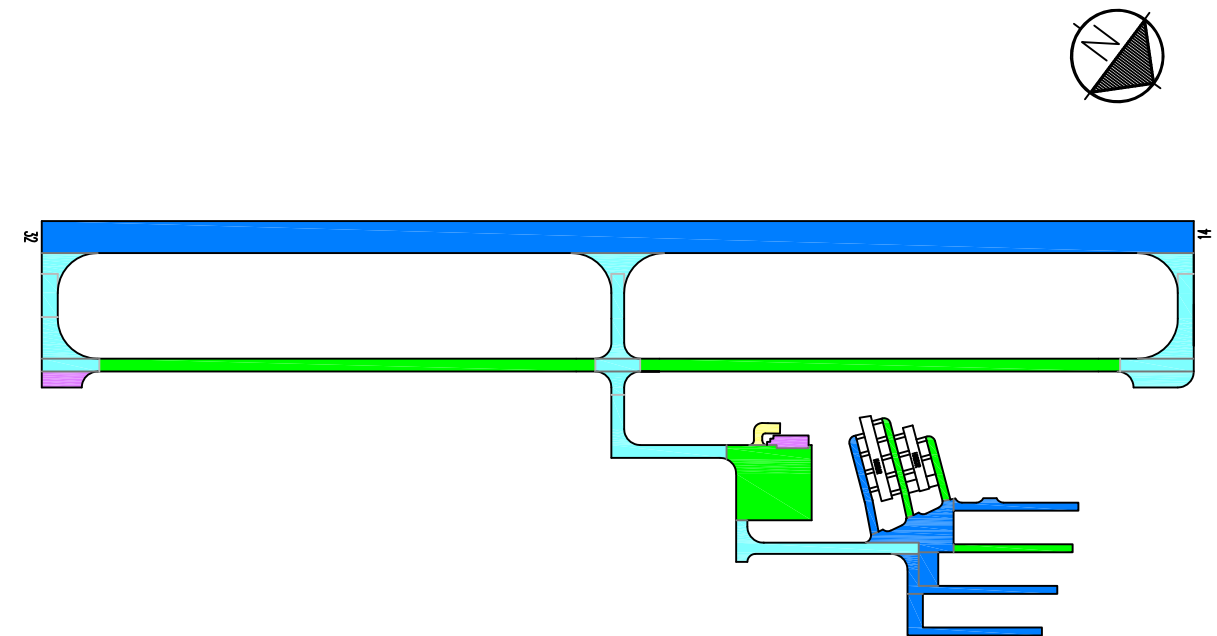
Figure MU-5. Future Pavement Condition.

A graphical representation of the projected PCIs listed in Table 1 is shown in Figure MU-5.
