NEHALEM BAY STATE AIRPORT

Figure NB-1. Airport Layout, Dimensions and Pavement Cross-Sections.
Nehalem Bay State Airport

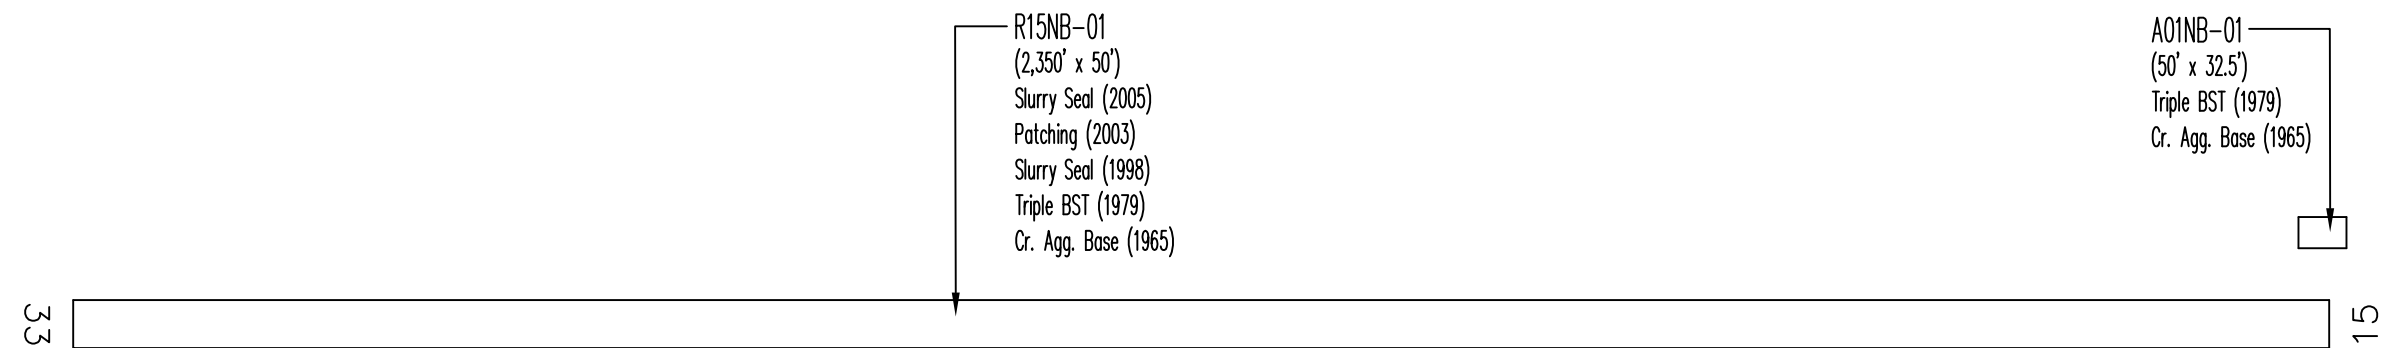
To determine how your pavements were constructed and their age, a records review was conducted. Figure NB-1 shows the records review results. This figure identifies pavement boundaries, dimensions, pavement layer types, thicknesses and dates of construction. The most recent construction date for each pavement can also be found in the Section Condition Report in Appendix 2. Figure NB-1 and the information contained in Appendices 1, 2 and 4 ensure that your airport complies with the “pavement inventory” requirement of FAA’s PMMP guidelines.

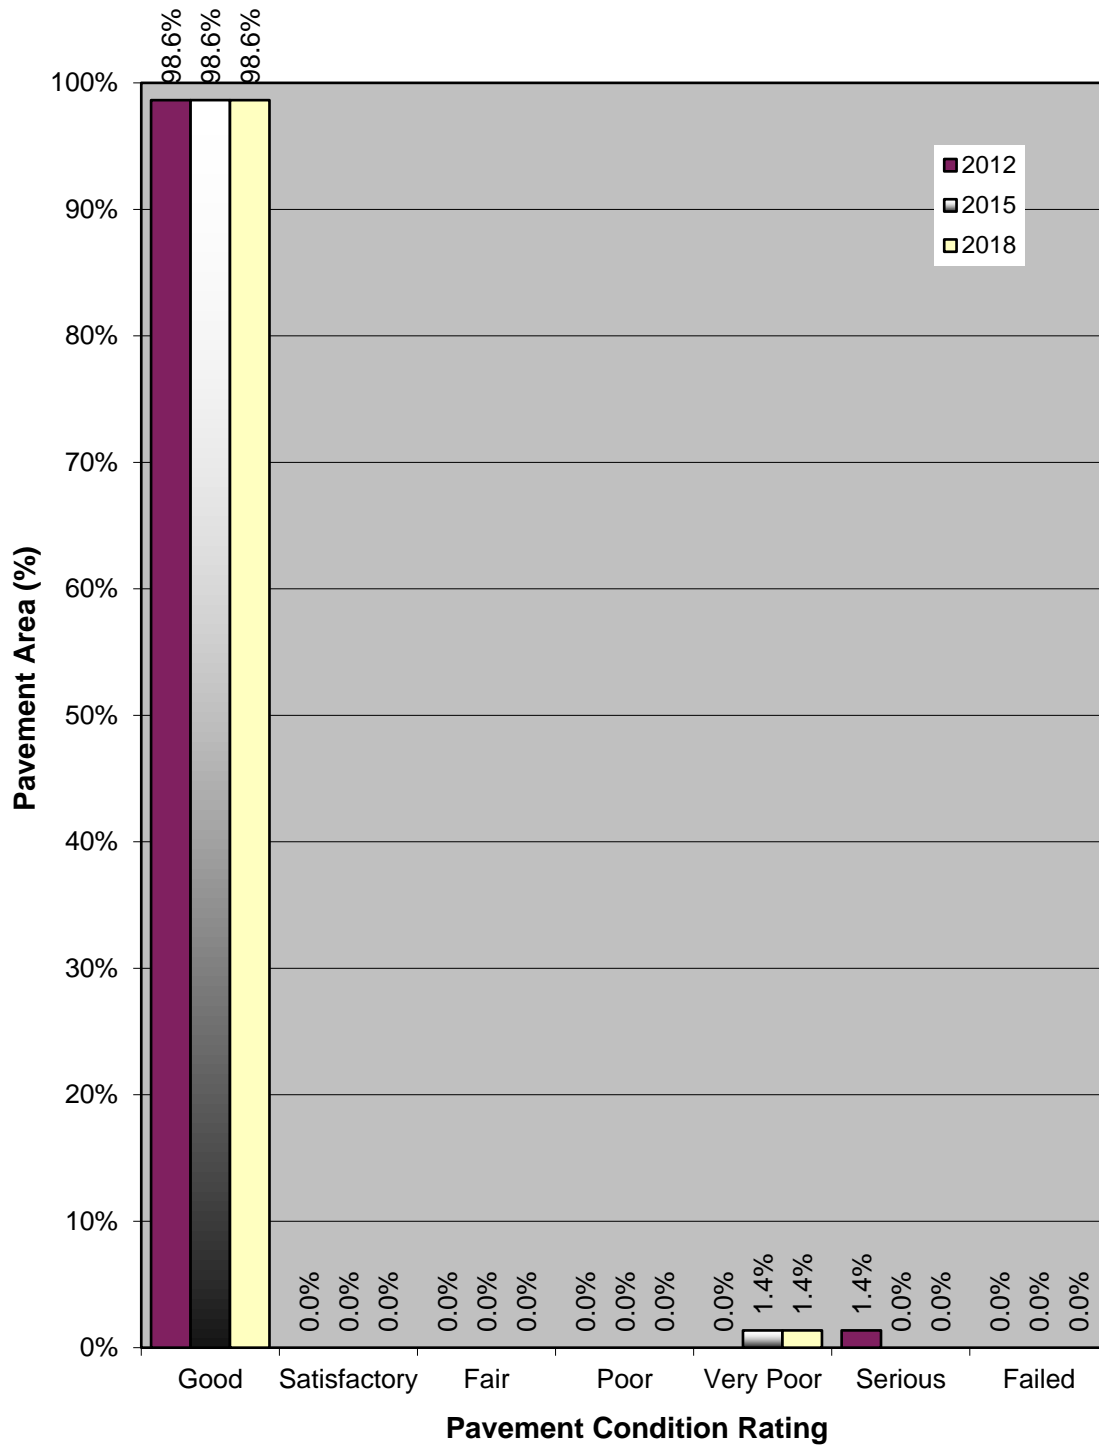
**Figure NB-4. Pavement Condition Distribution
Nehalem Bay State Airport**

Section PCIs at Nehalem Bay State Airport range from a low of 33 (a PCR of "Very Poor") to a high of 86 (a PCR of "Good"). The area-weighted average PCI for all airport pavements is 85, corresponding to an overall PCR of "Satisfactory". Figure NB-4 shows how much pavement area is associated with each Pavement Condition Rating category and also shows pavement condition distribution from the inspections conducted in 2012 and 2015.

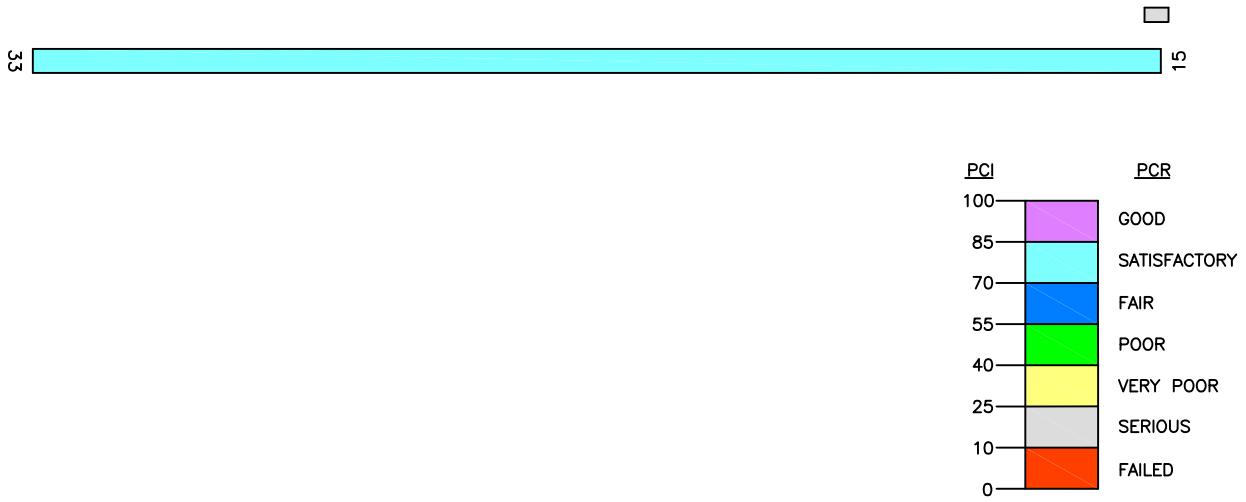
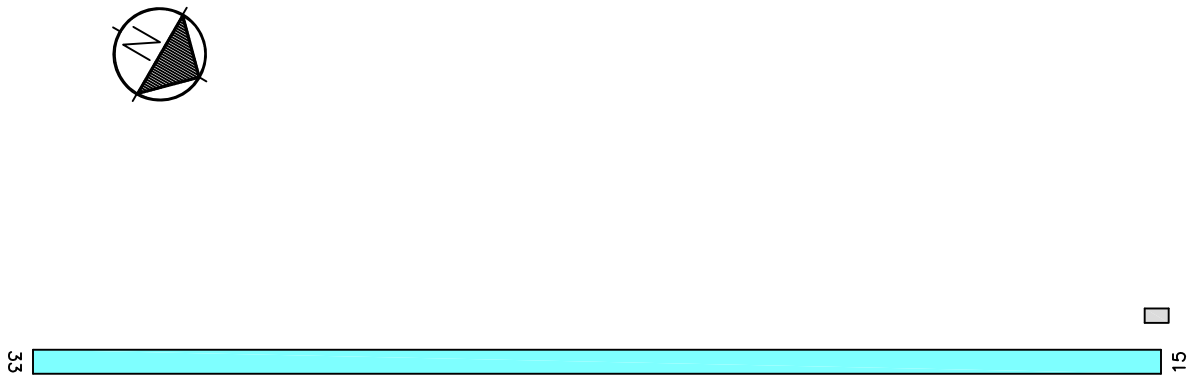
Figure NB-5. Future Pavement Condition.

A graphical representation of the projected PCIs listed in Table 1 is shown in Figure NB-5.
