# NEWPORT MUNICIPAL AIRPORT

This report describes how your Pavement Maintenance Management Program (PMMP) was developed. Your Program was developed as part of the Oregon Continuous Aviation System Plan sponsored in part by the Oregon Department of Aviation and the Federal Aviation Administration (FAA). The information and data contained in this report ensures you comply with the requirements of FAA Grant Assurance Number 11 which states that any airport requesting federal funds for pavement improvement projects must have implemented a pavement maintenance management program.

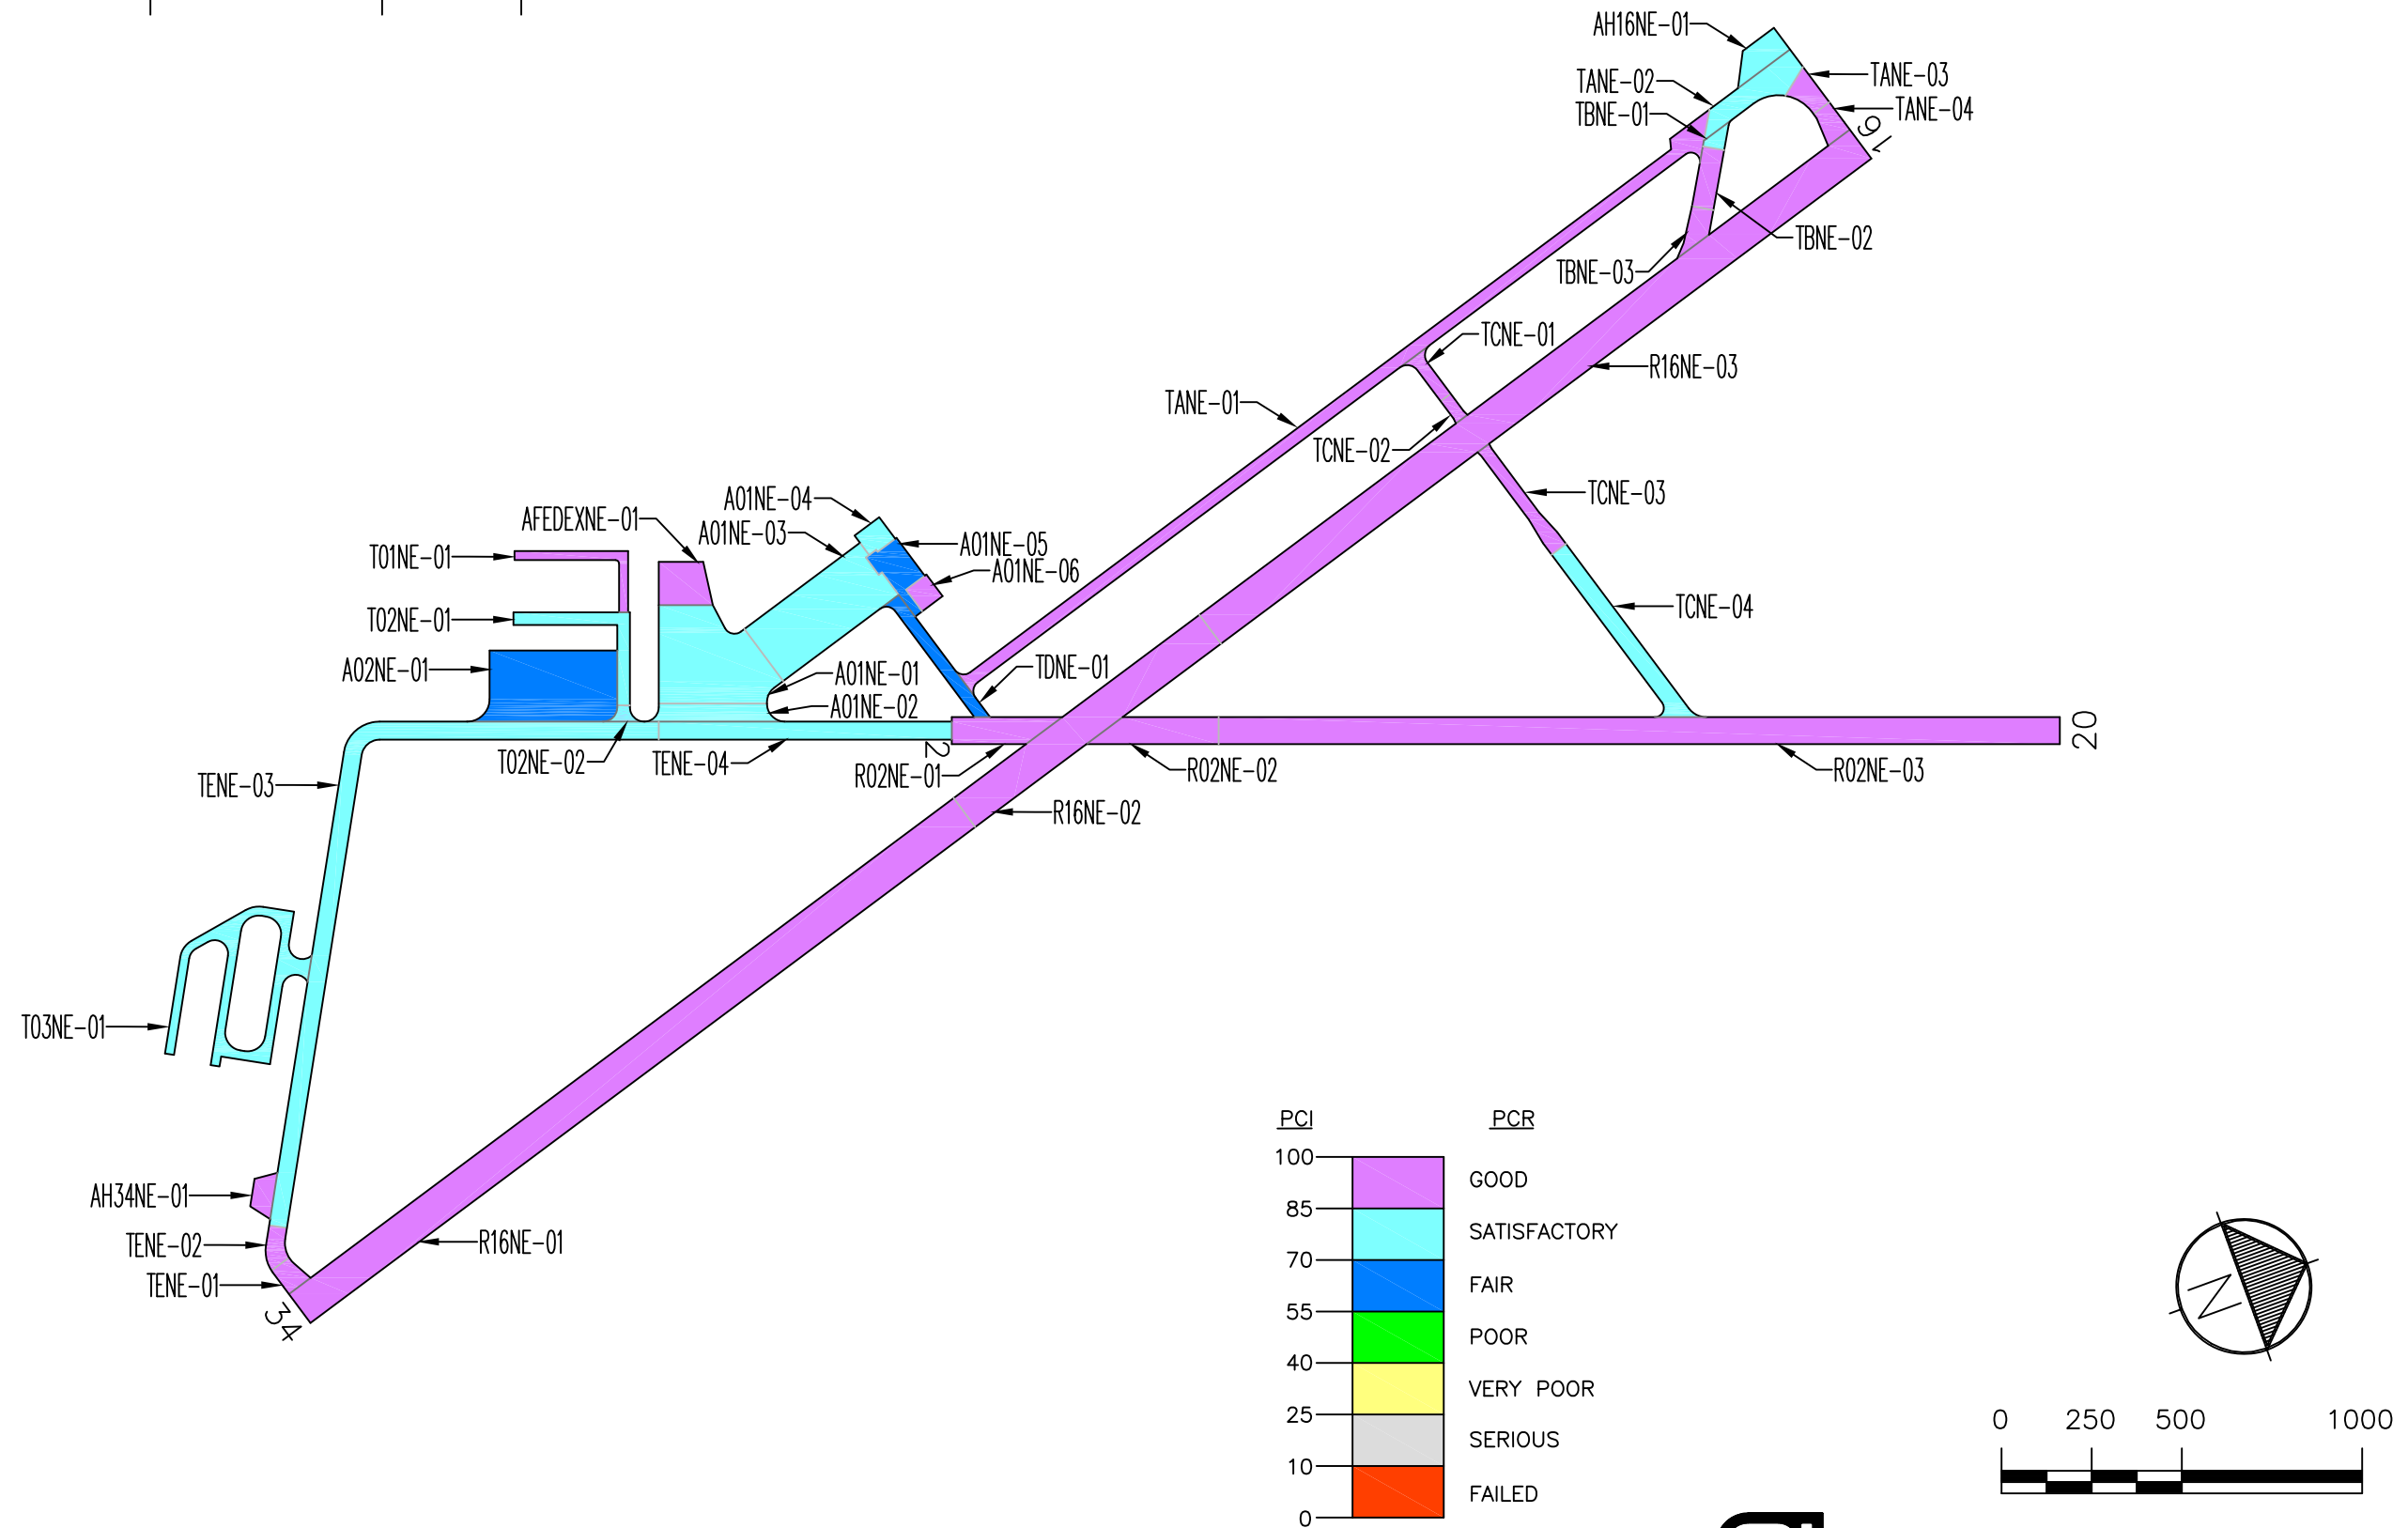
Figure NE-3. Pavement Condition in May 2018.  
Newport Municipal Airport

Section PCIs at Newport Municipal Airport range from a low of 66 (a PCR of “Fair”) to a high of 100 (a PCR of “Good”). The area-weighted average PCI for all airport pavements is 89, corresponding to an overall PCR of “Good”. Figure NE-4 shows how much pavement area is associated with each Pavement Condition Rating category and also shows pavement condition distribution from the inspections conducted in 2012 and 2015.

The primary distresses observed in the asphalt pavements during the inspection were: longitudinal and transverse cracking, depressions, weathering, patching, and isolated occurrences of alligator cracking and raveling.

Data collected during the visual condition survey were used by the PAVER software to generate the Network Maintenance Report contained in Appendix 3. This report identifies, for each pavement section, the recommended localized maintenance activities (i.e.-crack sealing, patching) that should be completed to repair the defects observed during the visual inspection. The repair quantities identified in the report were extrapolated to cover the entire pavement section, based on the distresses measured in the inspected sample units. If the repair activities identified are completed, the pavement deterioration rate will be slowed.

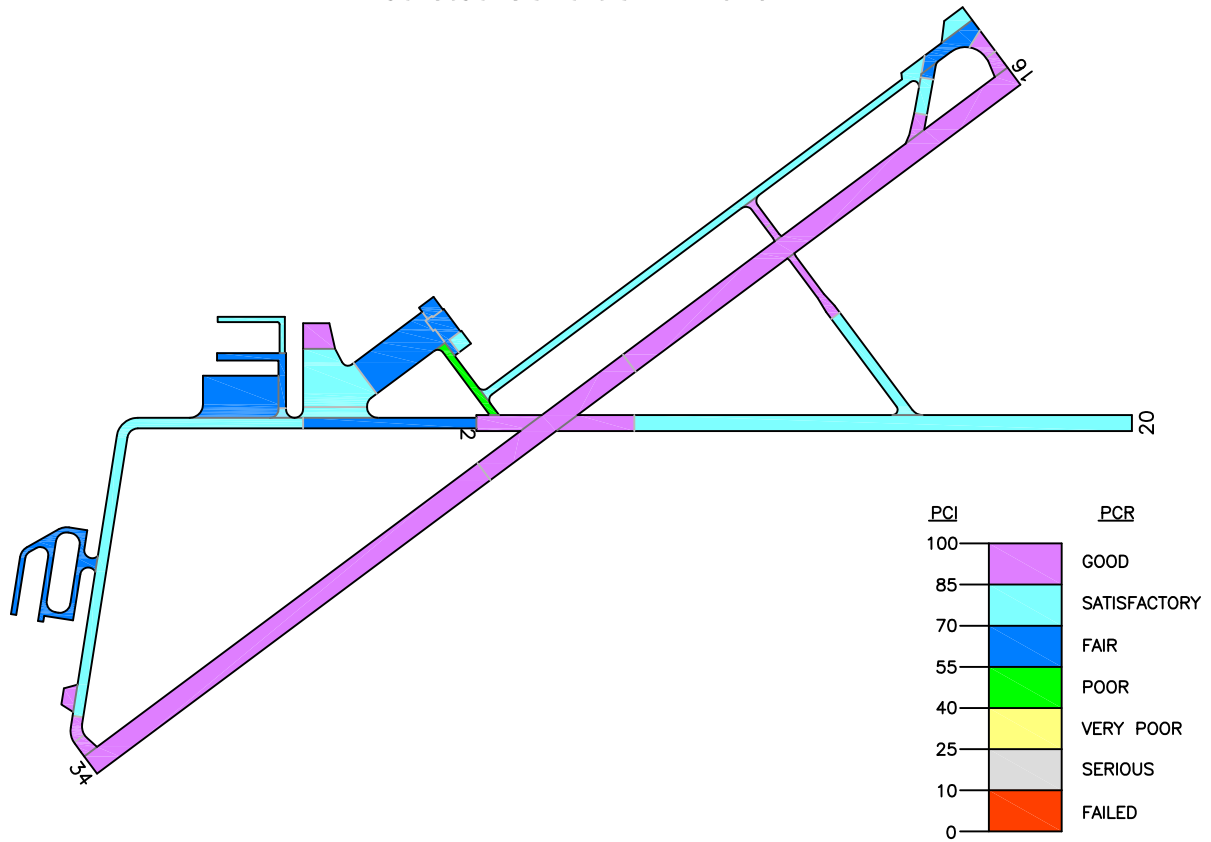
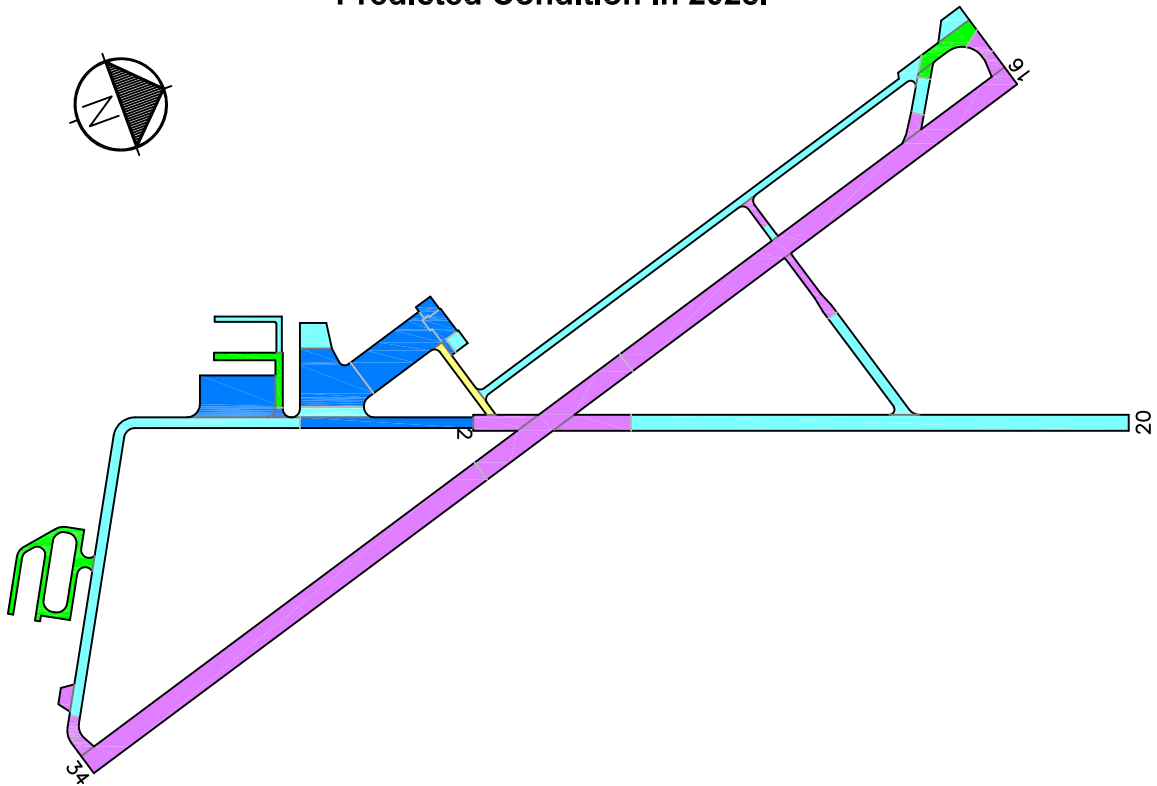
**Figure NE-5. Future Pavement Condition.**

A graphical representation of the projected PCIs listed in Table 1 is shown in Figure NE-5.
