PACIFIC CITY STATE AIRPORT

Figure PC-1. Airport Layout, Dimensions and Pavement Cross-Sections.
Pacific City State Airport

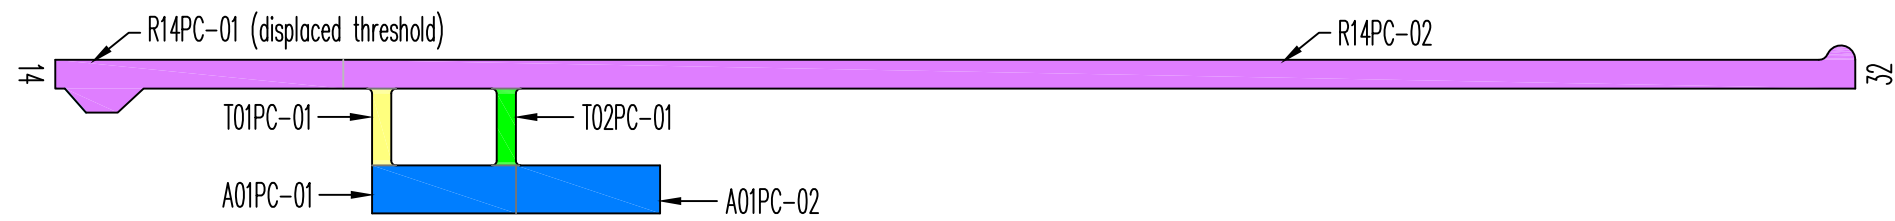
Figure PC-3. Pavement Condition in May 2018.
Pacific City State Airport

Section PCIs at Pacific City State Airport range from a low of 34 (a PCR of “Very Poor”) to a high of 95 (a PCR of “Good”). The area-weighted average PCI for all airport pavements is 81, corresponding to an overall PCR of “Satisfactory”. Figure PC-4 shows how much pavement area is associated with each Pavement Condition Rating category and also shows pavement condition distribution from the inspections conducted in 2012 and 2015.

The primary distresses observed during the inspection were: depressions, longitudinal and transverse cracking, alligator cracking, block cracking and raveling.
