# SALEM McNARY FIELD

This report describes how your Pavement Maintenance Management Program (PMMP) was developed. Your Program was developed as part of the Oregon Continuous Aviation System Plan sponsored in part by the Oregon Department of Aviation and the Federal Aviation Administration (FAA). The information and data contained in this report ensures you comply with the requirements of FAA Grant Assurance Number 11 which states that any airport requesting federal funds for pavement improvement projects must have implemented a pavement maintenance management program.

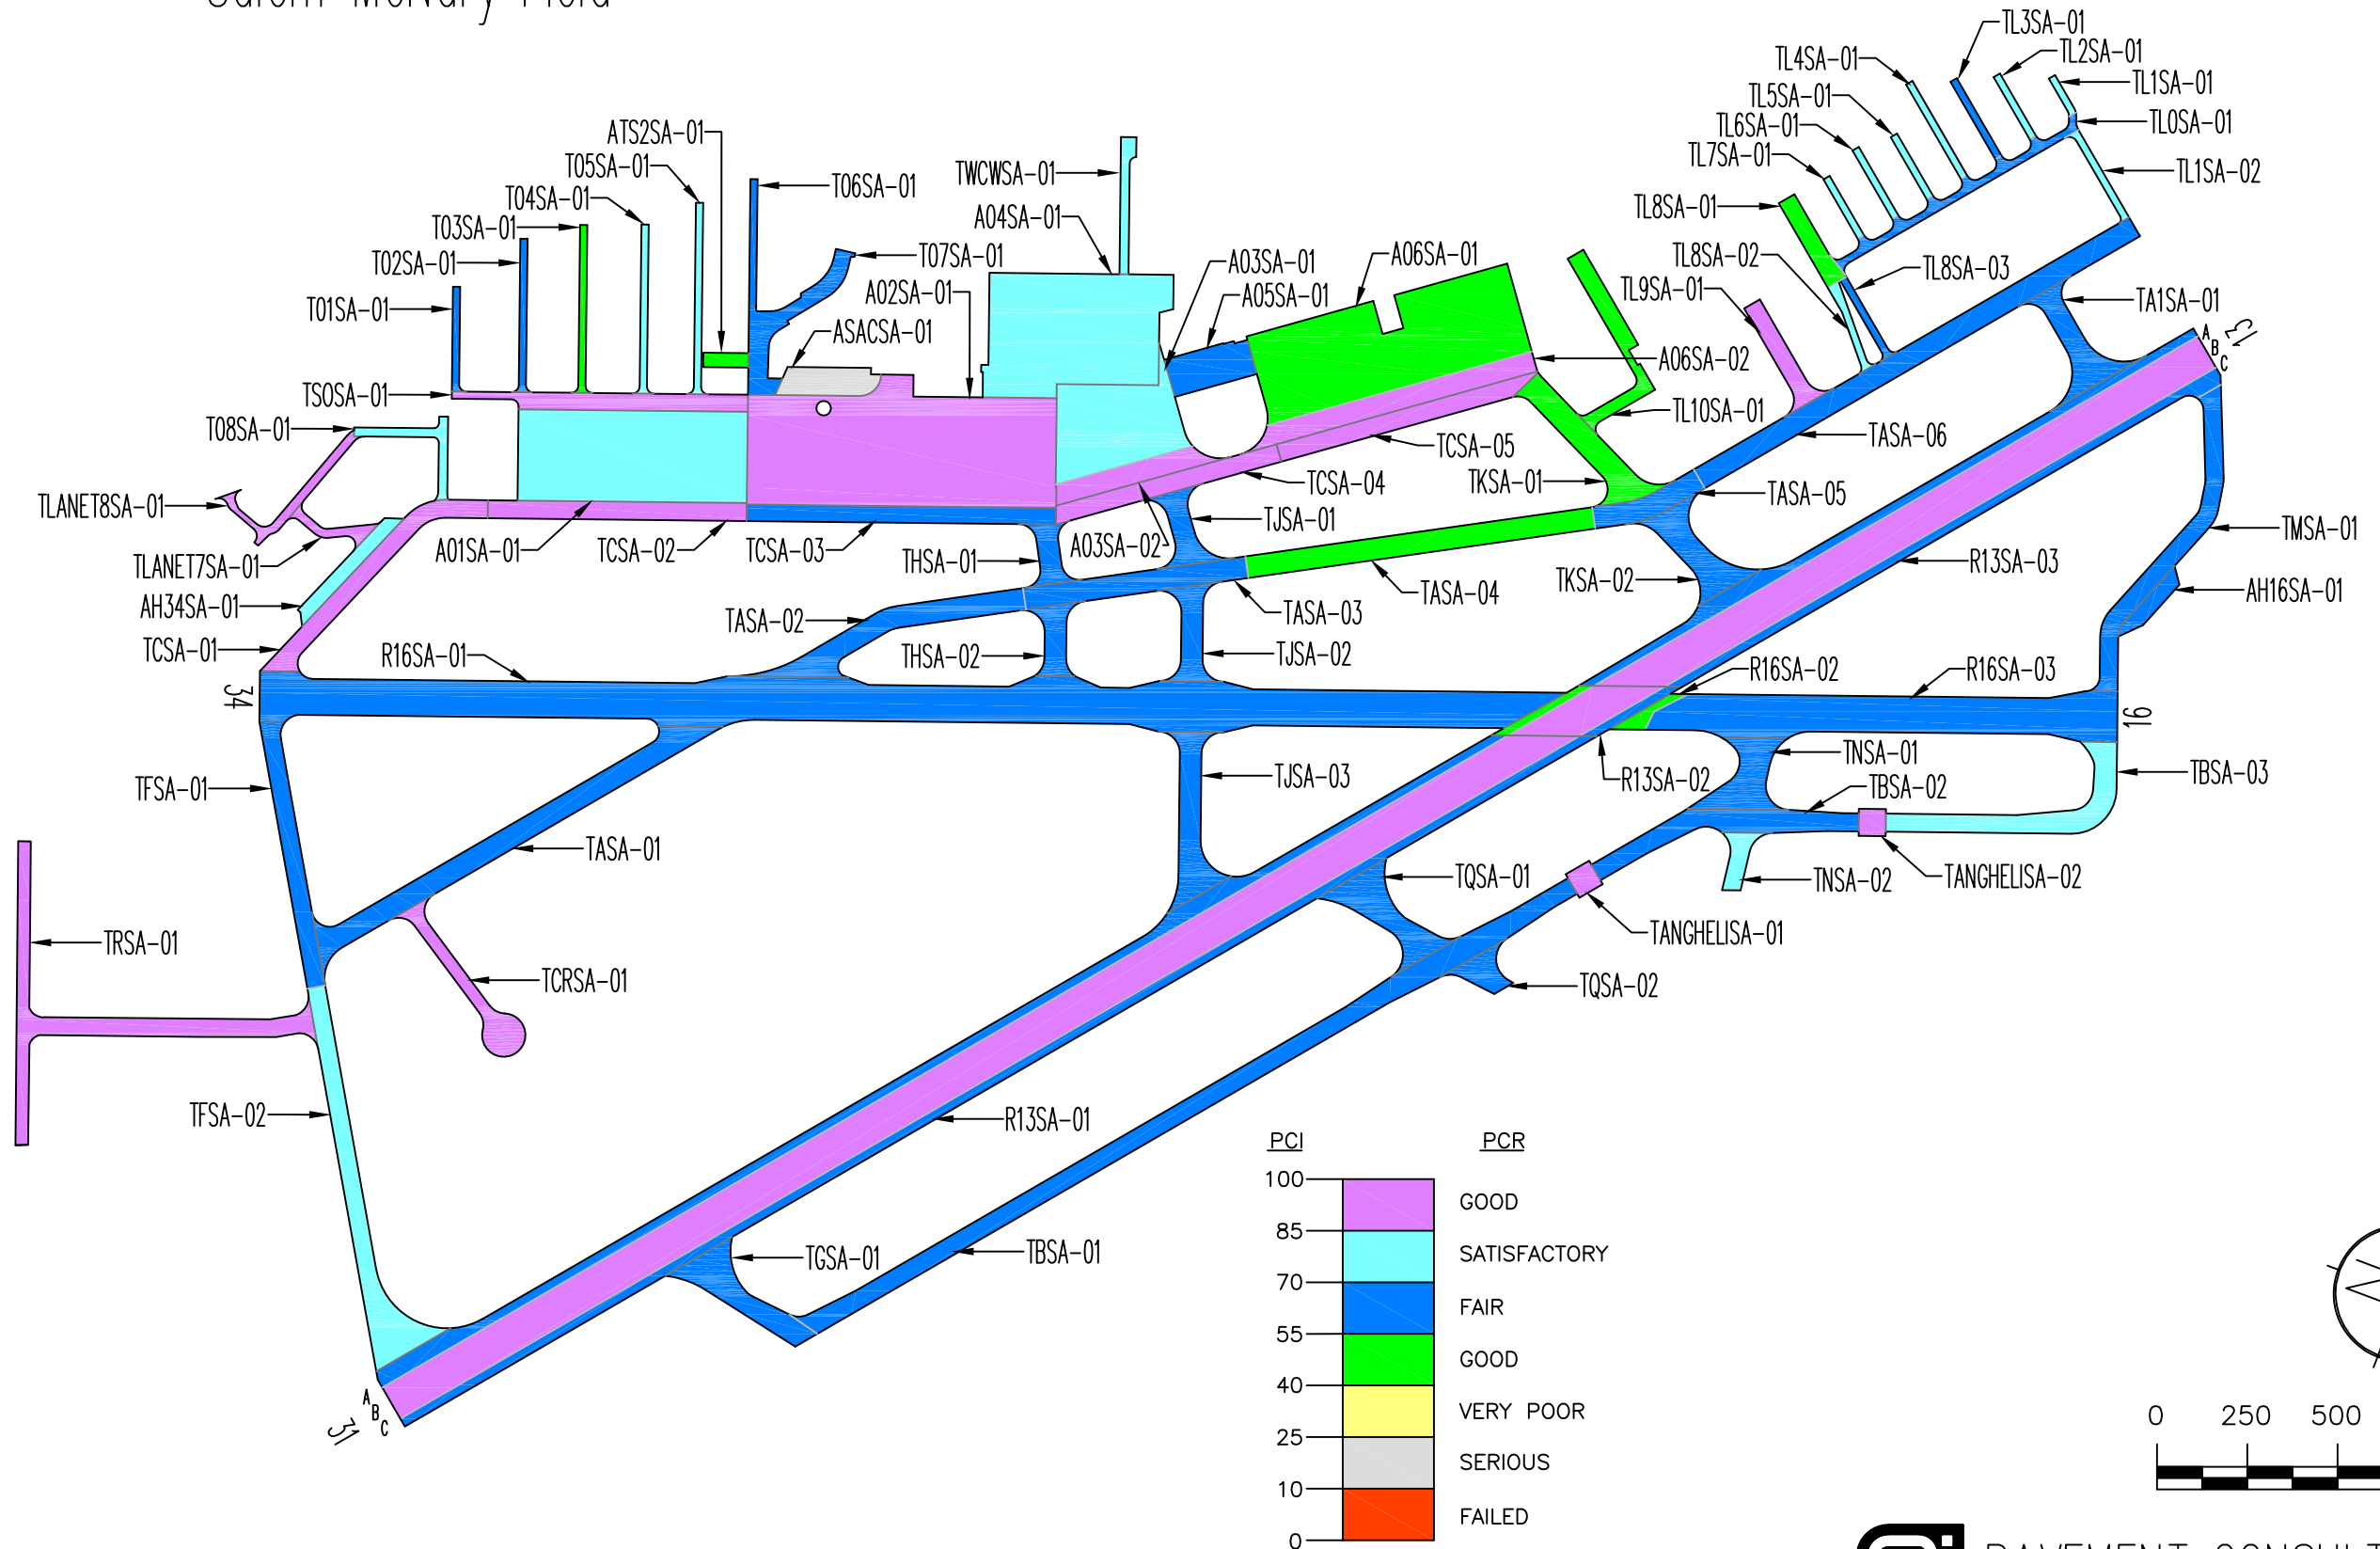
Figure SA-3. Pavement Condition in May 2018.  
Salem McNary Field

Section PCIs at Salem McNary Field range from a low of 16 (a PCR of “Serious”) to a high of 100 (a PCR of “Good”). The area-weighted average PCI for all airport pavements is 74, corresponding to an overall PCR of “Satisfactory”. Figure SA-4 shows how much pavement area is associated with each Pavement Condition Rating category and also shows pavement condition distribution from the inspections conducted in 2012 and 2015.

The primary distresses observed in the asphalt pavements during the inspection were: longitudinal and transverse cracking, weathering, block cracking, patching, alligator cracking, and depressions, with an isolated occurrence of raveling. The primary distresses observed in the concrete pavements were: linear cracking, small patches, corner spalls, and joint seal damage, and with isolated occurrences of joint spalls, shattered slabs, corner breaks, large patches and shrinkage cracks.

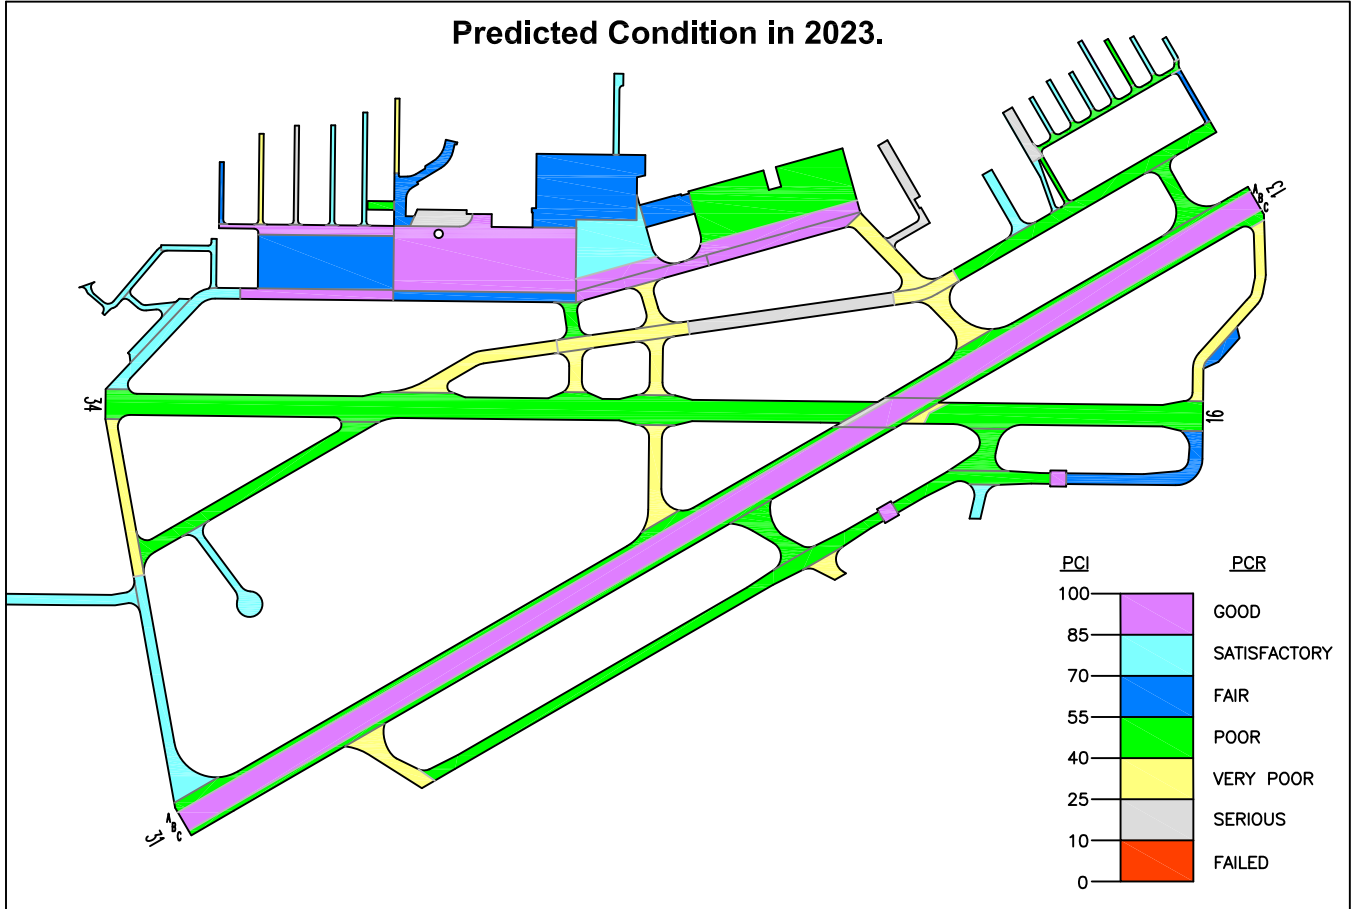
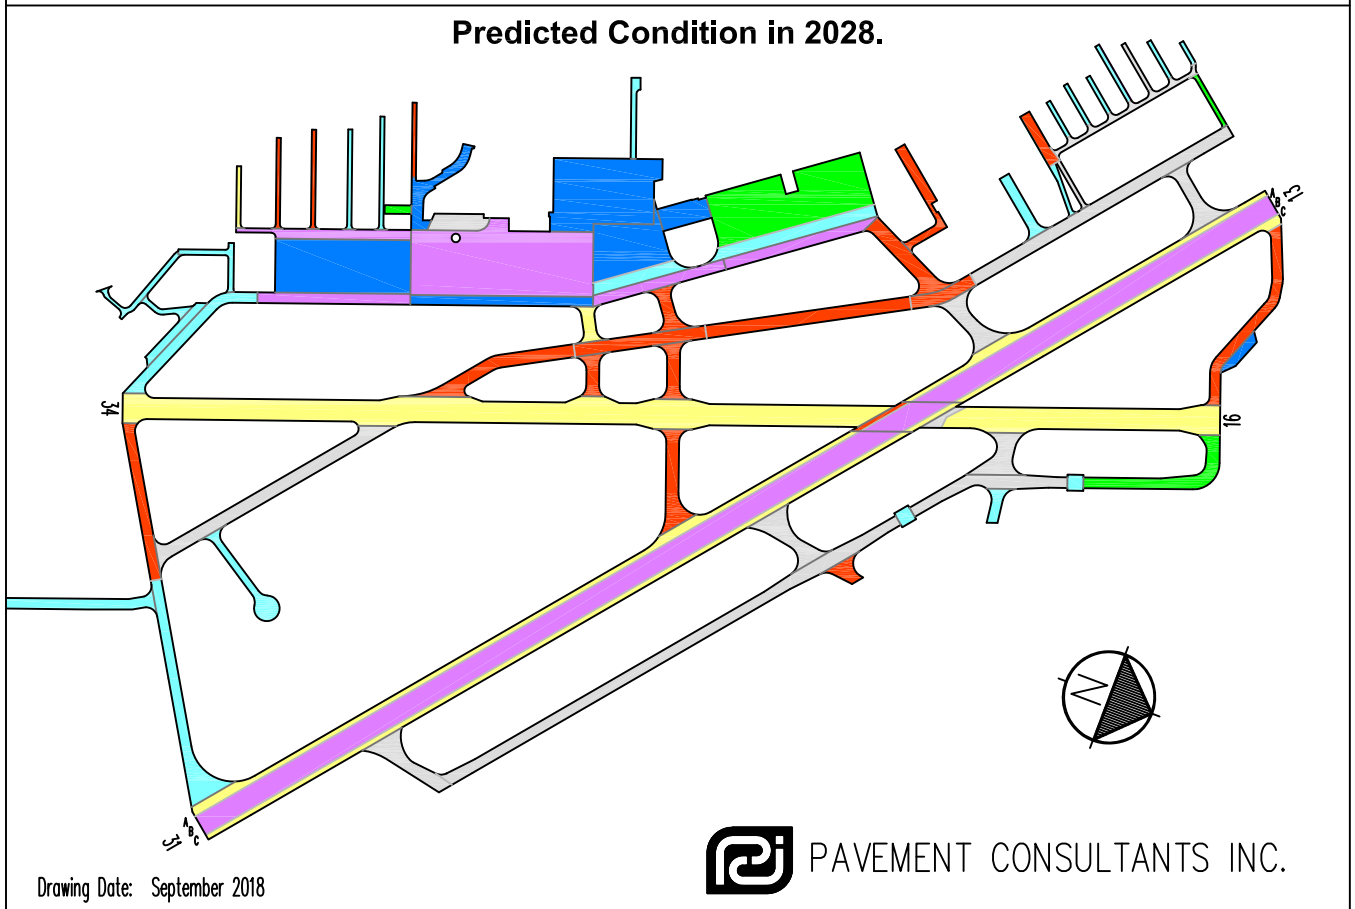
**Figure SA-5. Future Pavement Condition.**

A graphical representation of the projected PCIs listed in Table 1 is shown in Figure SA-5.
