SCAPPOOSE INDUSTRIAL AIRPARK

This report describes how your Pavement Maintenance Management Program (PMMP) was developed. Your Program was developed as part of the Oregon Continuous Aviation System Plan sponsored in part by the Oregon Department of Aviation and the Federal Aviation Administration (FAA). The information and data contained in this report ensures you comply with the requirements of FAA Grant Assurance Number 11 which states that any airport requesting federal funds for pavement improvement projects must have implemented a pavement maintenance management program.

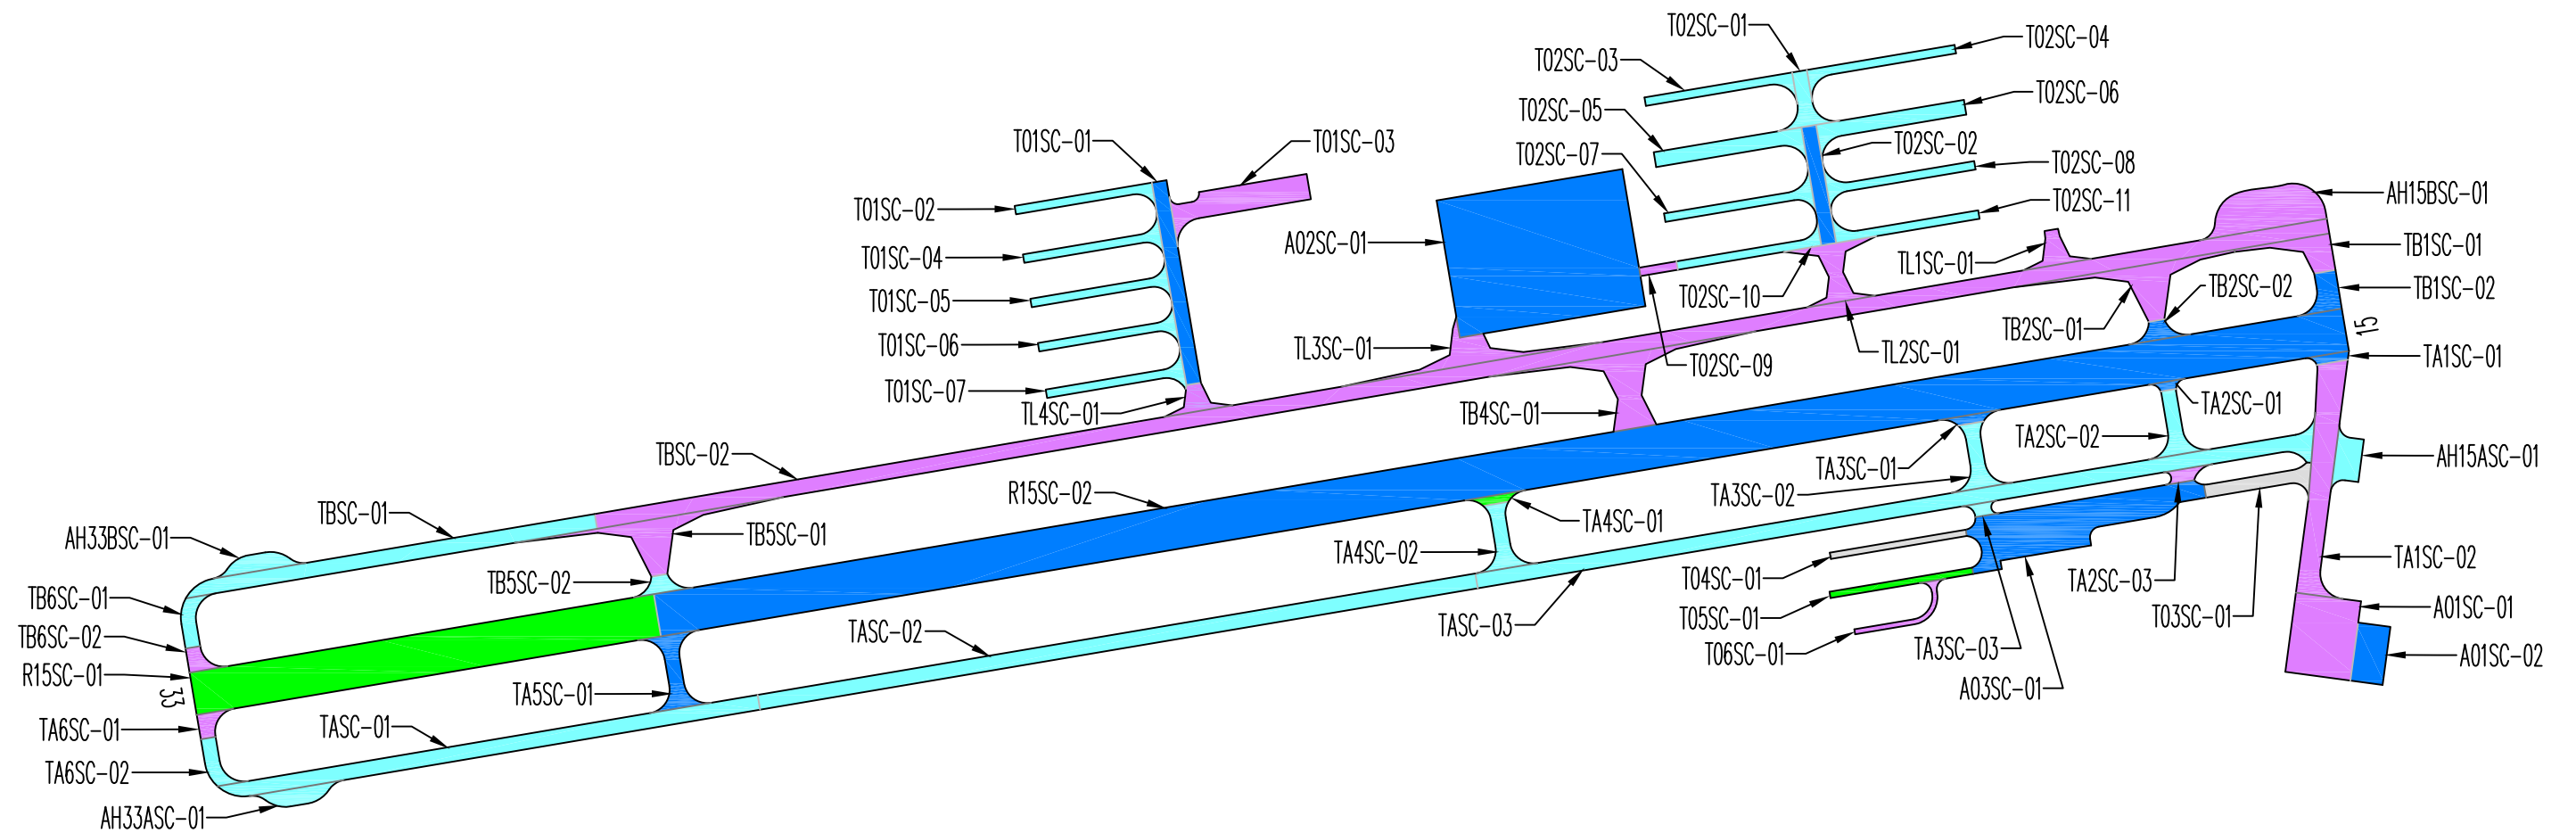
Figure SC-3. Pavement Condition in July 2018.
Scappoose Industrial Airpark

The Branch Condition Report in Appendix 1 summarizes current pavement condition by branch while the Section Condition Report in Appendix 2 lists pavement condition by section. The current Pavement Condition Rating (PCR) is shown graphically in Figure SC-3.’

Section PCIs at Scappoose Industrial Airpark range from a low of 11 (a PCR of “Serious”) to a high of 100 (a PCR of “Good”). The area-weighted average PCI for all airport pavements is 73, corresponding to an overall PCR of “Satisfactory”. Figure SC-4 shows how much pavement area is associated with each Pavement Condition Rating category and also shows pavement condition distribution from the inspections conducted in 2012 and 2015.

The primary distresses observed during the inspection were: longitudinal and transverse cracking, weathering, block cracking, patching and alligator cracking, with an isolated occurrence of raveling.

Data collected during the visual condition survey were used by the PAVER software to generate the Network Maintenance Report contained in Appendix 3. This report identifies, for each pavement section, the recommended localized maintenance activities (i.e.-crack sealing, patching) that should be completed to repair the defects observed during the visual inspection. The repair quantities identified in the report were extrapolated to cover the entire pavement section, based on the distresses measured in the inspected sample units. If the repair activities identified are completed, the pavement deterioration rate will be slowed.

The recommended localized maintenance activities to be applied are selected by the PAVER software based on a Distress Maintenance Policy established for the Oregon airport system. The report results indicate that, over your entire airport, the following quantities of localized maintenance are needed:

- 59,421 linear feet of asphalt concrete crack sealing
- 10 linear feet of asphalt concrete wide crack sealing/repair
- 3,554 square feet of asphalt concrete deep patching.

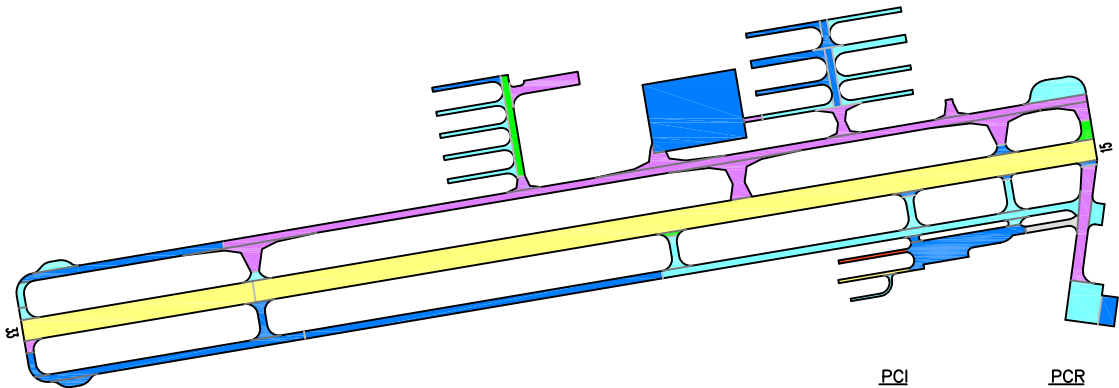
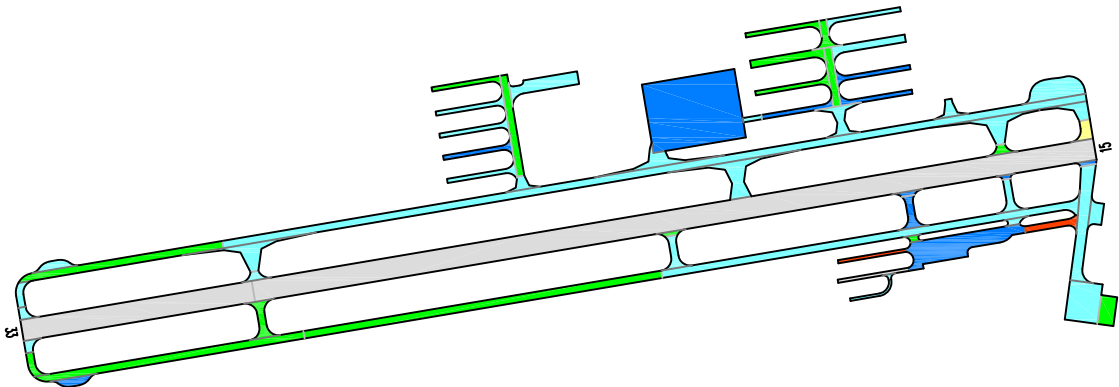
Figure SC-5. Future Pavement Condition.

A graphical representation of the projected PCIs listed in Table 1 is shown in Figure SC-5.
