SEASIDE MUNICIPAL AIRPORT

Figure SS-1. Airport Layout, Dimensions and Pavement Cross-Sections.
Seaside Municipal Airport

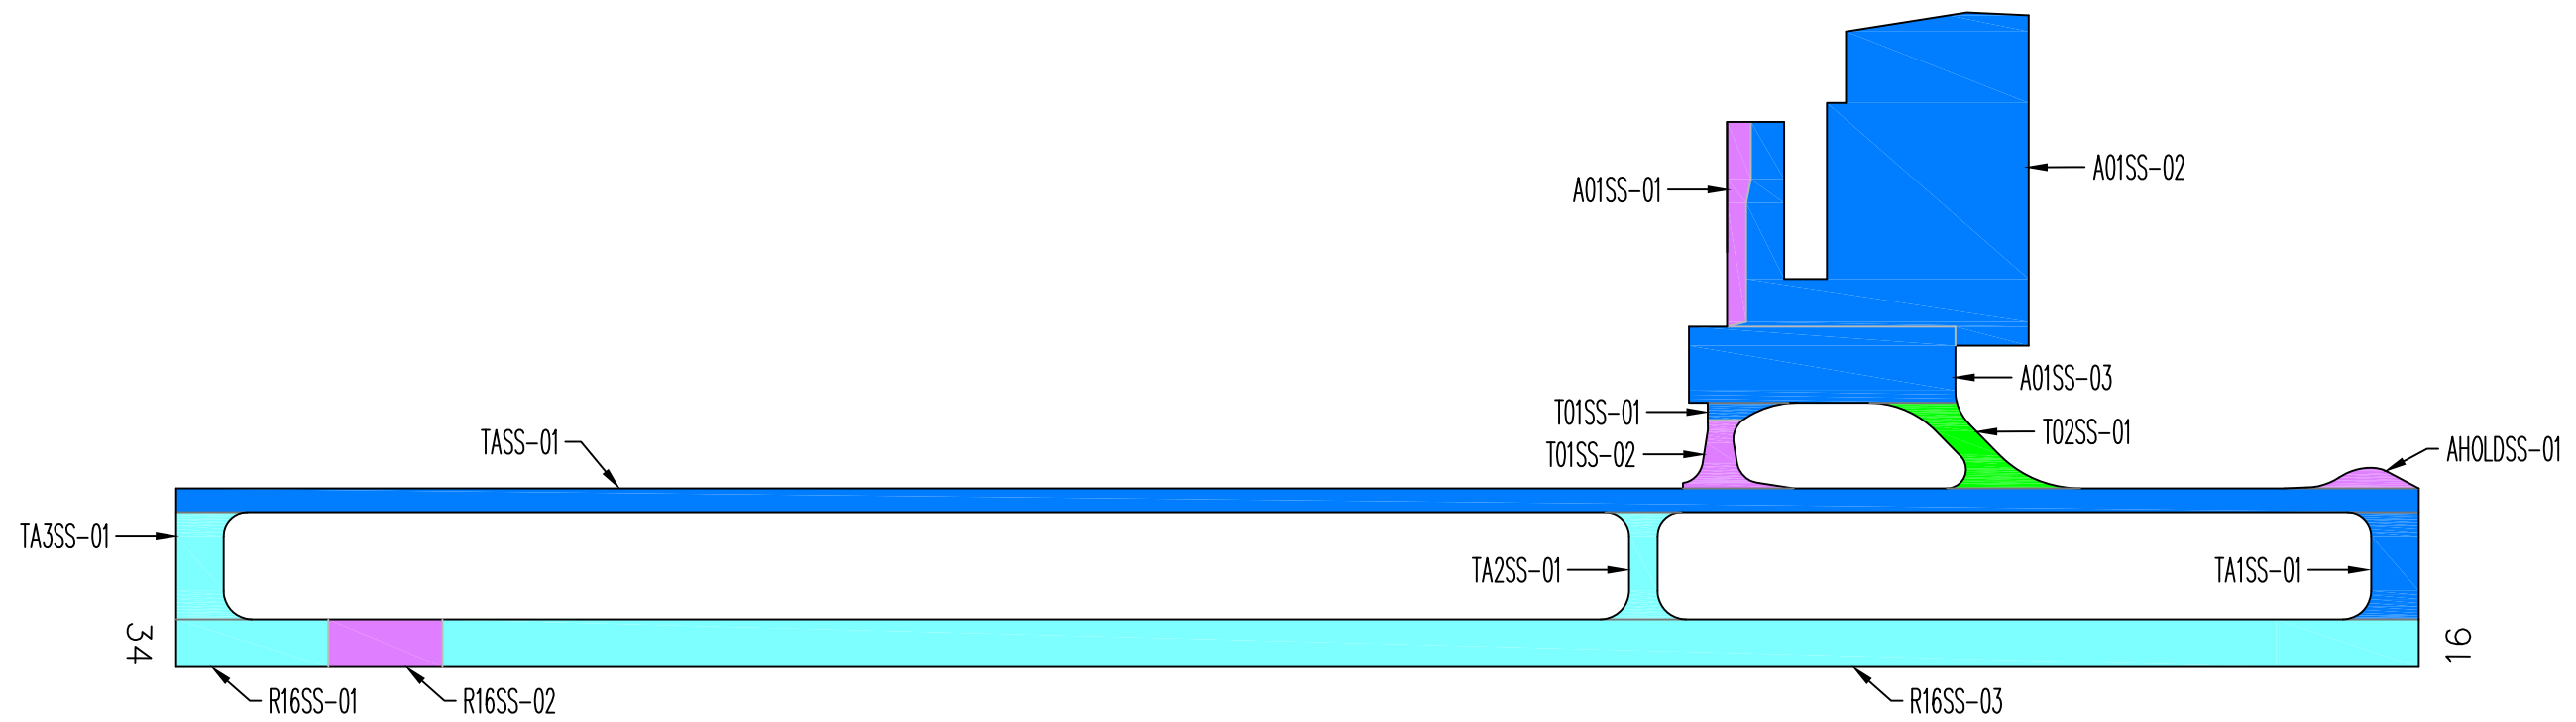
Figure SS-3. Pavement Condition in May 2018.
Seaside Municipal Airport

Section PCIs at Seaside Municipal Airport range from a low of 51 (a PCR of “Poor”) to a high of 100 (a PCR of “Good”). The area-weighted average PCI for all airport pavements is 75, corresponding to an overall PCR of “Satisfactory”. Figure SS-4 shows how much pavement area is associated with each Pavement Condition Rating category and also shows pavement condition distribution from the inspections conducted in 2012 and 2015.

The primary distresses observed during the inspection were: longitudinal and transverse cracking, patching, and an isolated occurrence of depressions.

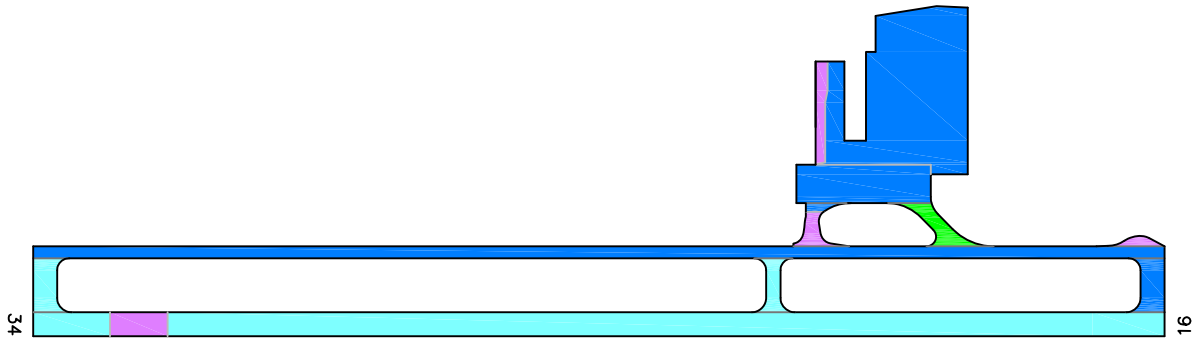
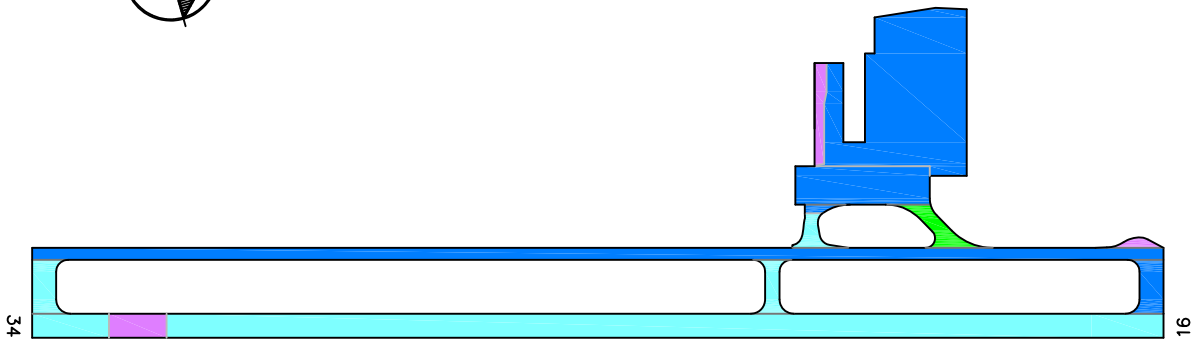
Figure SS-5. Future Pavement Condition.

A graphical representation of the projected PCIs listed in Table 1 is shown in Figure SS-5.
