SILETZ BAY STATE AIRPORT

This report describes how your Pavement Maintenance Management Program (PMMP) was developed. Your Program was developed as part of the Oregon Continuous Aviation System Plan sponsored in part by the Oregon Department of Aviation and the Federal Aviation Administration (FAA). The information and data contained in this report ensures you comply with the requirements of FAA Grant Assurance Number 11 which states that any airport requesting federal funds for pavement improvement projects must have implemented a pavement maintenance management program.

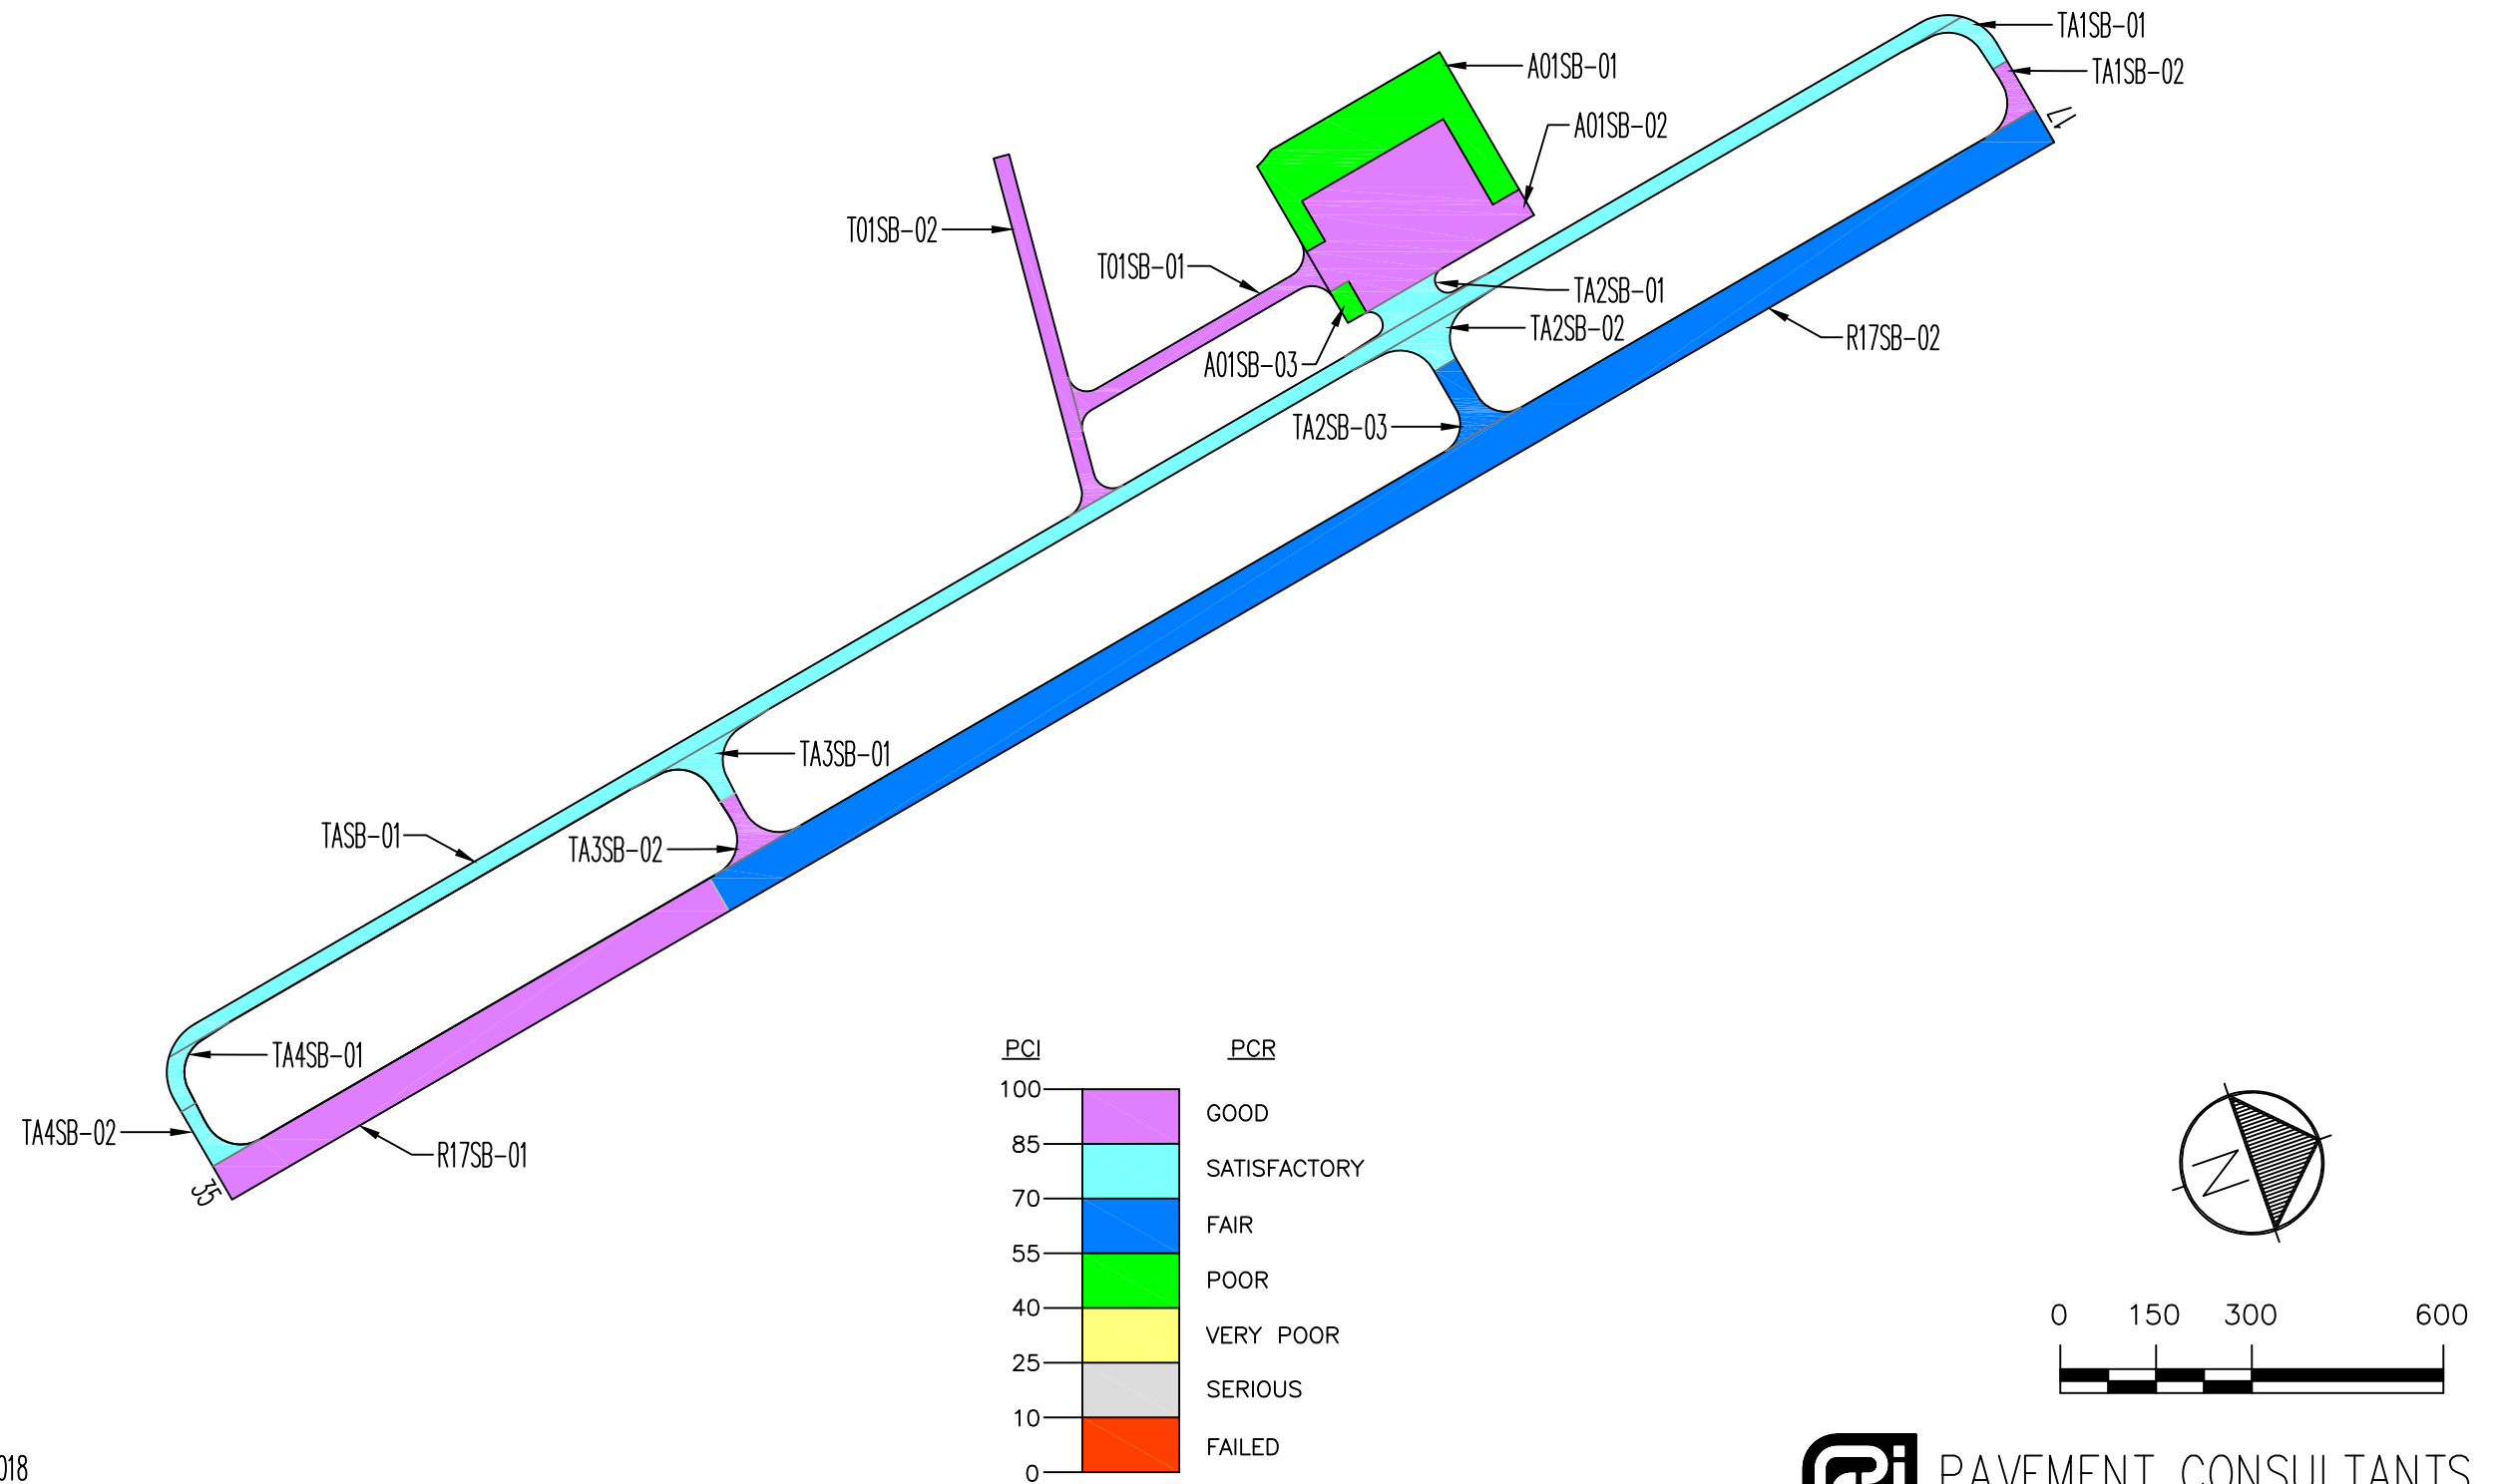
Figure SB-3. Pavement Condition in May 2018.
Siletz Bay State Airport

Section PCIs at Siletz Bay State Airport range from a low of 42 (a PCR of “Poor”) to a high of 100 (a PCR of “Good”). The area-weighted average PCI for all airport pavements is 76, corresponding to an overall PCR of “Satisfactory”. Figure SB-4 shows how much pavement area is associated with each Pavement Condition Rating category and also shows pavement condition distribution from the inspections conducted in 2012 and 2015.

The primary distresses observed during the inspection were: longitudinal and transverse cracking, weathering and block cracking.

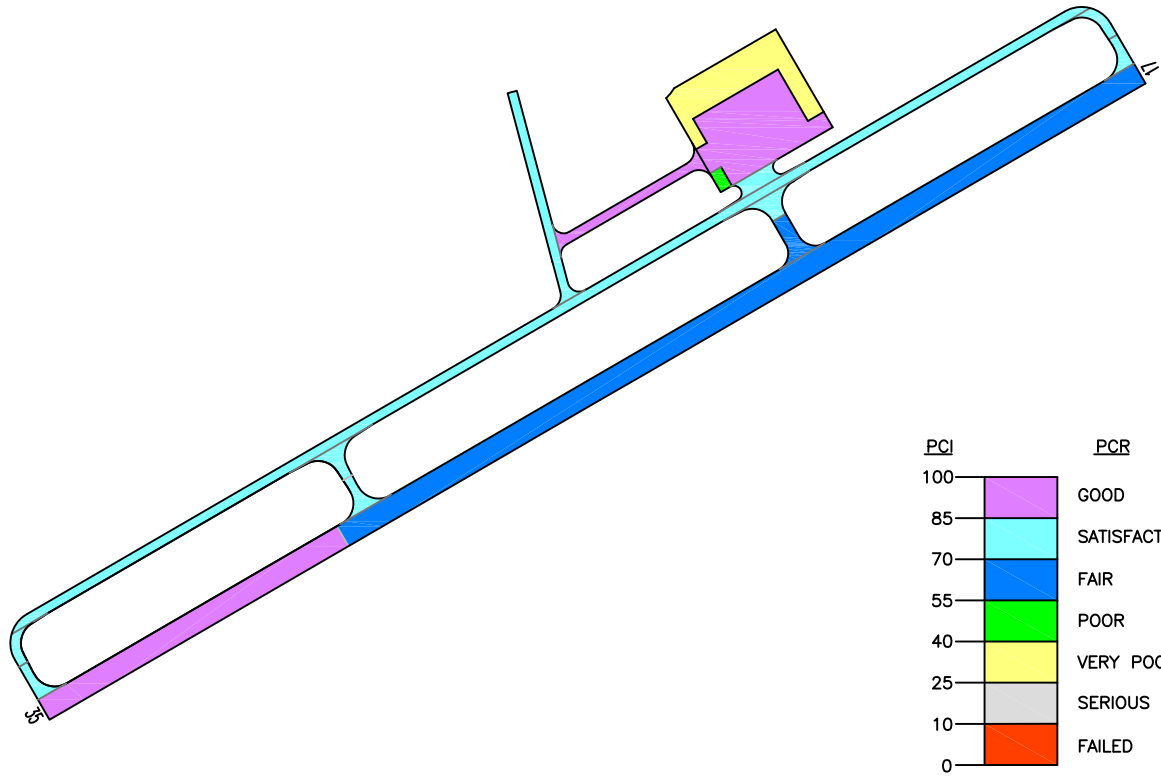
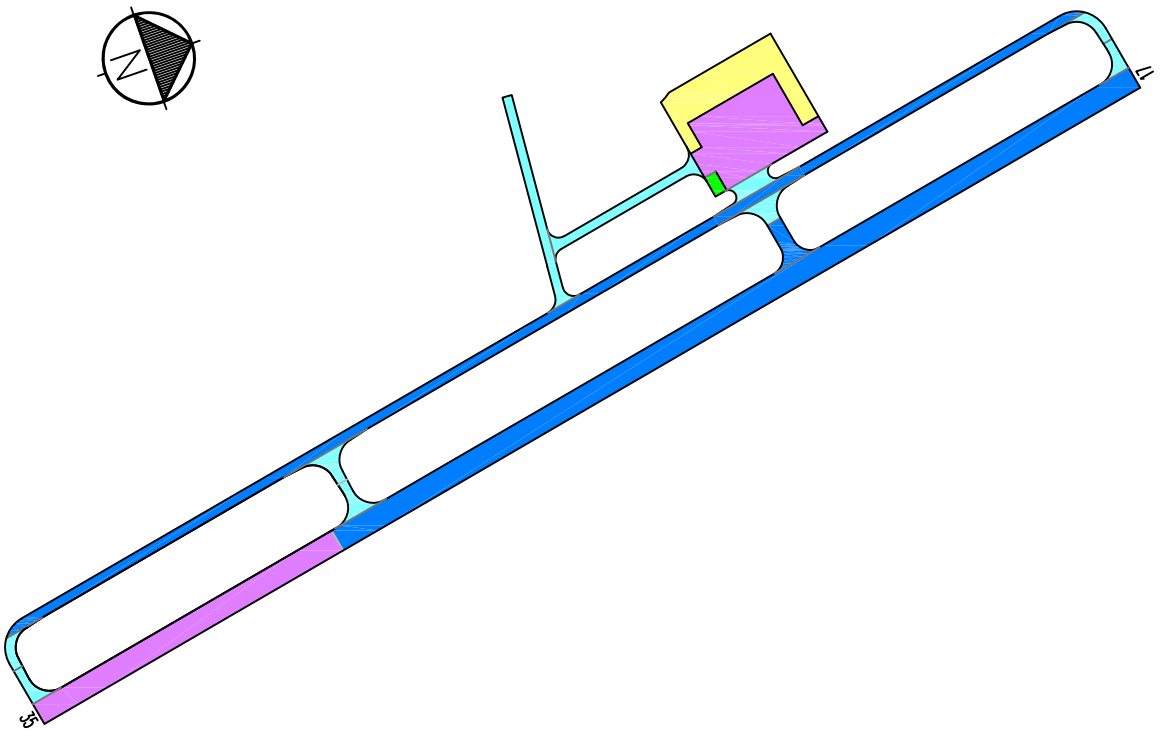
Figure SB-5. Future Pavement Condition.

A graphical representation of the projected PCIs listed in Table 1 is shown in Figure SB-5.
