SPORTSMAN AIRPARK

Figure SP-1. Airport Layout, Dimensions and Pavement Cross-Sections.
Sportsman Airpark

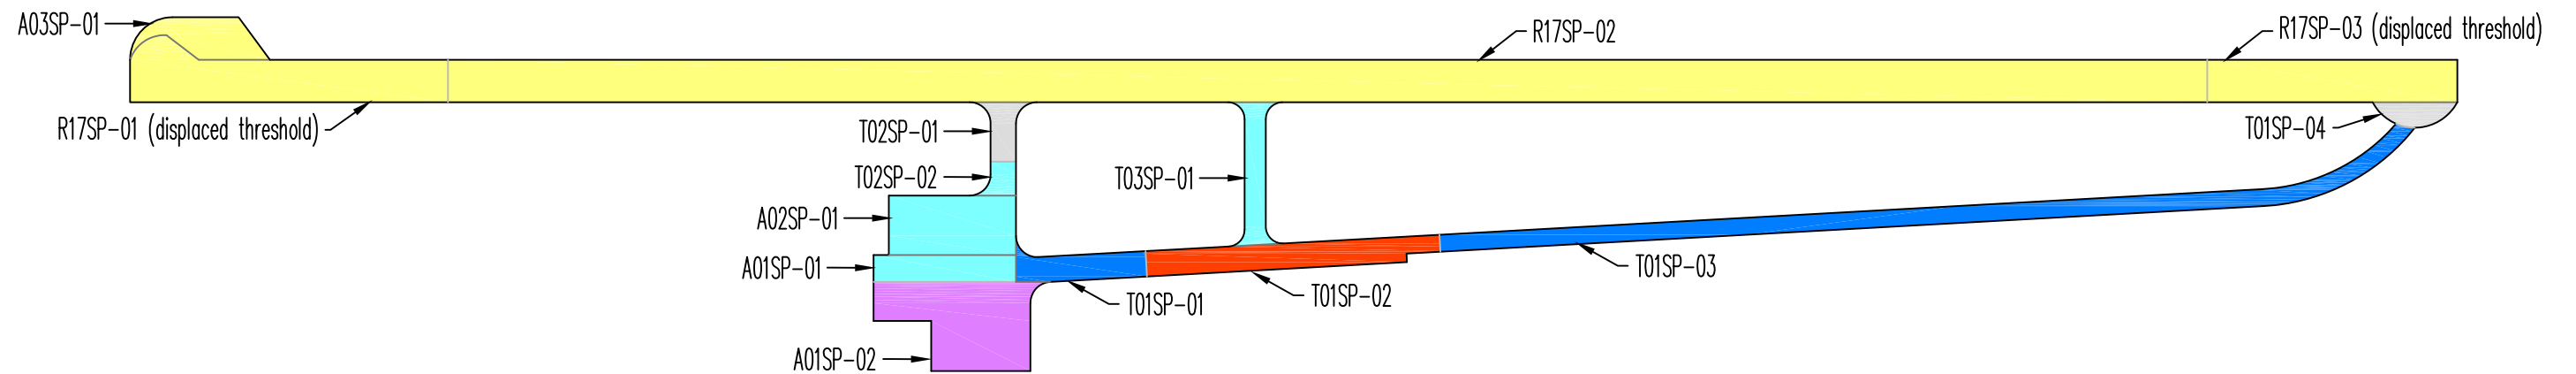
Figure SP-3. Pavement Condition in May 2018.
Sportsman Airpark

Section PCIs at Sportsman Airpark range from a low of 0 (a PCR of “Failed”) to a high of 92 (a PCR of “Good”). The area-weighted average PCI for all airport pavements is 44, corresponding to an overall PCR of “Poor”. Figure SP-4 shows how much pavement area is associated with each Pavement Condition Rating category and also shows pavement condition distribution from the inspections conducted in 2012 and 2015.

The primary distresses observed during the inspection were: weathering, longitudinal and transverse cracking, alligator cracking, block cracking, patching, raveling and depressions.
