STARK'S TWIN OAKS AIRPARK

This report describes how your Pavement Maintenance Management Program (PMMP) was developed. Your Program was developed as part of the Oregon Continuous Aviation System Plan sponsored in part by the Oregon Department of Aviation and the Federal Aviation Administration (FAA). The information and data contained in this report ensures you comply with the requirements of FAA Grant Assurance Number 11 which states that any airport requesting federal funds for pavement improvement projects must have implemented a pavement maintenance management program.

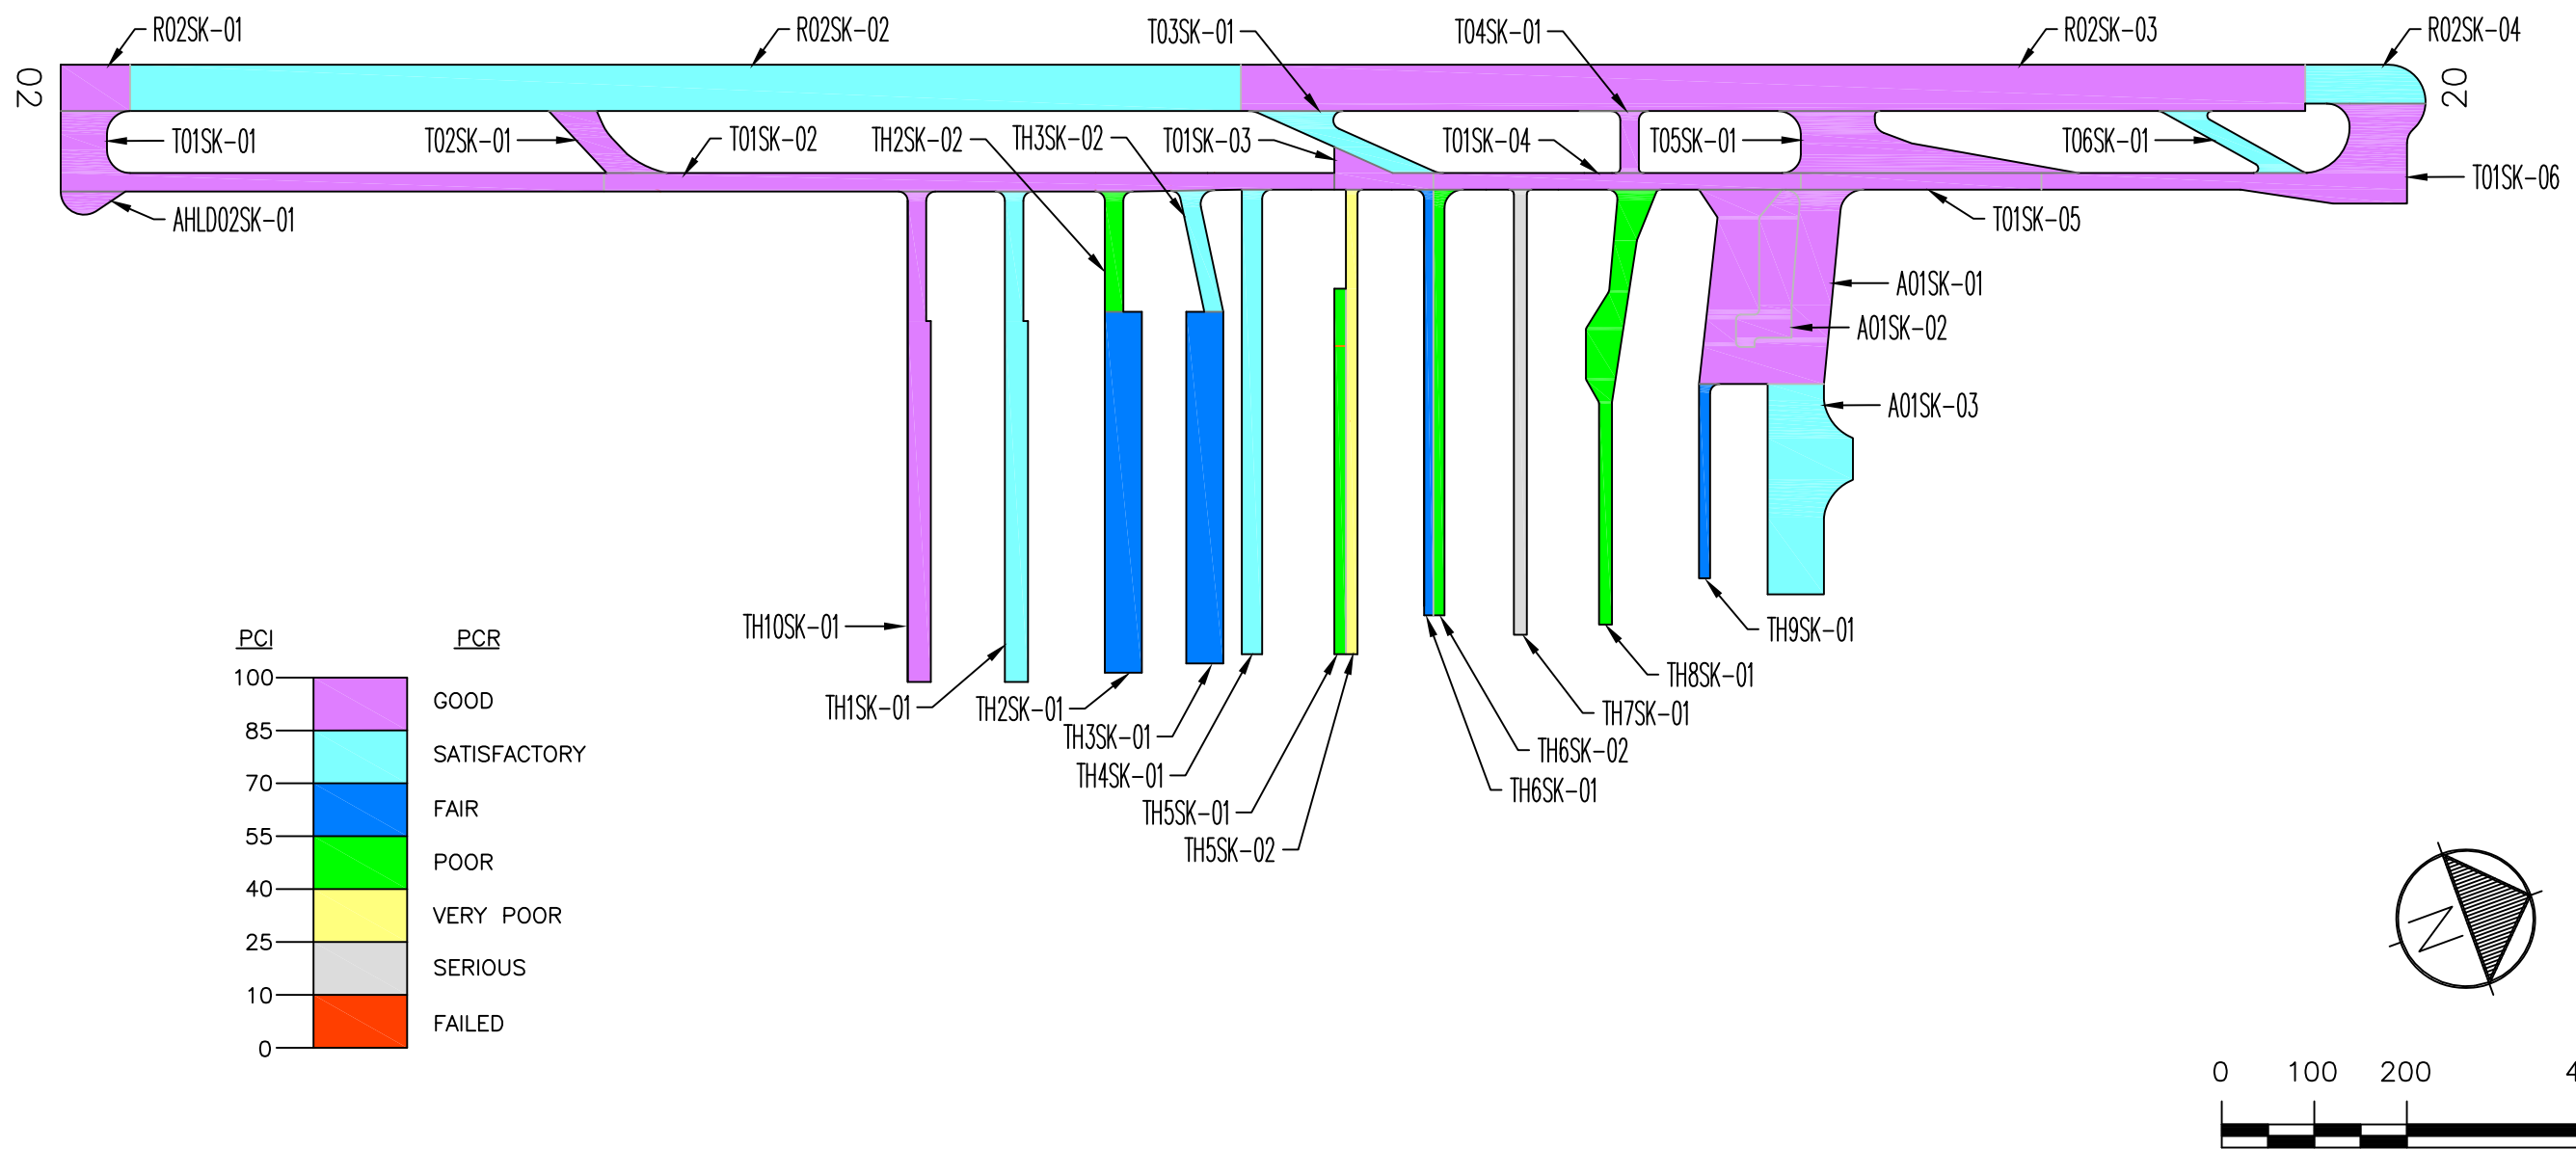
Figure SK-3. Pavement Condition in July 2018.
Stark's Twin Oaks Airpark

The Branch Condition Report in Appendix 1 summarizes current pavement condition by branch while the Section Condition Report in Appendix 2 lists pavement condition by section. The current Pavement Condition Rating (PCR) is shown graphically in Figure SK-3.

Section PCIs at Stark’s Twin Oaks Airpark range from a low of 17 (a PCR of “Serious”) to a high of 100 (a PCR of “Good”). The area-weighted average PCI for all airport pavements is 81, corresponding to an overall PCR of “Satisfactory”. Figure SK-4 shows how much pavement area is associated with each Pavement Condition Rating category and also shows pavement condition distribution from the inspections conducted in 2012 and 2015.

The primary distresses observed during the inspection were: longitudinal and transverse cracking, weathering, alligator cracking, depressions, patching and raveling.

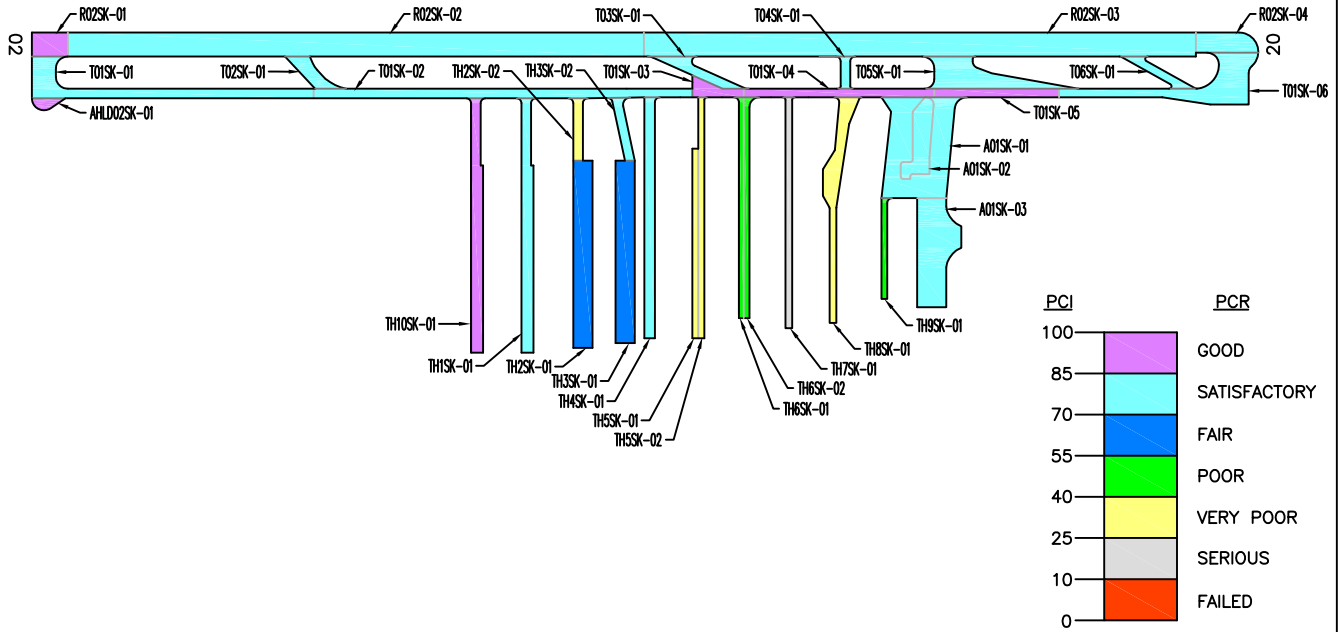
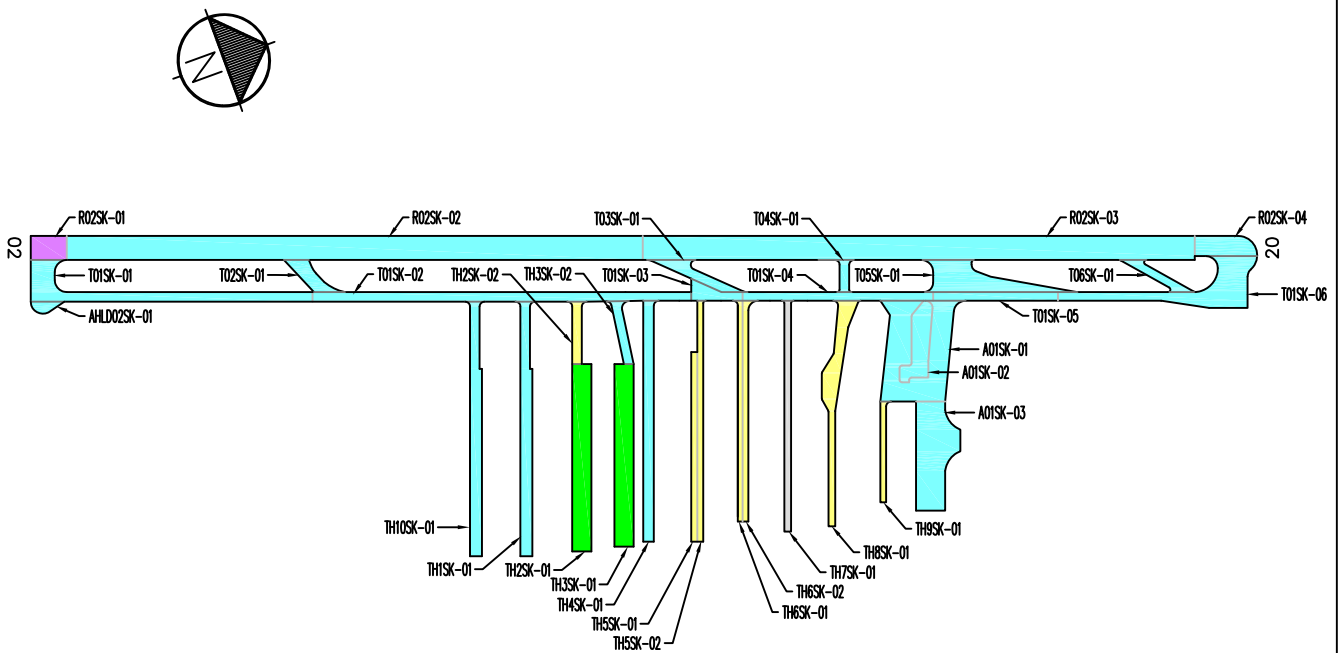
Figure SK-5. Future Pavement Condition.

A graphical representation of the projected PCIs listed in Table 1 is shown in Figure SK-5.
