# TILLAMOOK AIRPORT

This report describes how your Pavement Maintenance Management Program (PMMP) was developed. Your Program was developed as part of the Oregon Continuous Aviation System Plan sponsored in part by the Oregon Department of Aviation and the Federal Aviation Administration (FAA). The information and data contained in this report ensures you comply with the requirements of FAA Grant Assurance Number 11 which states that any airport requesting federal funds for pavement improvement projects must have implemented a pavement maintenance management program.

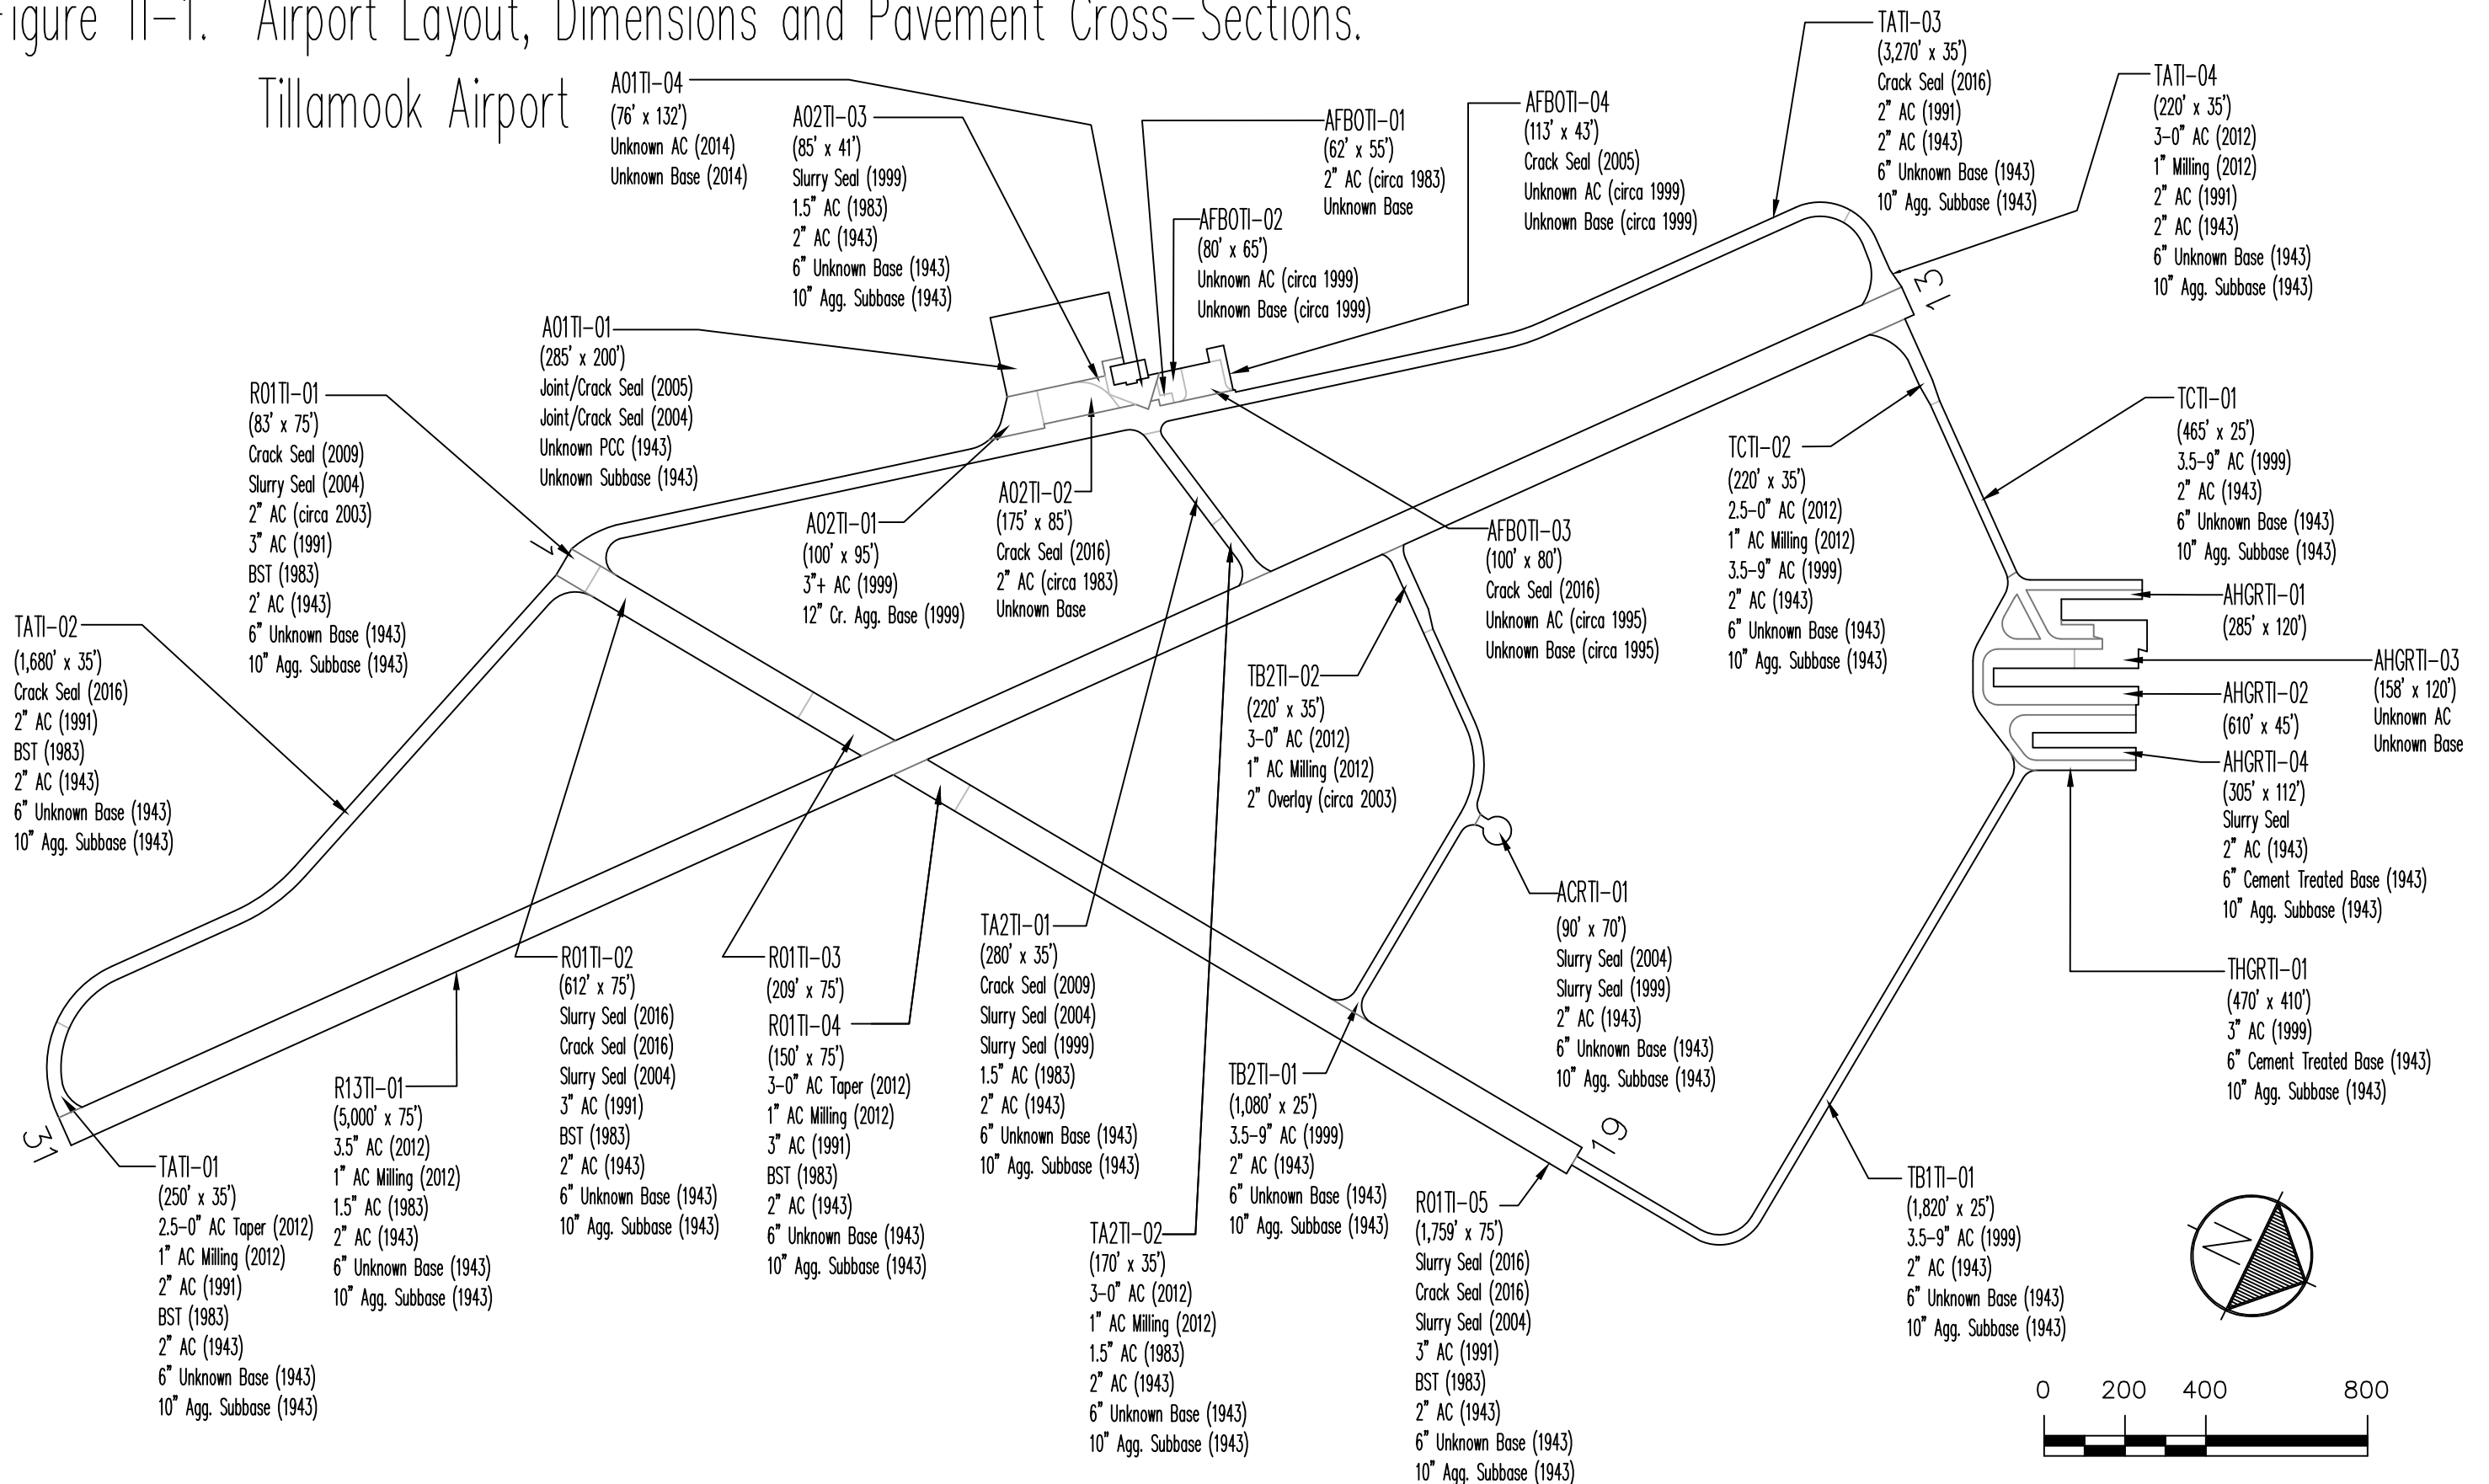
Figure TI-1. Airport Layout, Dimensions and Pavement Cross-Sections.  
Tillamook Airport

To determine how your pavements were constructed and their age, a records review was conducted. Figure TI-1 shows the records review results. This figure identifies pavement boundaries, dimensions, pavement layer types, thicknesses and dates of construction. The most recent construction date for each pavement can also be found in the Section Condition Report in Appendix 2. Figure TI-1 and the information contained in Appendices 1, 2 and 4 ensure that your airport complies with the “pavement inventory” requirement of FAA’s PMMP guidelines.

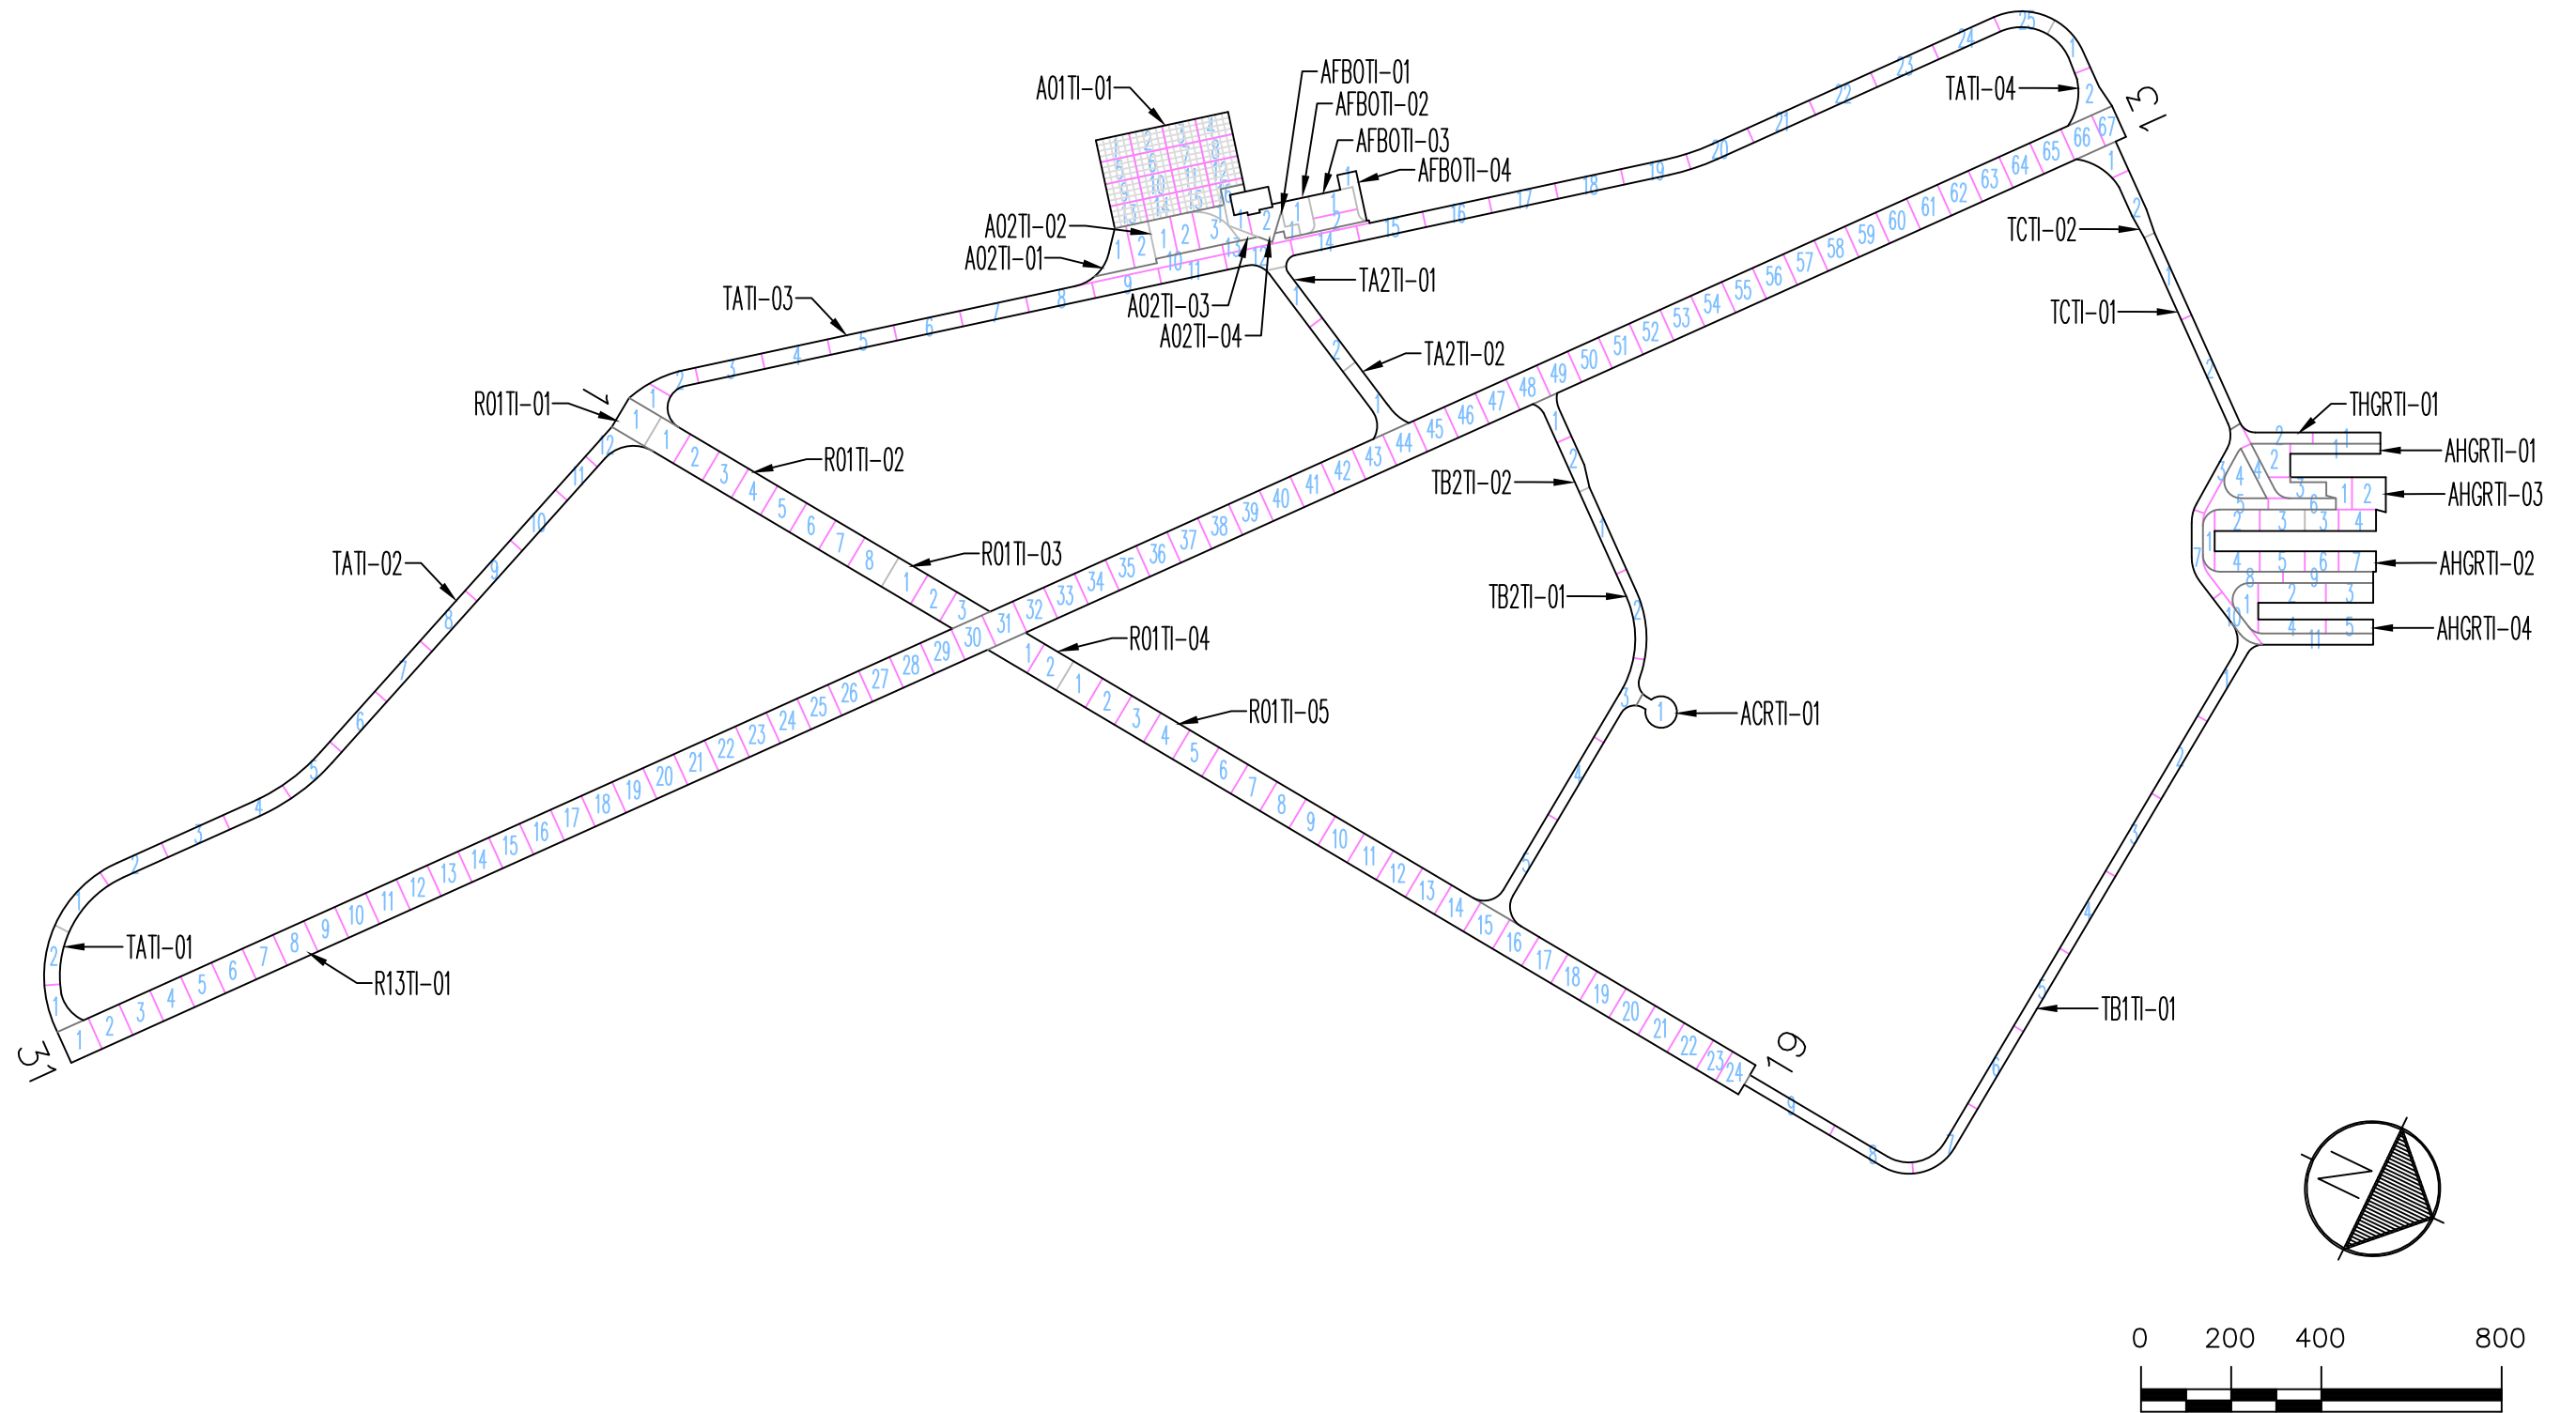
Figure TI-2. Pavement Branch, Section and Sample Unit Layout.  
Tillamook Airport

The pavements at your airport were divided into branches, sections and sample units in accordance with the methodology outlined in the current edition of ASTM D5430, *Standard Test Method for Airport Condition Index Surveys*. The branches, sections and sample units established at your airport are shown in Figure TI-2. A Branch Condition Report showing all branches, their associated areas, and their area-weighted average condition is provided in Appendix 1. Additionally, the Appendix 2 Section Condition Report provides information used to define each branch and section in the PAVER database.

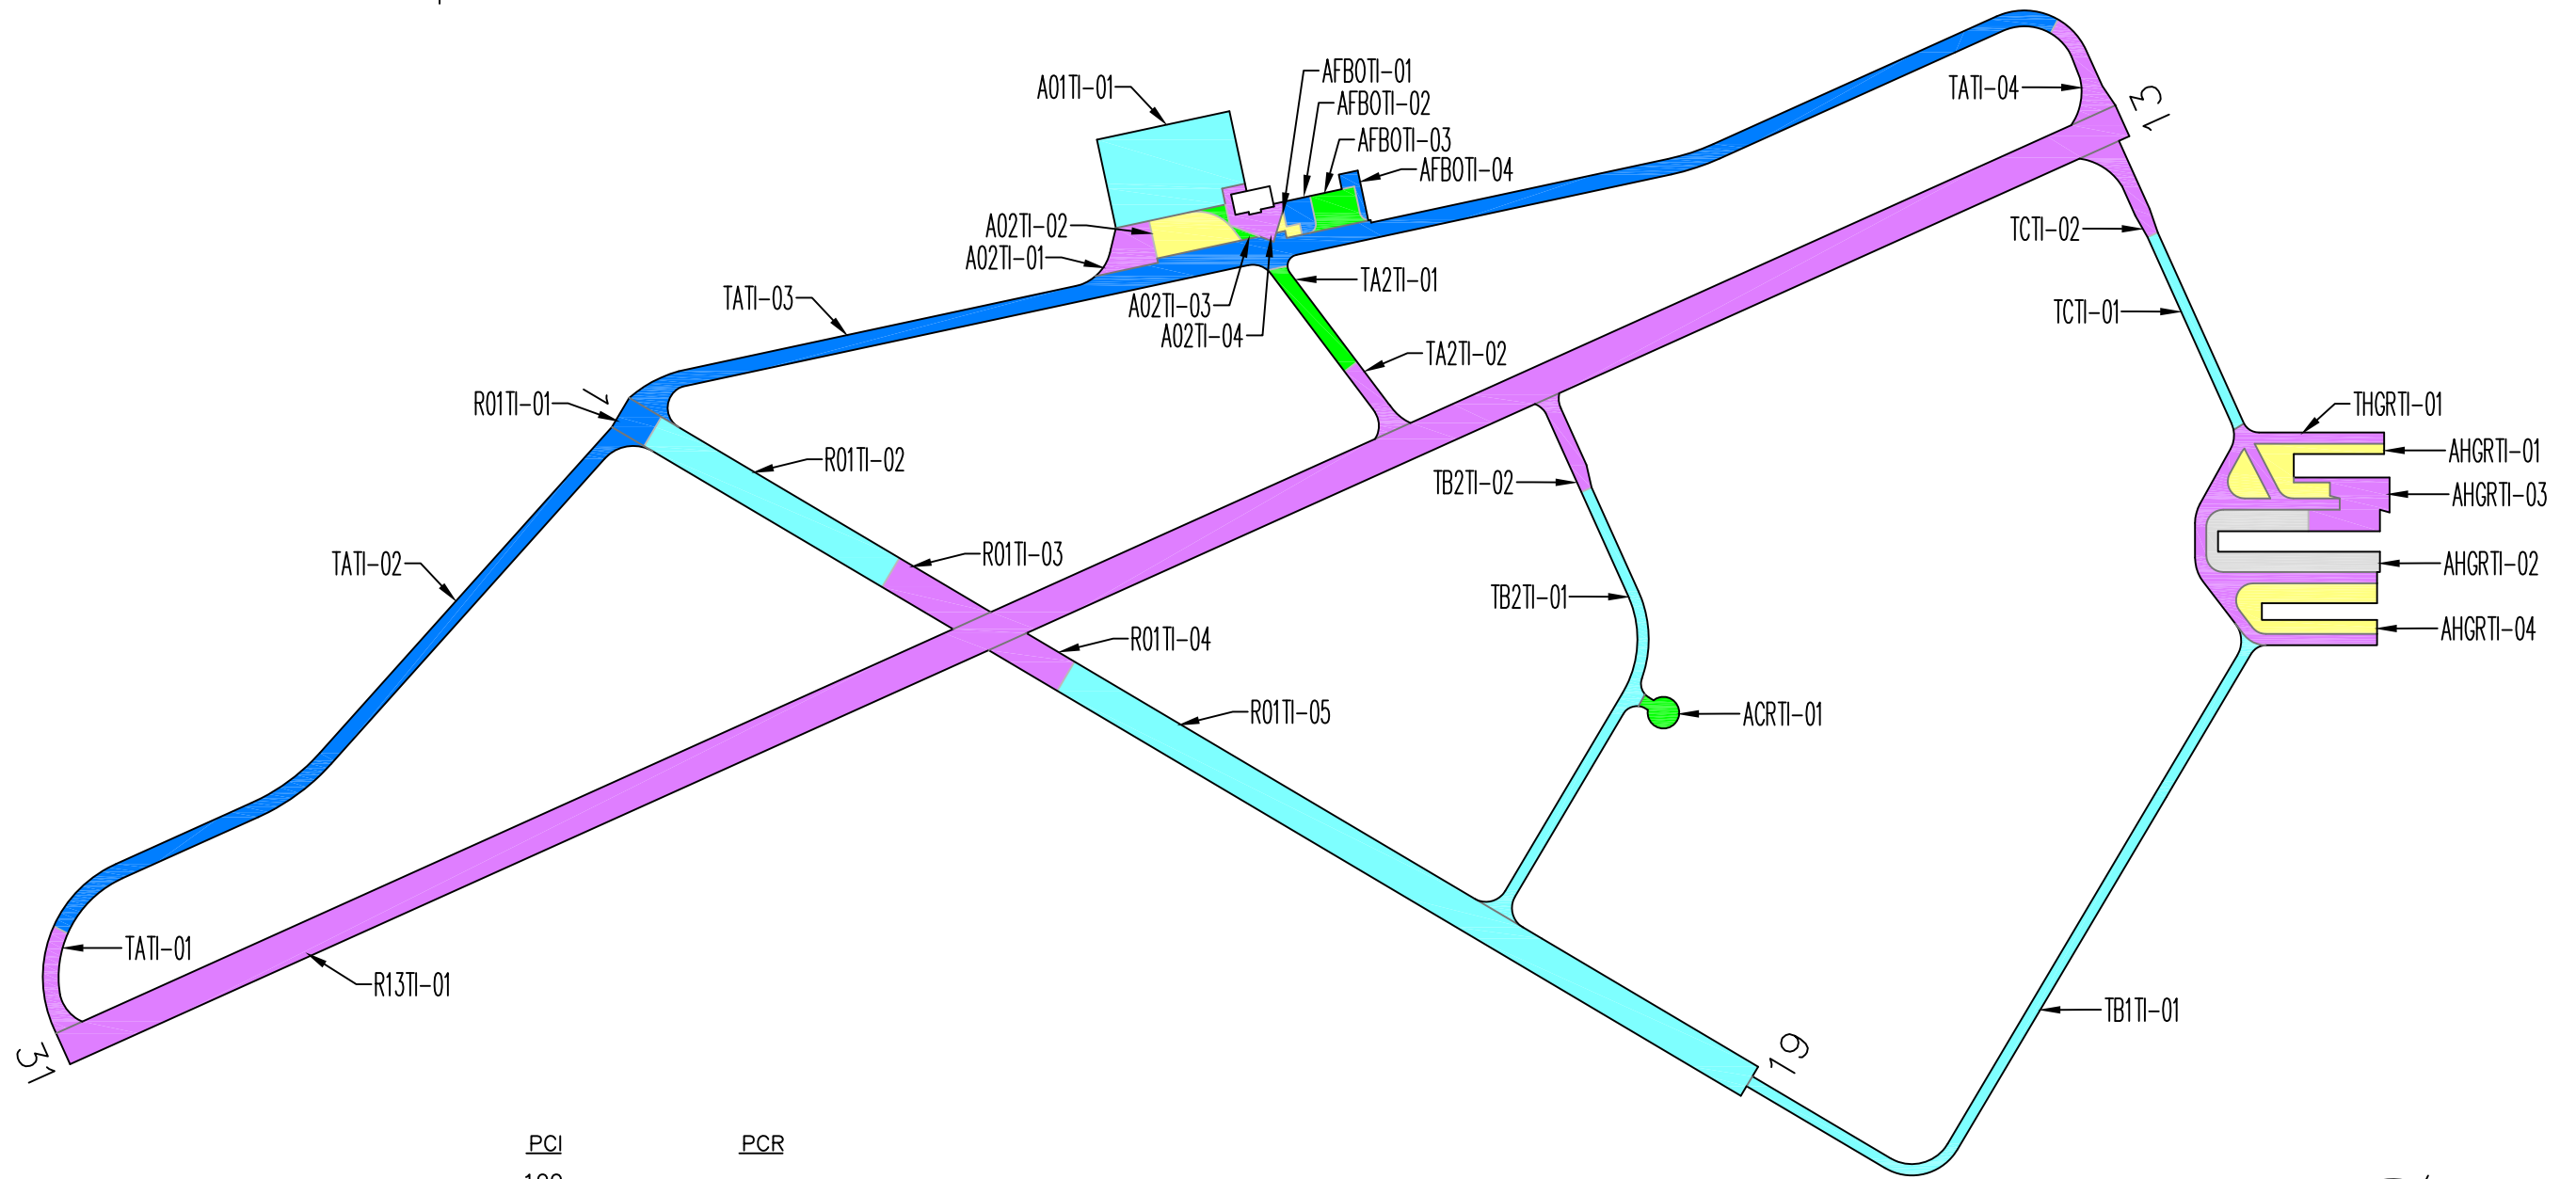
Figure TI-3. Pavement Condition in May 2018.  
Tillamook Airport

The Branch Condition Report in Appendix 1 summarizes current pavement condition by branch while the Section Condition Report in Appendix 2 lists pavement condition by section. The current Pavement Condition Rating (PCR) is shown graphically in Figure TI-3.

Section PCIs at Tillamook Airport range from a low of 18 (a PCR of “Serious”) to a high of 100 (a PCR of “Good”). The area-weighted average PCI for all airport pavements is 81, corresponding to an overall PCR of “Satisfactory”. Figure TI-4 shows how much pavement area is associated with each Pavement Condition Rating category and also shows pavement condition distribution from the inspections conducted in 2012 and 2015.

The primary distresses observed in the asphalt pavements during the inspection were: longitudinal and transverse cracking, block cracking, raveling, weathering, and depressions. Joint seal damage, small patches, shattered slabs, shrinkage cracks and linear cracking were observed in the concrete pavement.

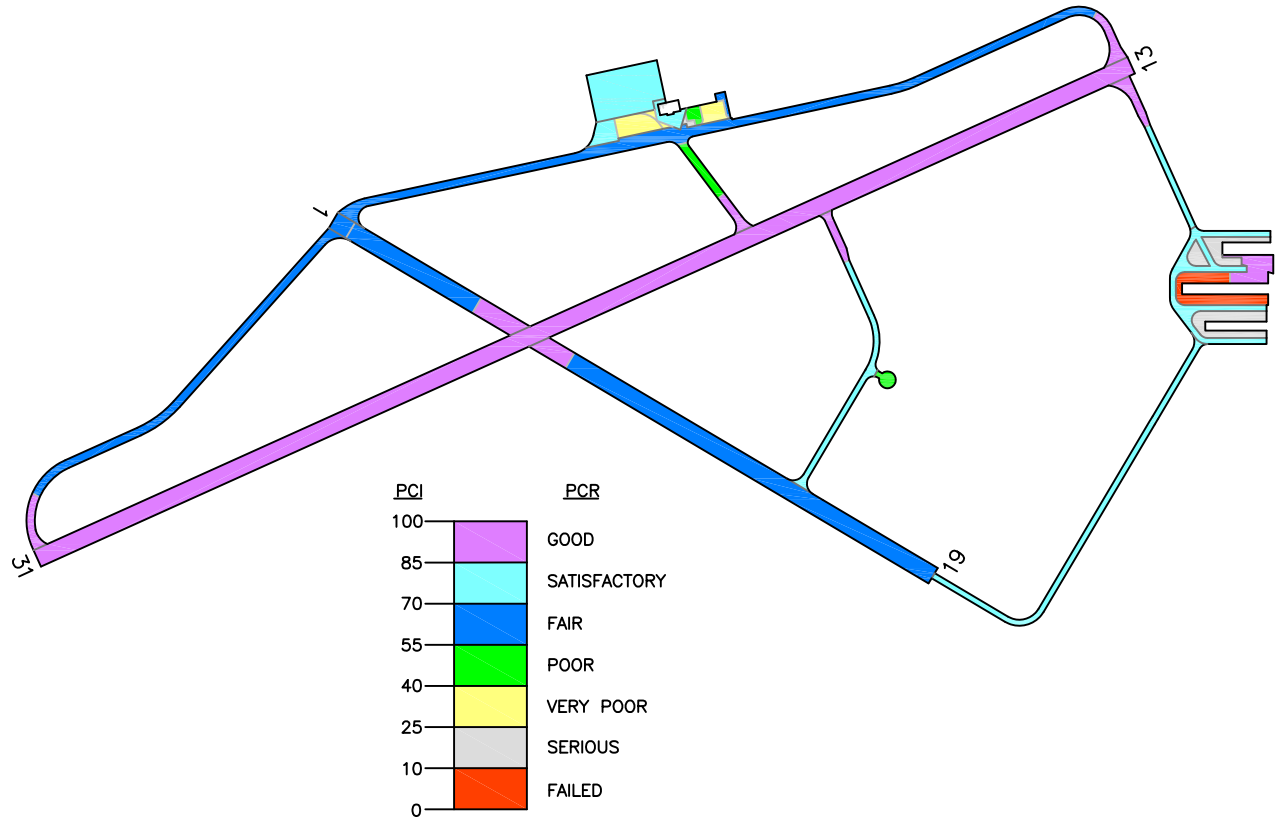
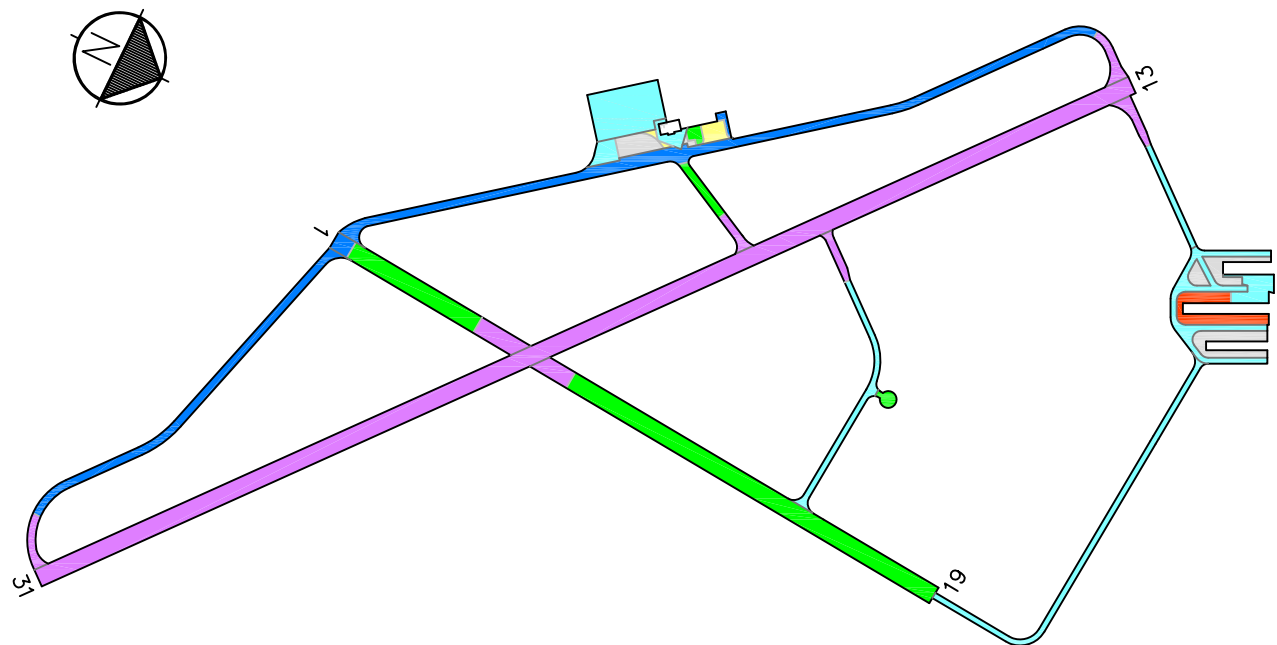
**Figure TI-5. Future Pavement Condition.**

A graphical representation of the projected PCIs listed in Table 1 is shown in Figure TI-5.
