# TOLEDO STATE AIRPORT

Figure T0-1. Airport Layout, Dimensions and Pavement Cross-Sections.  
Toledo State Airport

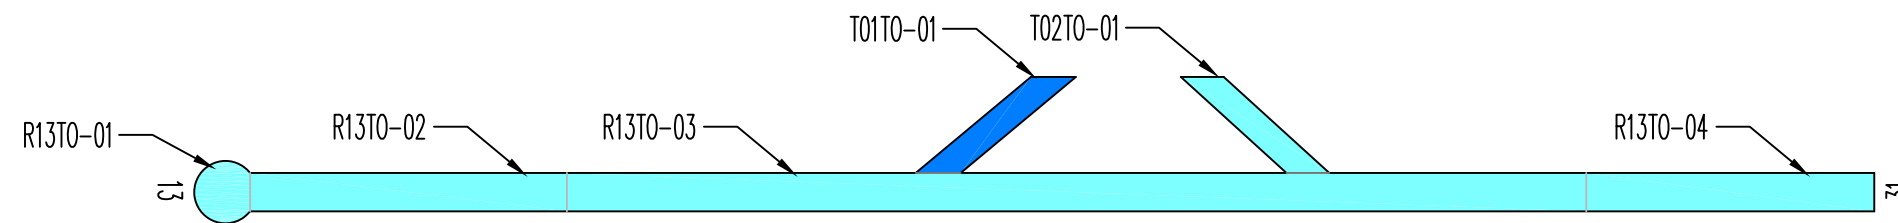
Figure T0-3. Pavement Condition in May 2018.  
Toledo State Airport

Section PCIs at Toledo State Airport range from a low of 66 (a PCR of “Fair”) to a high of 82 (a PCR of “Satisfactory”). The area-weighted average PCI for all airport pavements is 76, corresponding to an overall PCR of “Satisfactory”. Figure TO-4 shows how much pavement area is associated with each Pavement Condition Rating category and also shows pavement condition distribution from the inspections conducted in 2012 and 2018.

The primary distresses observed during the inspection were: longitudinal and transverse cracking and depressions.
