# PORTLAND TROUTDALE AIRPORT

This report describes how your Pavement Maintenance Management Program (PMMP) was developed. Your Program was developed as part of the Oregon Continuous Aviation System Plan sponsored in part by the Oregon Department of Aviation and the Federal Aviation Administration (FAA). The information and data contained in this report ensures you comply with the requirements of FAA Grant Assurance Number 11 which states that any airport requesting federal funds for pavement improvement projects must have implemented a pavement maintenance management program.

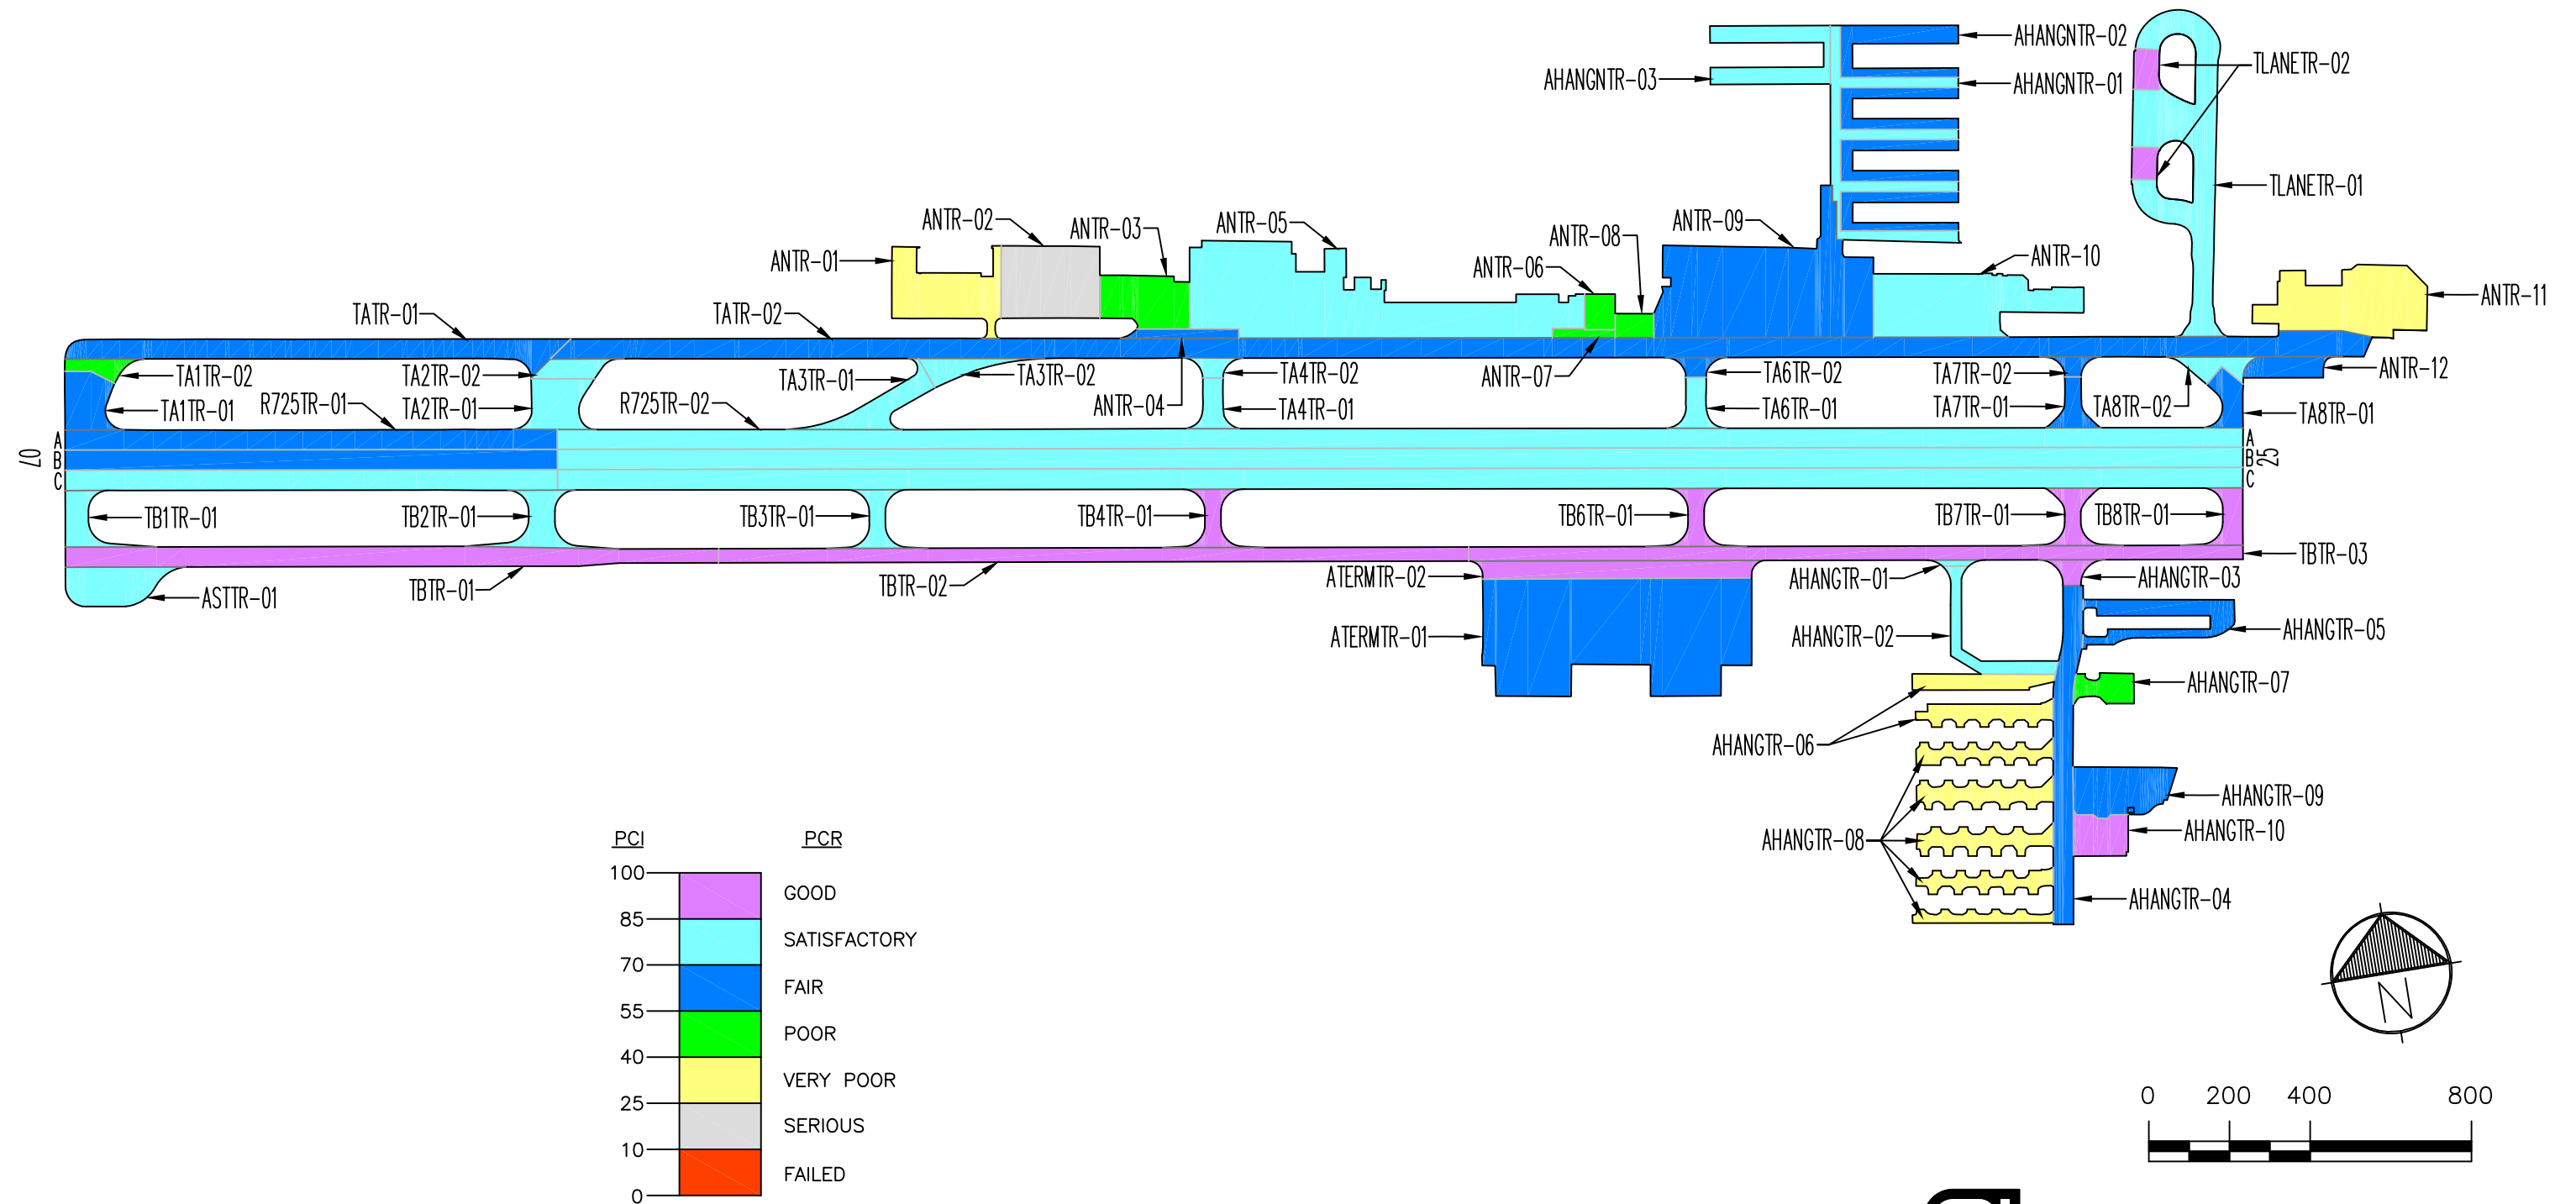
Figure TR-3. Pavement Condition in July 2018.  
Portland Troutdale Airport

Section PCIs at Portland Troutdale Airport range from a low of 25 (a PCR of “Serious”) to a high of 100 (a PCR of “Good”). The area-weighted average PCI for all airport pavements is 69, corresponding to an overall PCR of “Fair”. Figure TR-4 shows how much pavement area is associated with each Pavement Condition Rating category and also shows pavement condition distribution from the inspections conducted in 2012 and 2015.

The primary distresses observed in the asphalt concrete sections during the inspection were: longitudinal and transverse cracking, weathering, block cracking, alligator cracking, patching, raveling and depressions. Joint seal damage was observed in the concrete section.

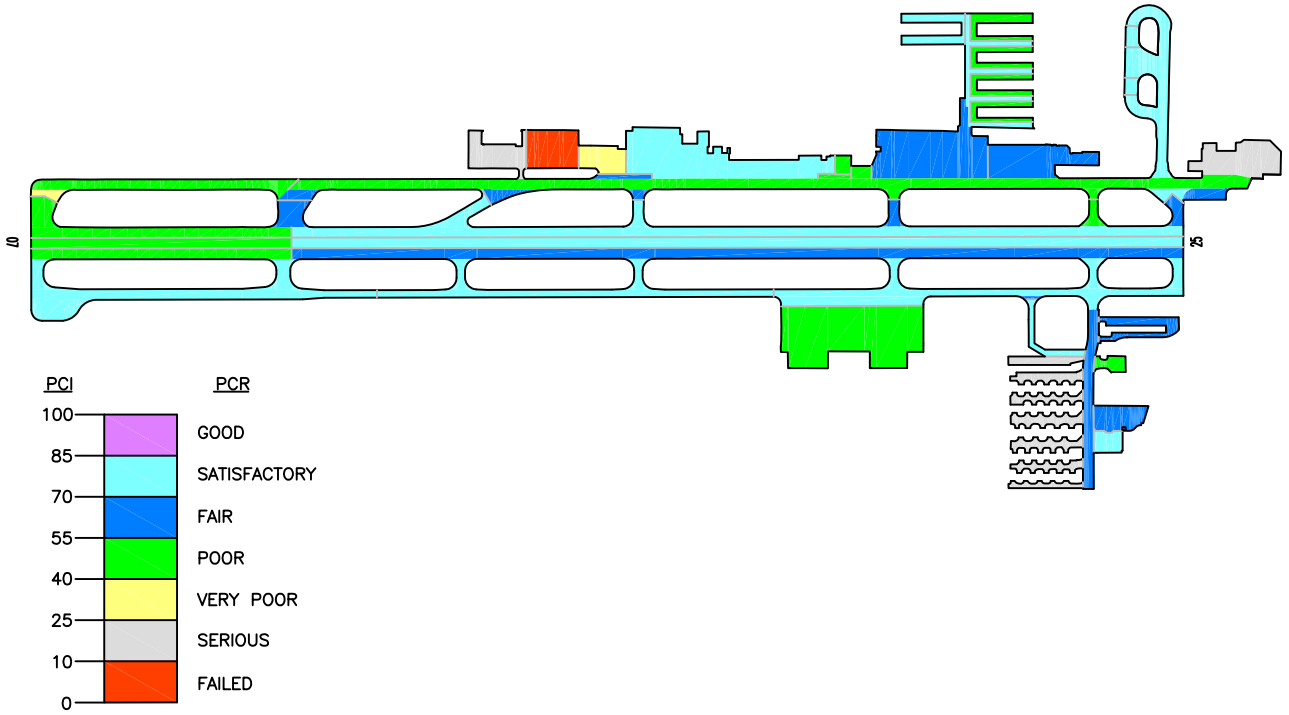
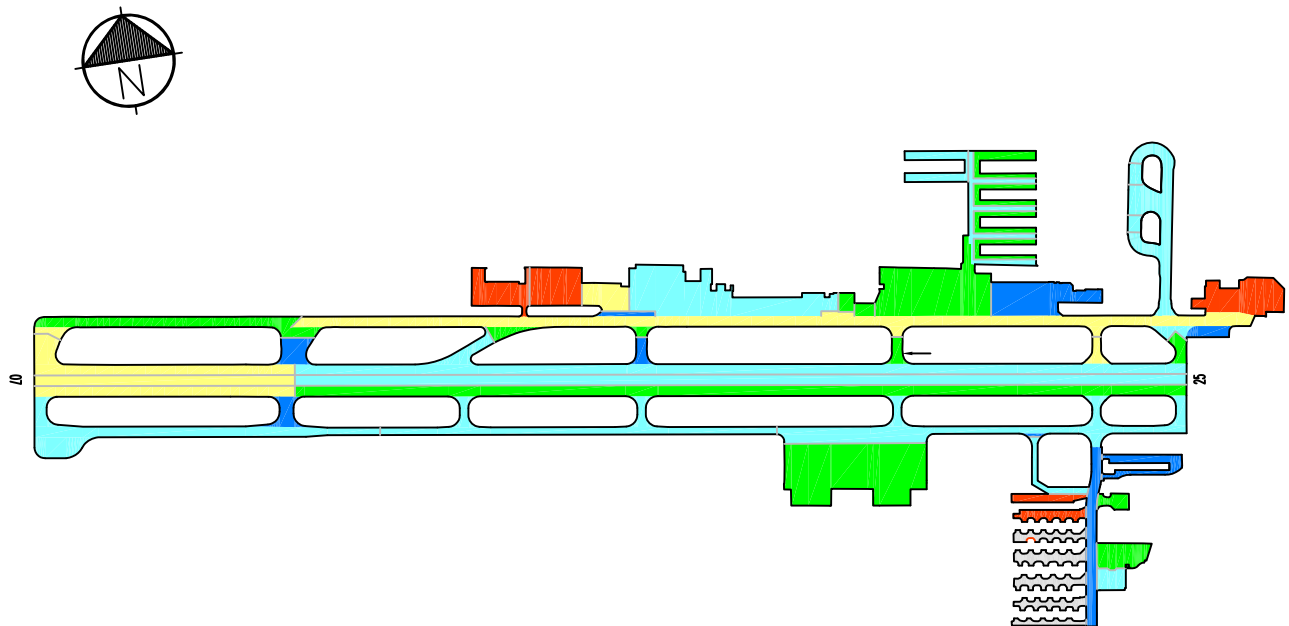
**Figure TR-5. Future Pavement Condition.**

A graphical representation of the projected PCIs listed in Table 1 is shown in Figure TR-5.
