VALLEY VIEW AIRPORT

Using the branch, section and sample unit divisions established, a visual condition survey was conducted at Valley View Airport in May 2018. During the inspection, pavement defects were identified and measured in accordance with the methodology outlined in ASTM D5430. This inspection ensures your airport complies with the “detailed inspection” requirement of FAA’s PMMP guidelines. After collection, the data were entered into the PAVER software for analysis. These data are reproduced in the Re-Inspection Report attached as Appendix 4.

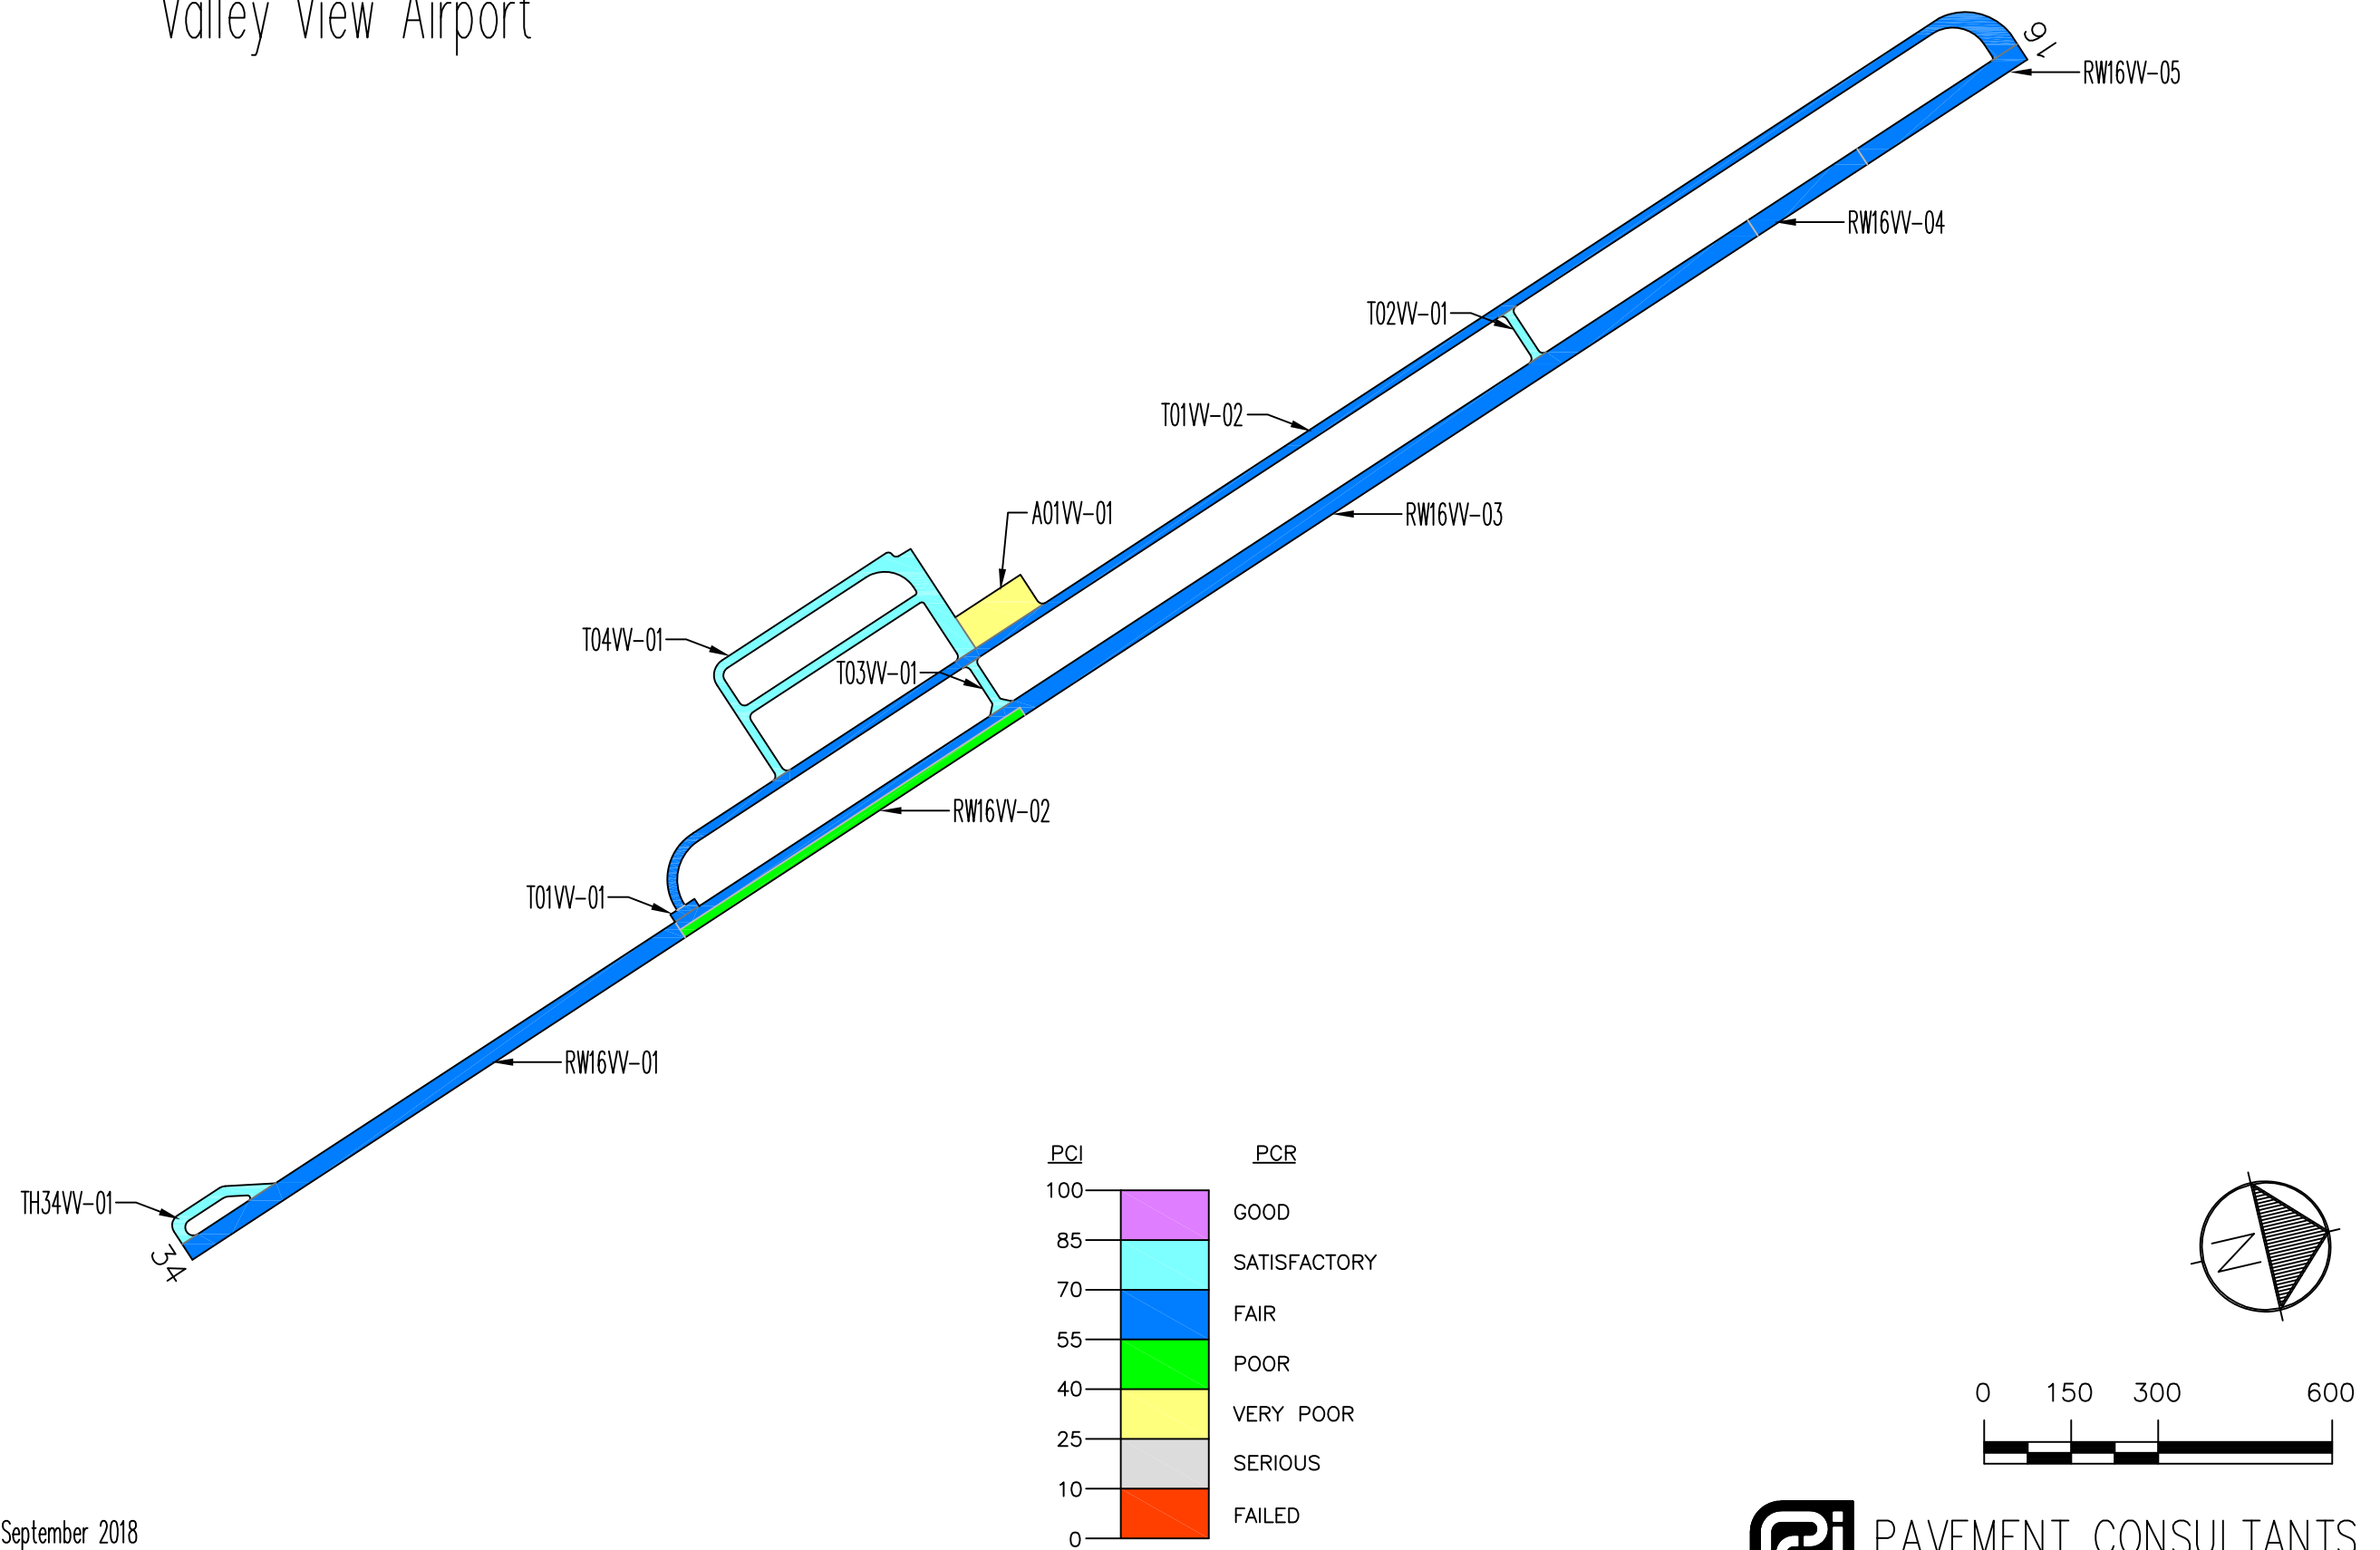
Figure VV-3. Pavement Condition in May 2018.
Valley View Airport

Section PCIs at Valley View Airport range from a low of 32 (a PCR of “Very Poor”) to a high of 79 (a PCR of “Satisfactory”). The area-weighted average PCI for all airport pavements is 66, corresponding to an overall PCR of “Fair”. Figure VV-4 shows how much pavement area is associated with each Pavement Condition Rating category and also shows pavement condition distribution from the inspections conducted in 2012 and 2015.

The primary distresses observed during the inspection were: weathering, longitudinal and transverse cracking, block cracking, and patching, with an isolated occurrence of alligator cracking.

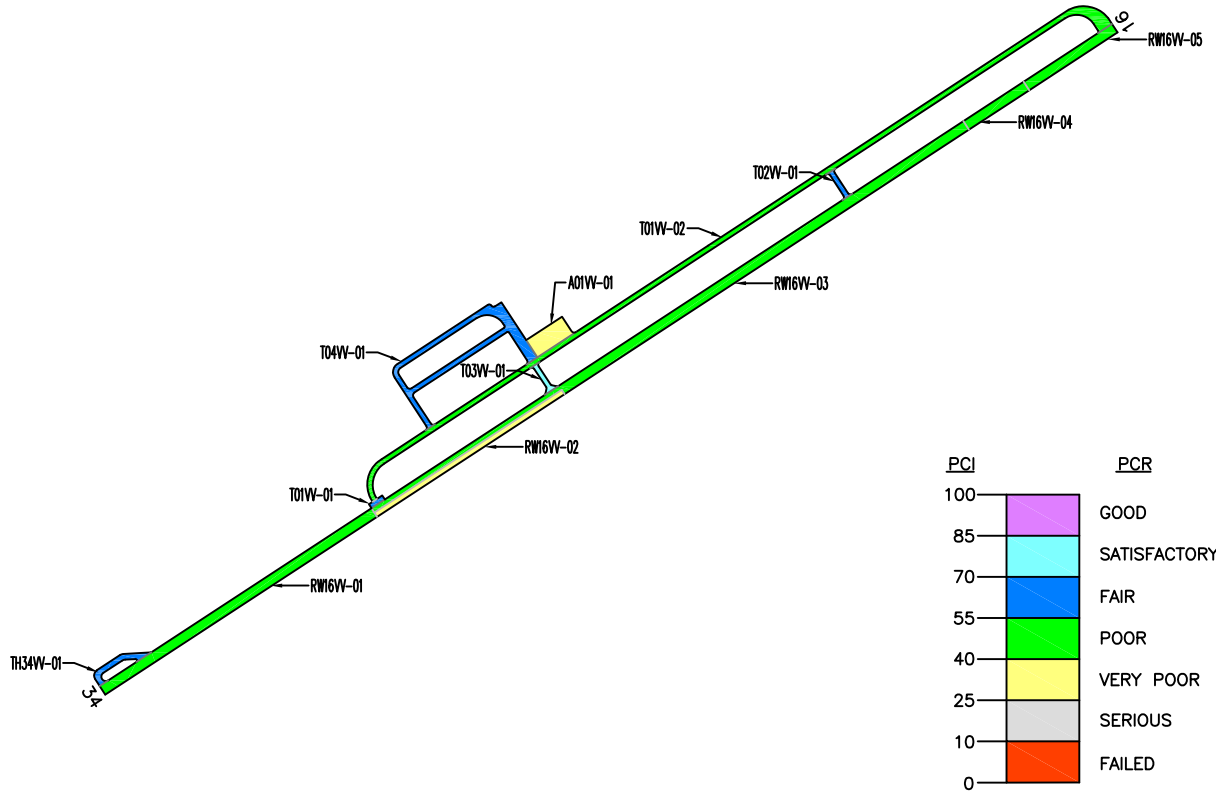
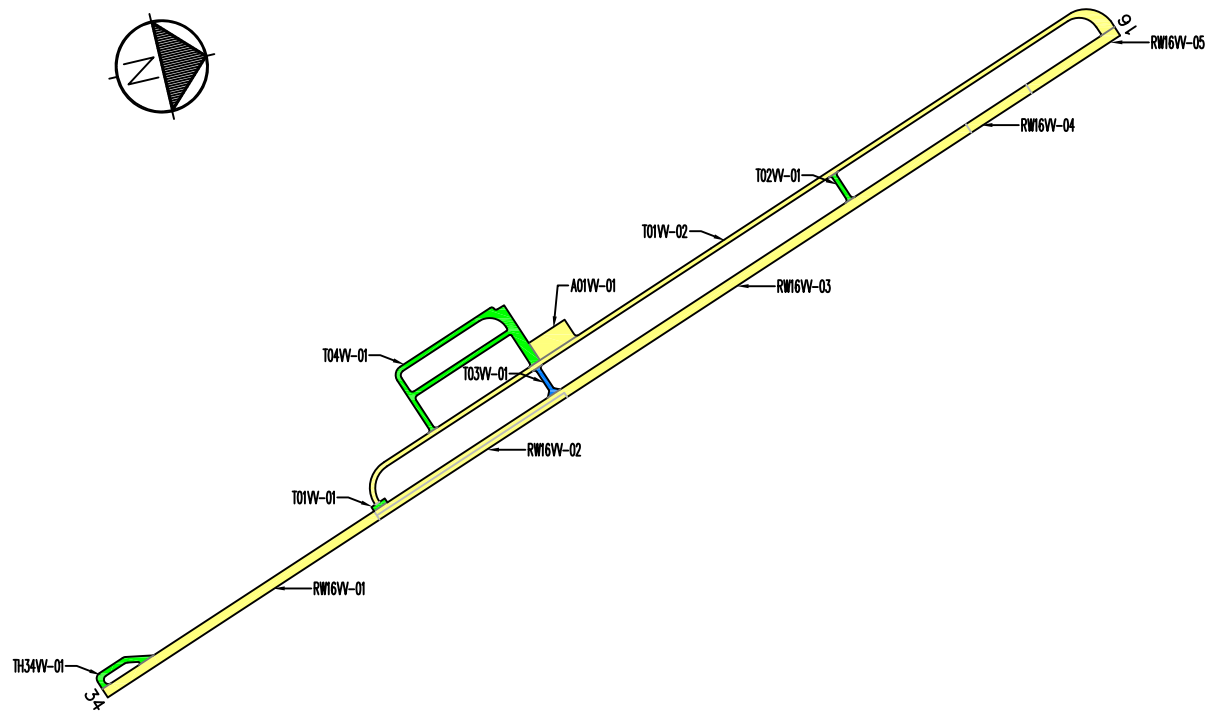
Figure VV-5. Future Pavement Condition.

A graphical representation of the projected PCIs listed in Table 1 is shown in Figure VV-5.
