ASHLAND MUNICIPAL AIRPORT – SUMNER PARKER FIELD

This report describes how your Pavement Maintenance Management Program (PMMP) was developed. Your Program was developed as part of the Oregon Continuous Aviation System Plan sponsored in part by the Oregon Department of Aviation and the Federal Aviation Administration (FAA). The information and data contained in this report ensures you comply with the requirements of FAA Grant Assurance Number 11 which states that any airport requesting federal funds for pavement improvement projects must have implemented a pavement maintenance management program.

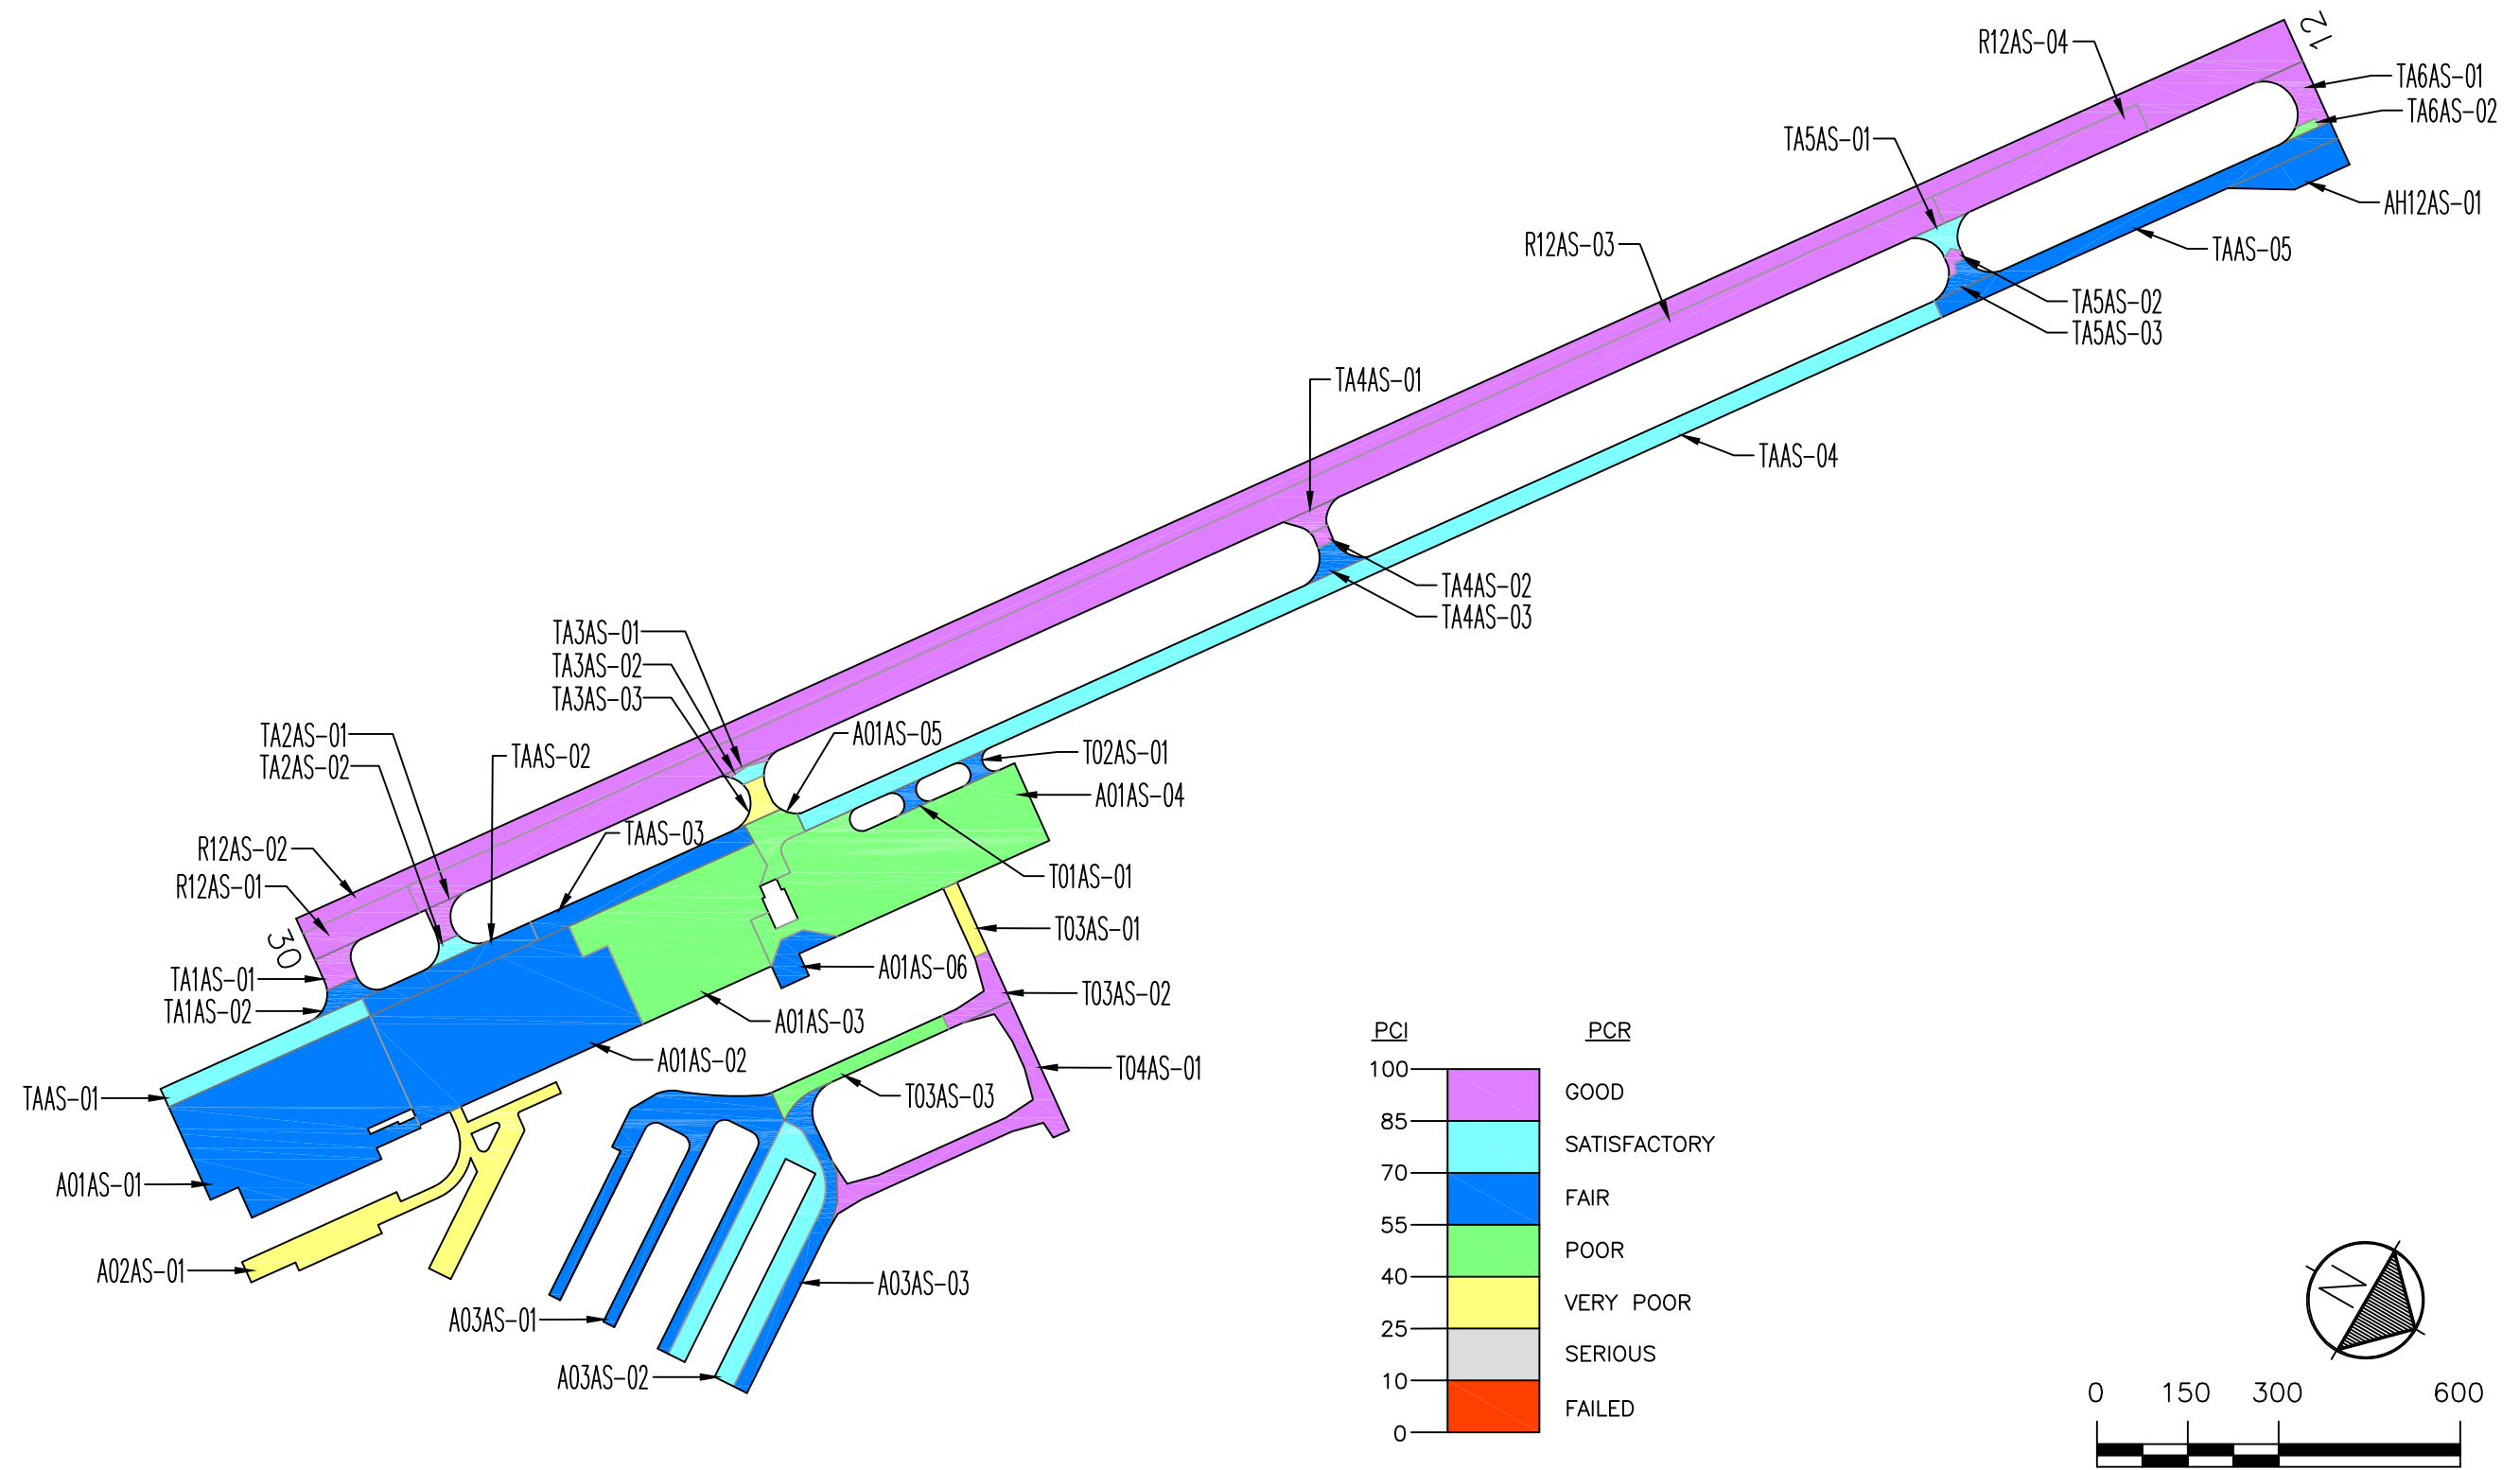
Figure AS-3. Pavement Condition in May 2019.
Ashland Municipal Airport (Sumner Parker Field)

Section PCIs at Ashland Municipal Airport range from a low of 33 (a PCR of “Very Poor”) to a high of 100 (a PCR of “Good”). The area-weighted average PCI for all airport pavements is 74, corresponding to an overall PCR of “Satisfactory”. Figure AS-4 shows how much pavement area is associated with each Pavement Condition Rating category and also shows pavement condition distribution from the inspections conducted in 2013 and 2016.

The primary distresses observed during the inspection were: longitudinal and transverse cracking, weathering, patching, alligator cracking, block cracking, depressions and an isolated occurrence of raveling.

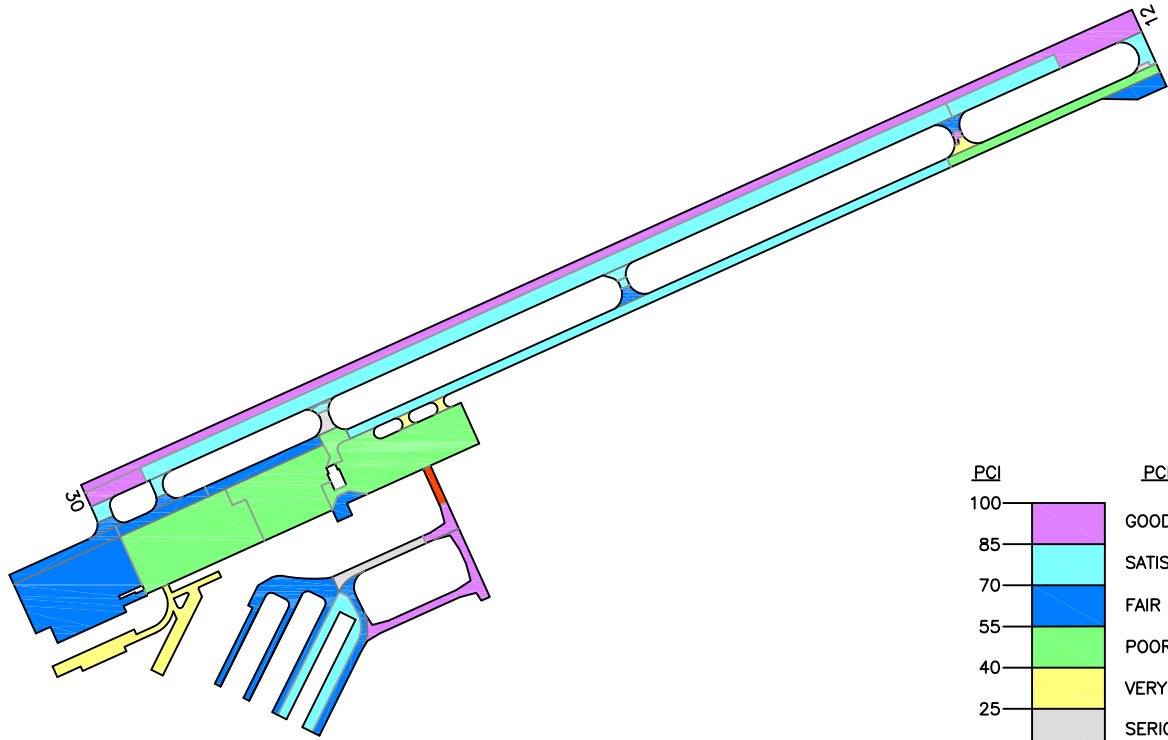
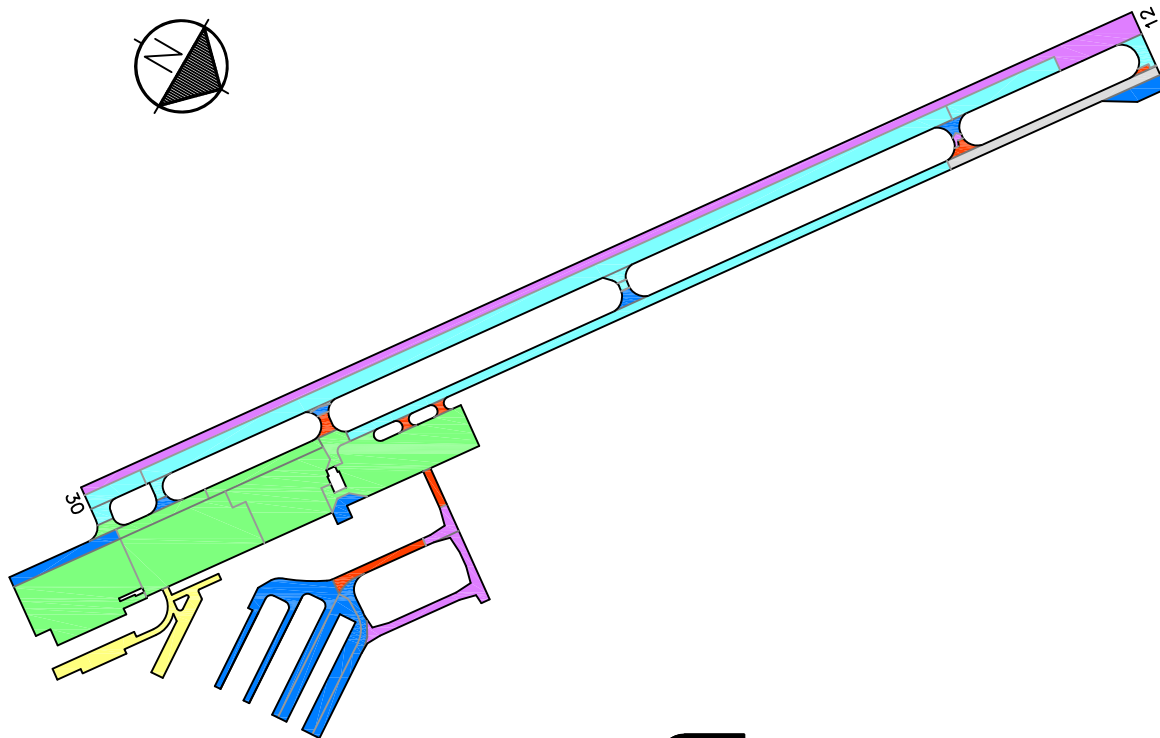
Figure AS-5. Future Pavement Condition.

A graphical representation of the projected PCIs listed in Table 1 is shown in Figure AS-5.
