BANDON STATE AIRPORT

Figure BN-1. Airport Layout, Dimensions and Pavement Cross-Sections.
Bandon State Airport

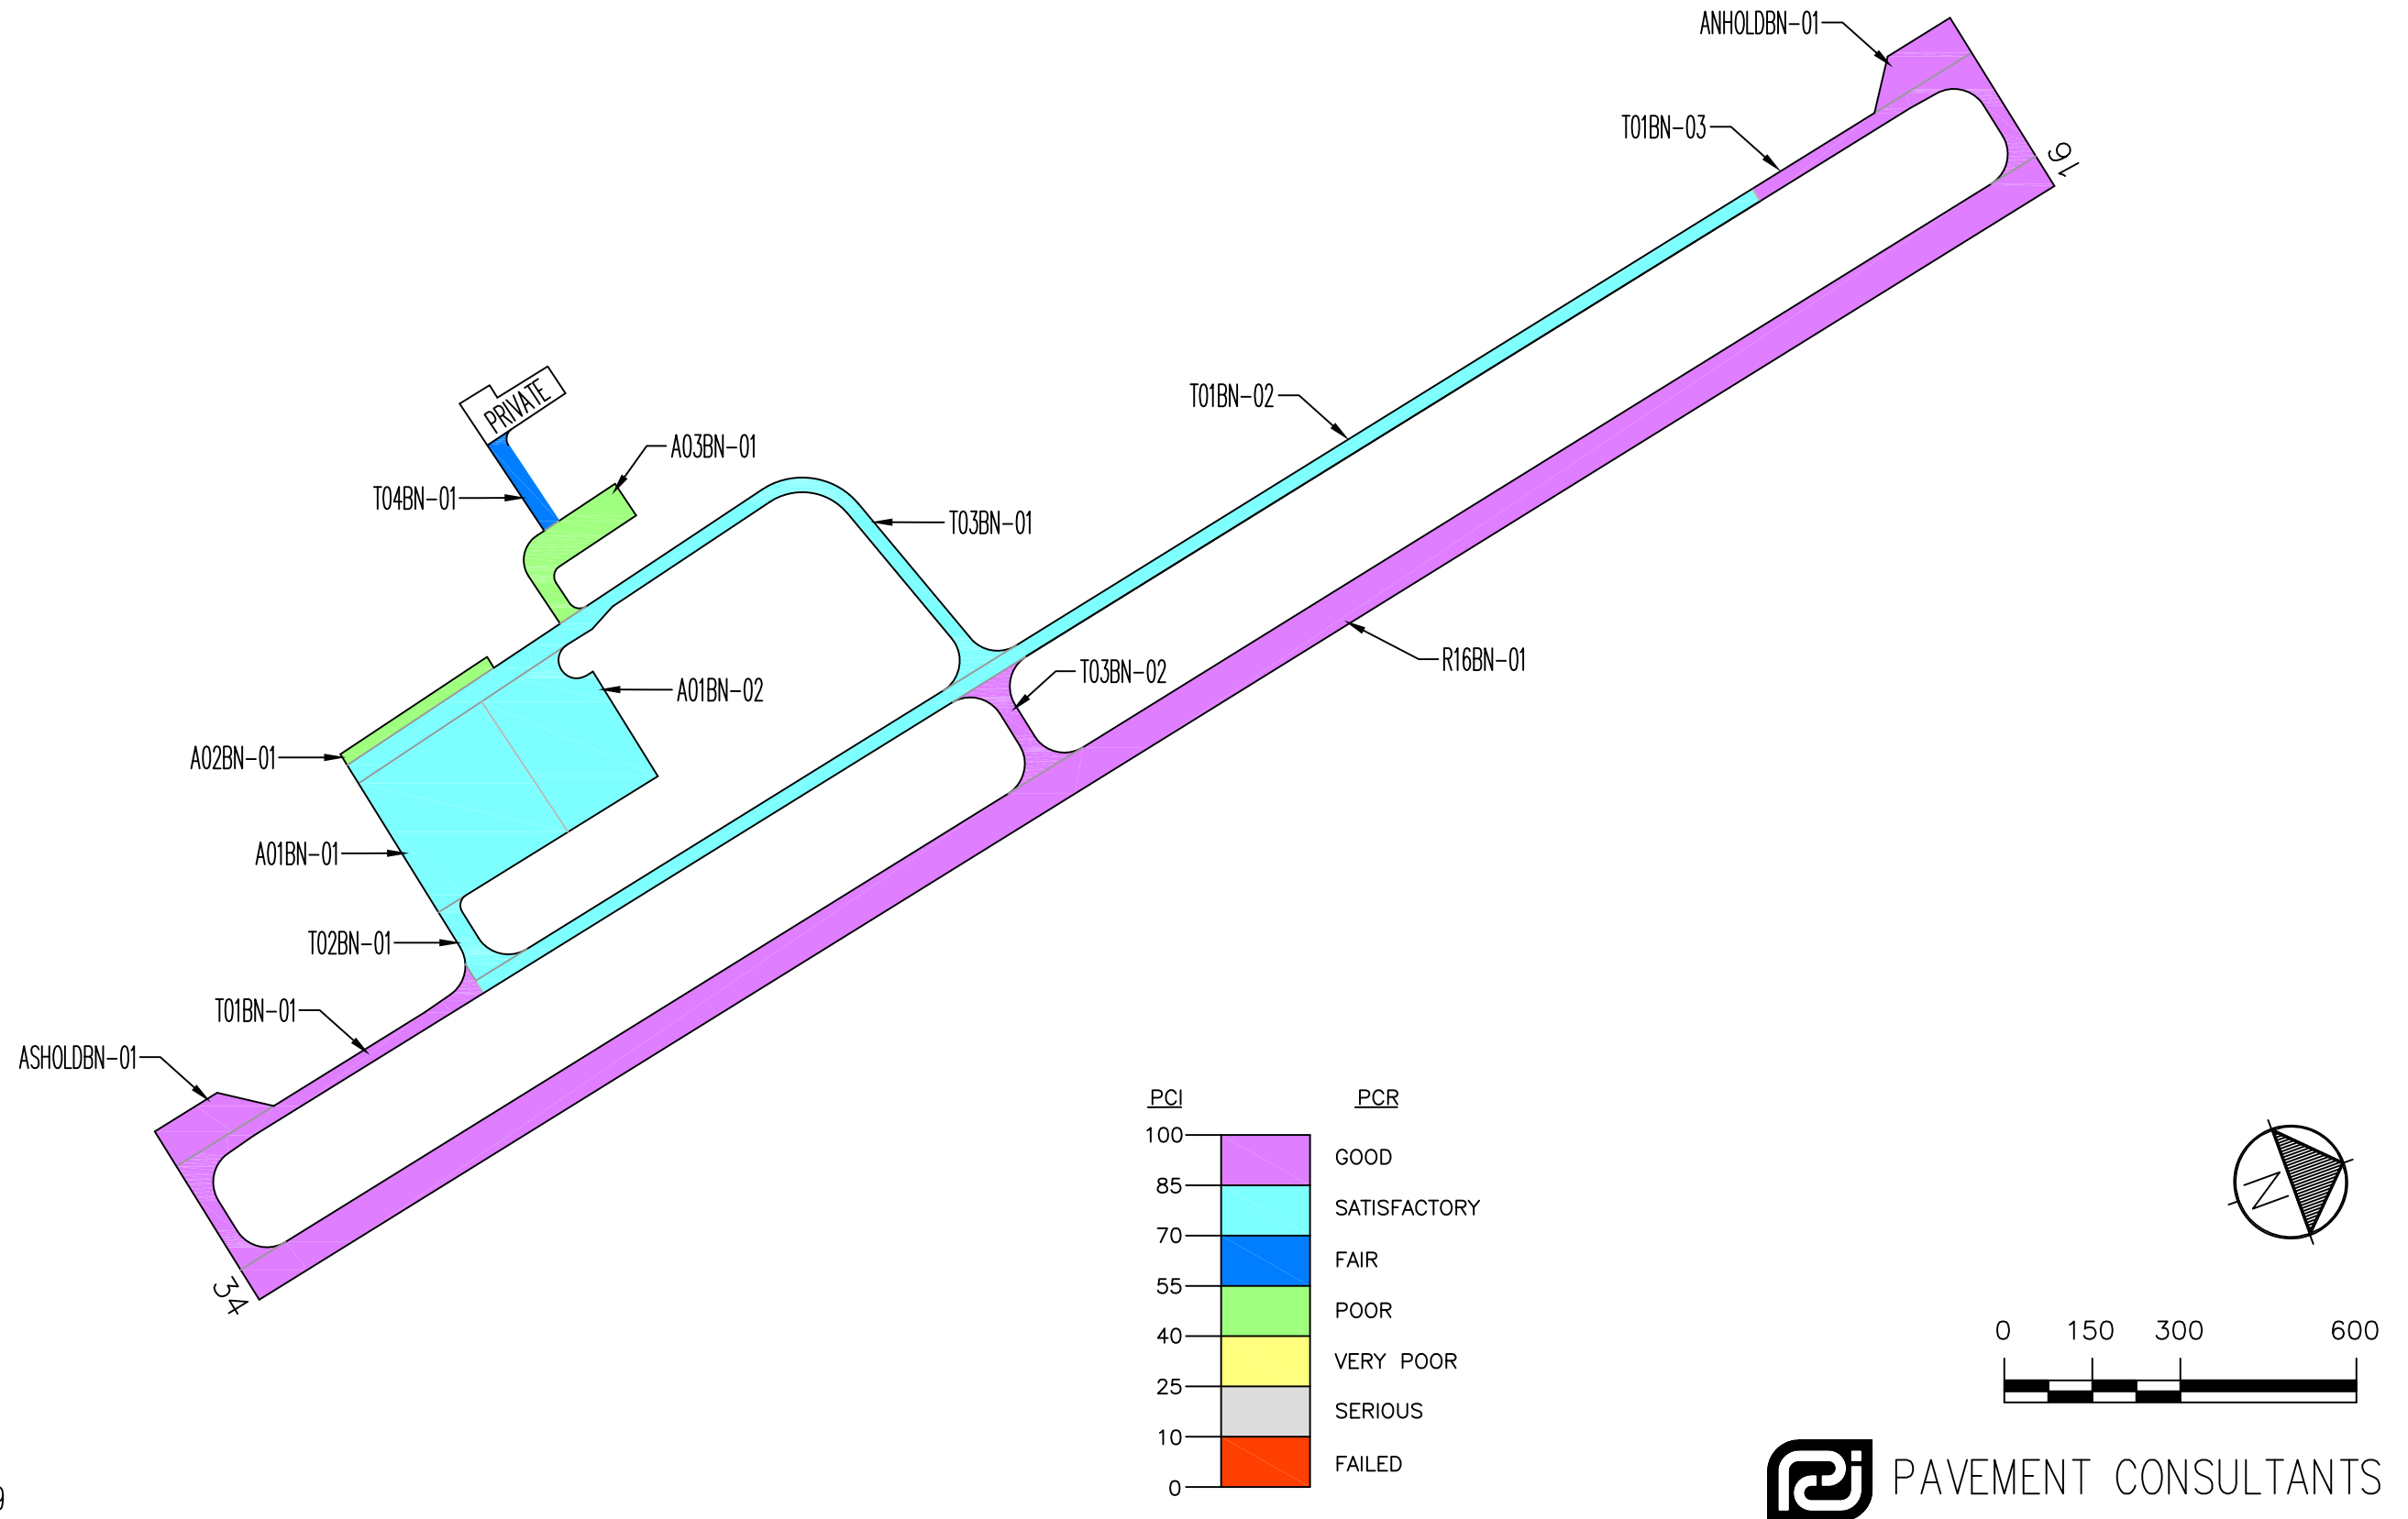
Figure BN-3. Pavement Condition in May 2019.
Bandon State Airport

The Branch Condition Report in Appendix 1 summarizes current pavement condition by branch while the Section Condition Report in Appendix 2 lists pavement condition by section. The current Pavement Condition Rating (PCR) is shown graphically in Figure BN-3.

Section PCIs at Bandon State Airport range from a low of 48 (a PCR of “Poor”) to a high of 100 (a PCR of “Good”). The area-weighted average PCI for all airport pavements is 84, corresponding to an overall PCR of “Satisfactory”. Figure BN-4 shows how much pavement area is associated with each Pavement Condition Rating category and also shows pavement condition distribution from the inspections conducted in 2013 and 2016.

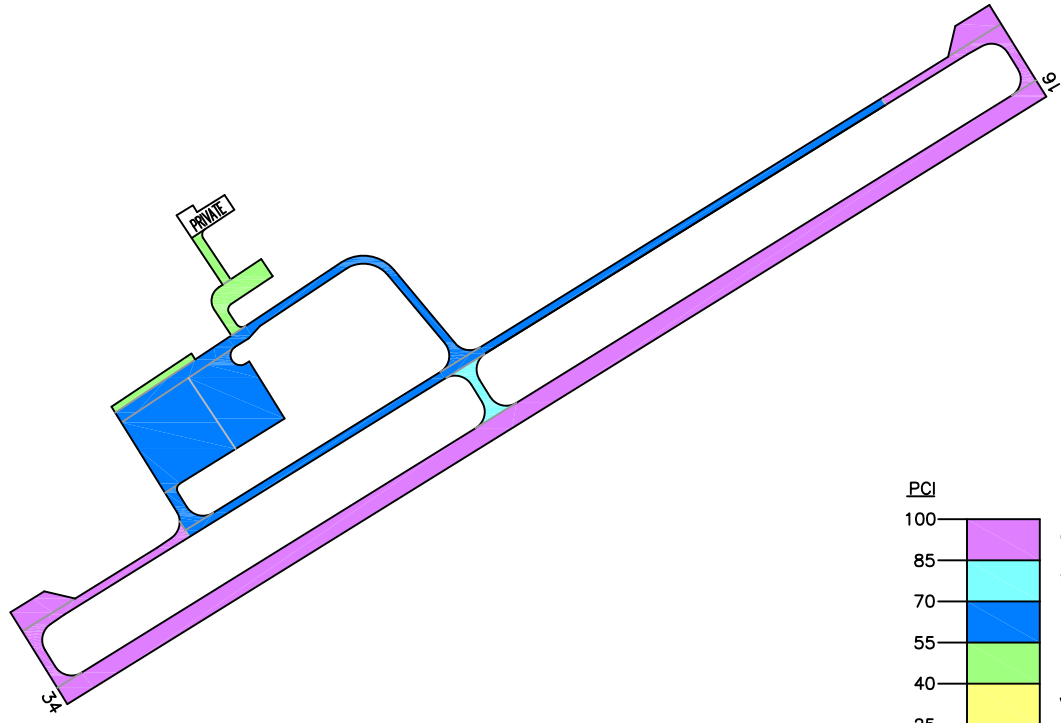
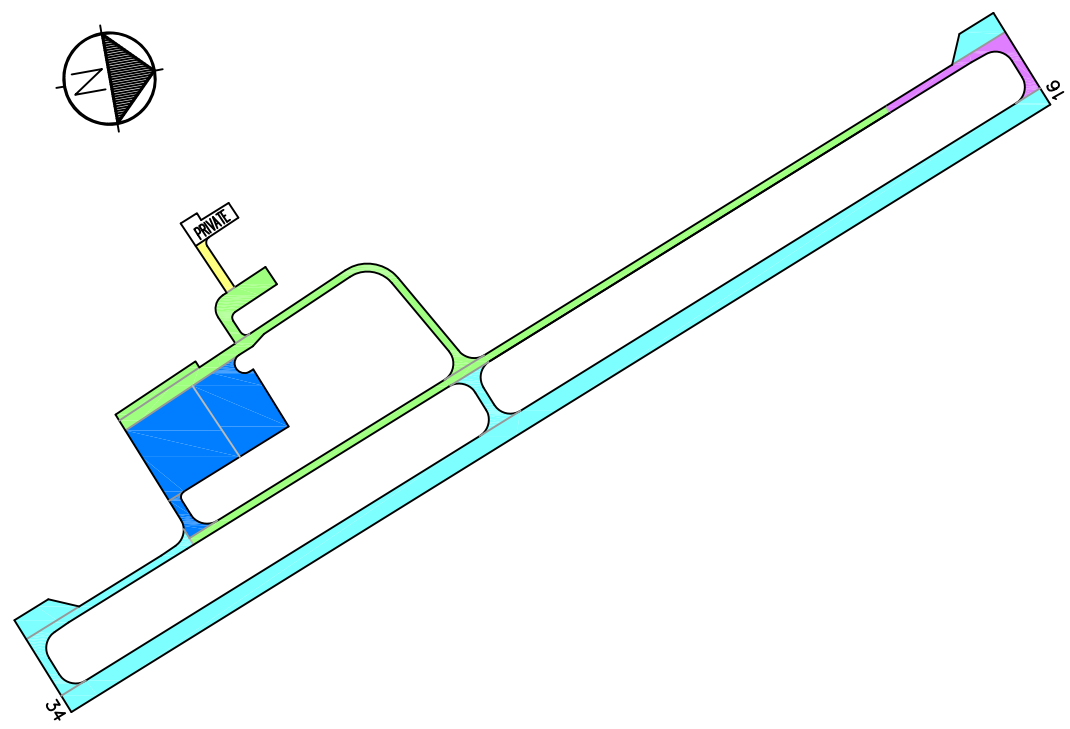
Figure BN-5. Future Pavement Condition.

A graphical representation of the projected PCIs listed in Table 1 is shown in Figure BN-5.
