BROOKINGS AIRPORT

Using the branch, section and sample unit divisions established, a visual condition survey was conducted at Brookings Airport in May 2019. During the inspection, pavement defects were identified and measured in accordance with the methodology outlined in ASTM D5430. This inspection ensures your airport complies with the “detailed inspection” requirement of FAA’s PMMP guidelines. After collection, the data were entered into the PAVER software for analysis. These data are reproduced in the Re-Inspection Report attached as Appendix 4.

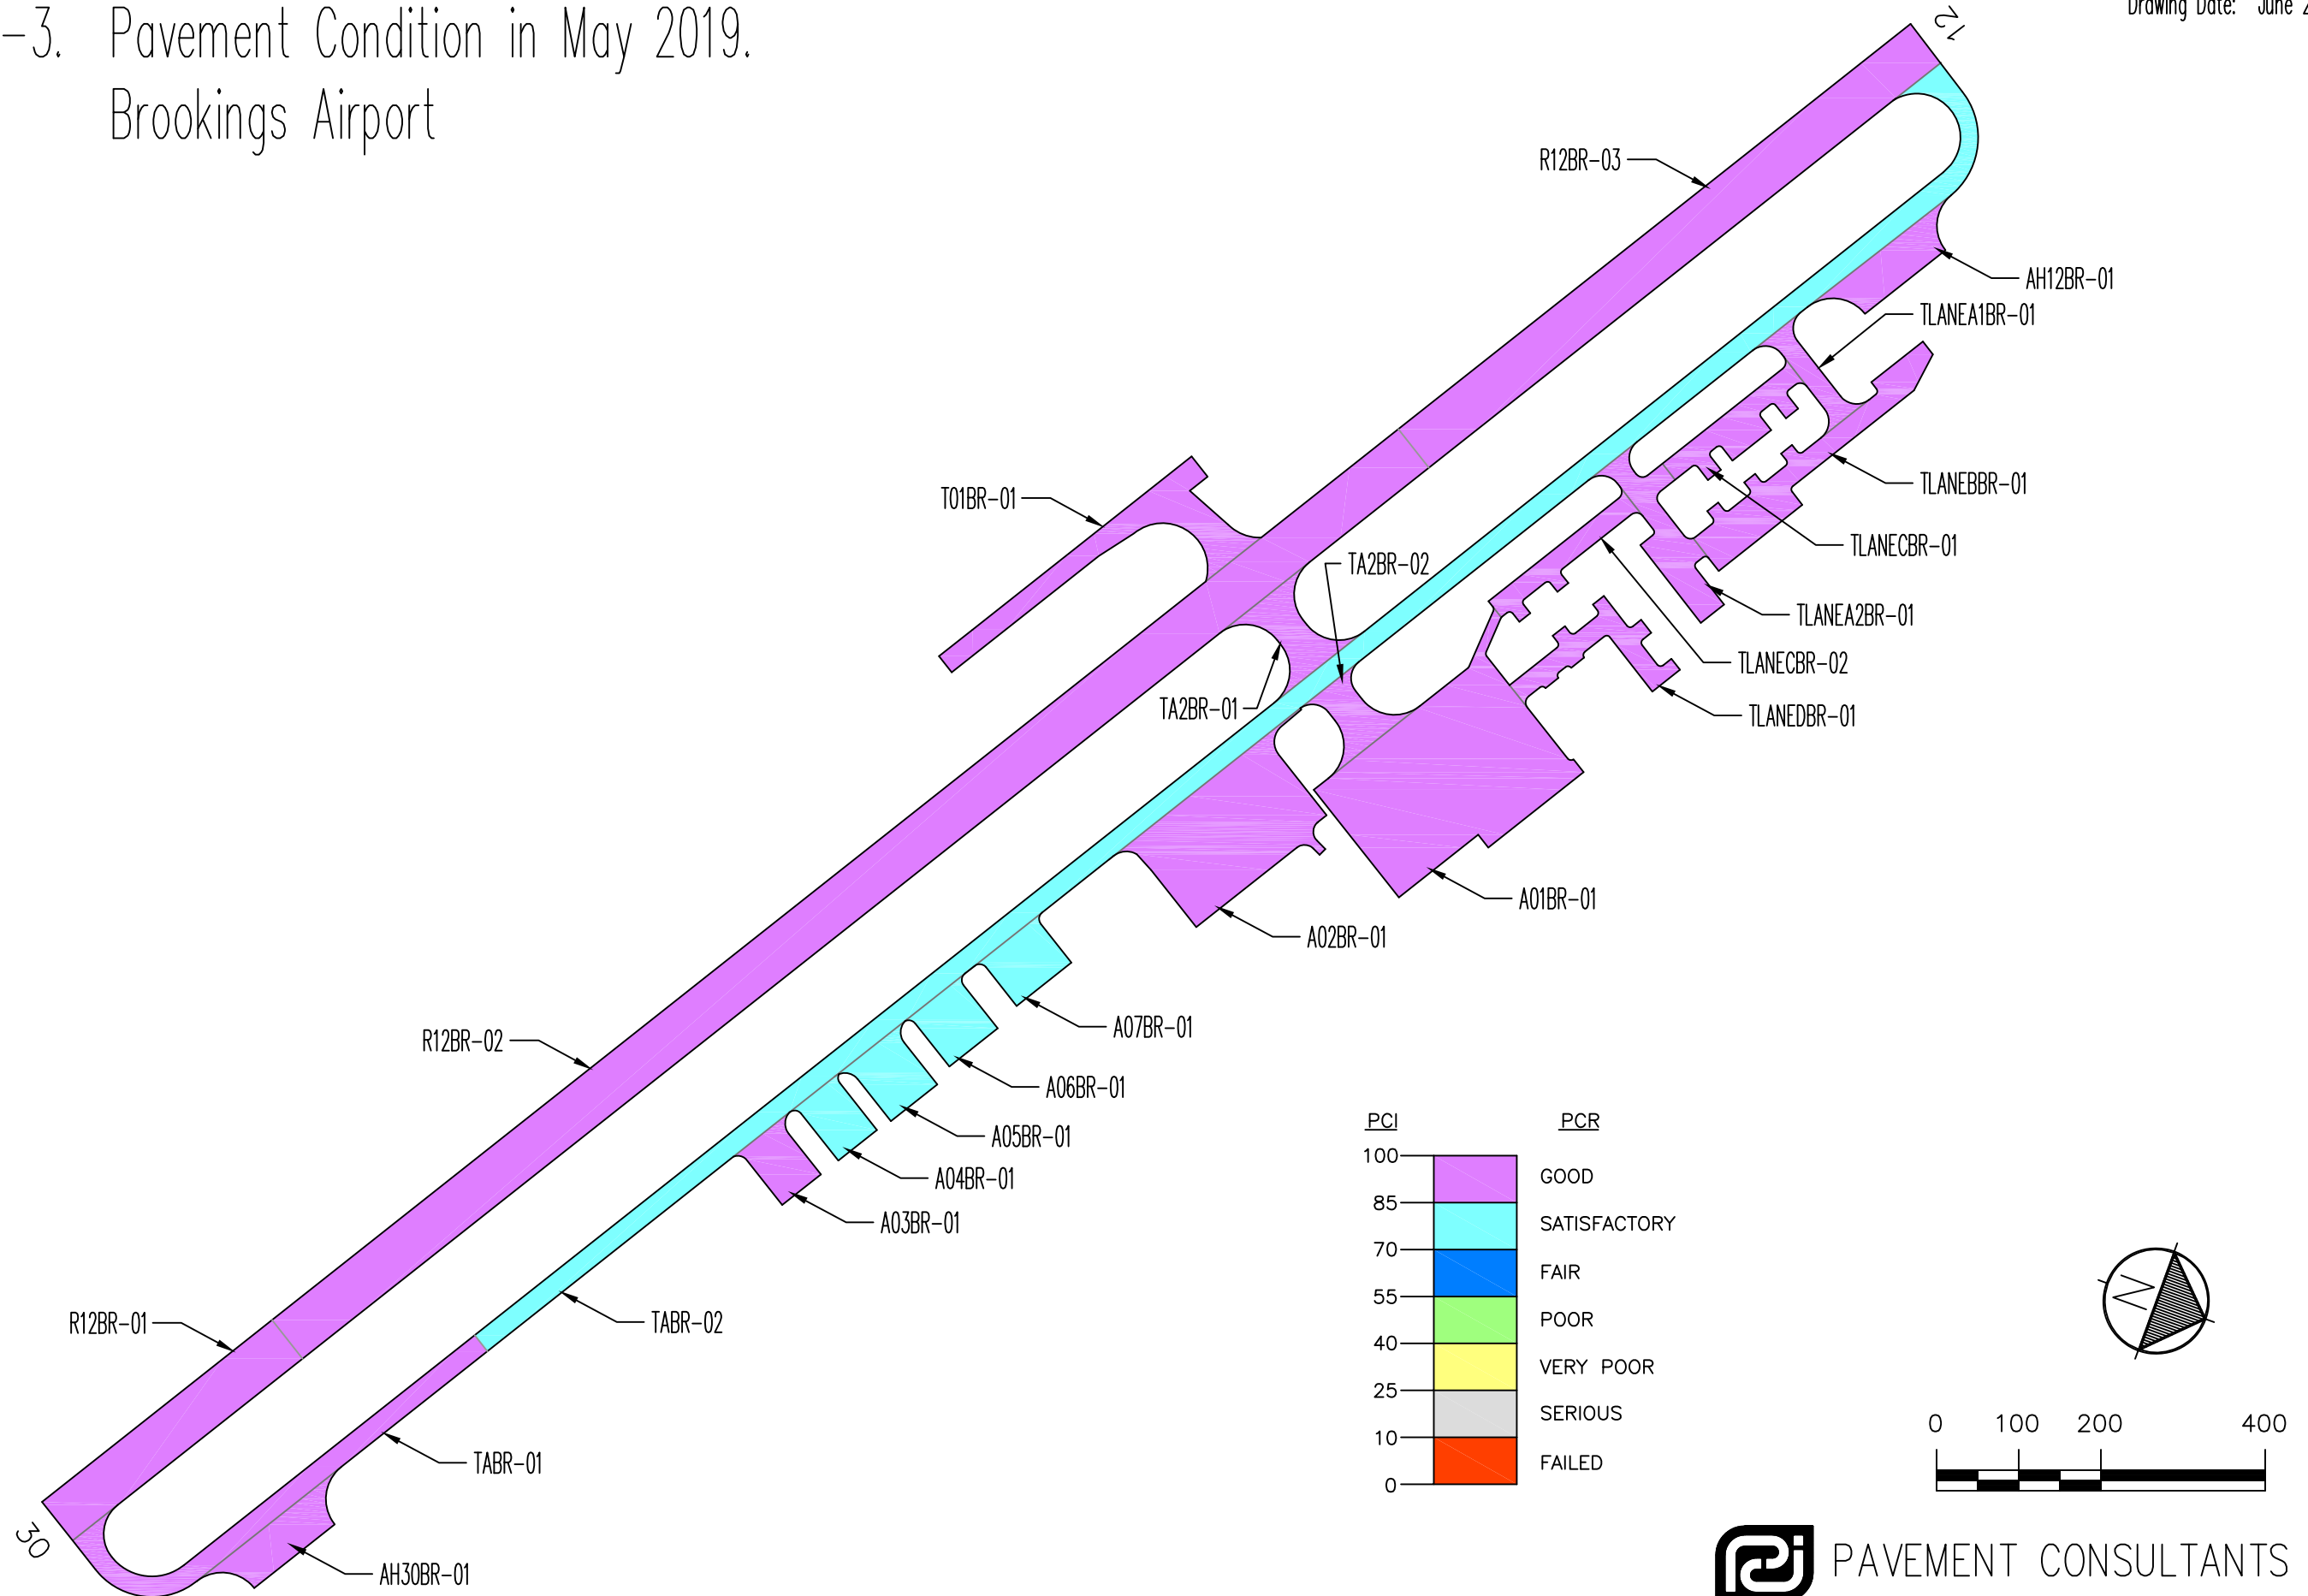
Figure BR-3. Pavement Condition in May 2019.
Brookings Airport

Section PCIs at Brookings Airport range from a low of 72 (a PCR of “Satisfactory”) to a high of 98 (a PCR of “Good”). The area-weighted average PCI for all airport pavements is 92, corresponding to an overall PCR of “Good”. Figure BR-4 shows how much pavement area is associated with each Pavement Condition Rating category and also shows pavement condition distribution from the inspections conducted in 2013 and 2016.

The primary distresses observed during the inspection were: longitudinal and transverse cracking, weathering, and depression with an isolated occurrence of alligator cracking and raveling.

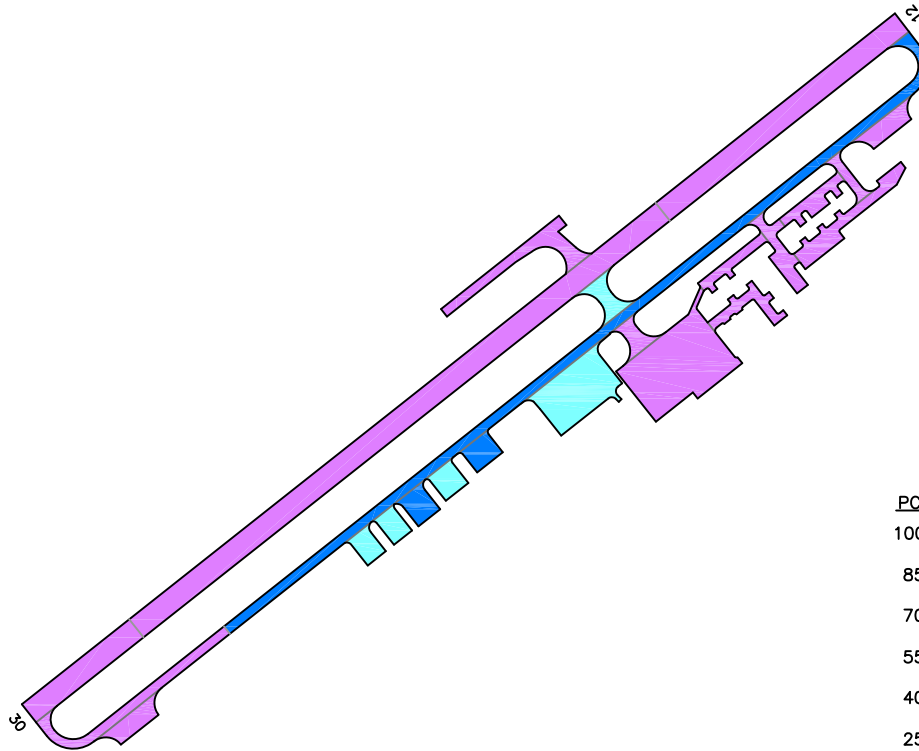
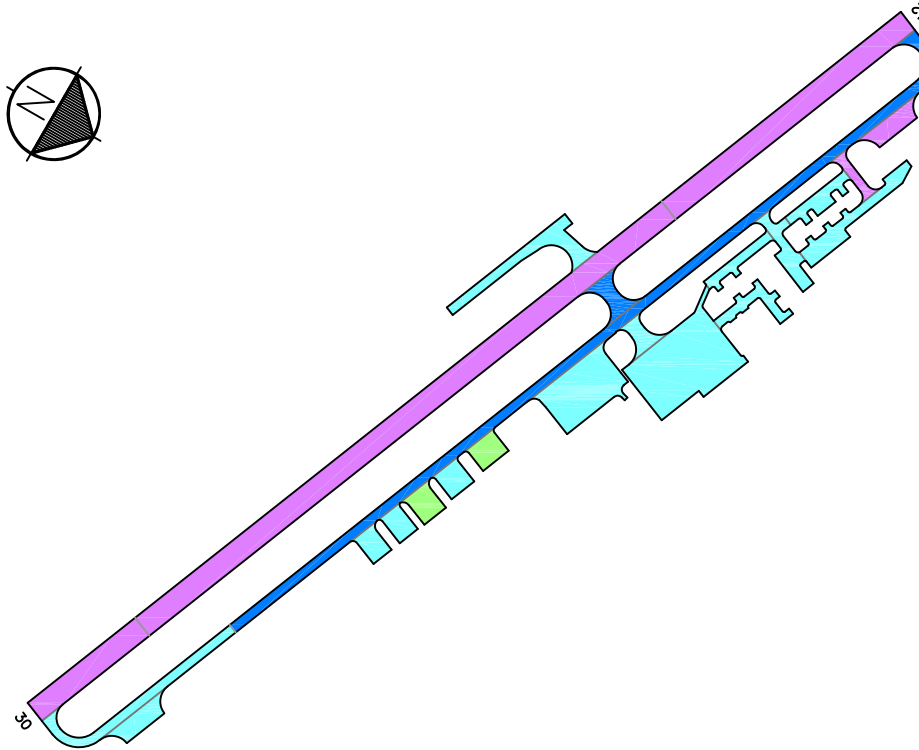
Figure BR-5. Future Pavement Condition.

A graphical representation of the projected PCIs listed in Table 1 is shown in Figure BR-5.
