CHILOQUIN STATE AIRPORT

Figure CH-1. Airport Layout, Dimensions and Pavement Cross-Sections.
Chiloquin State Airport

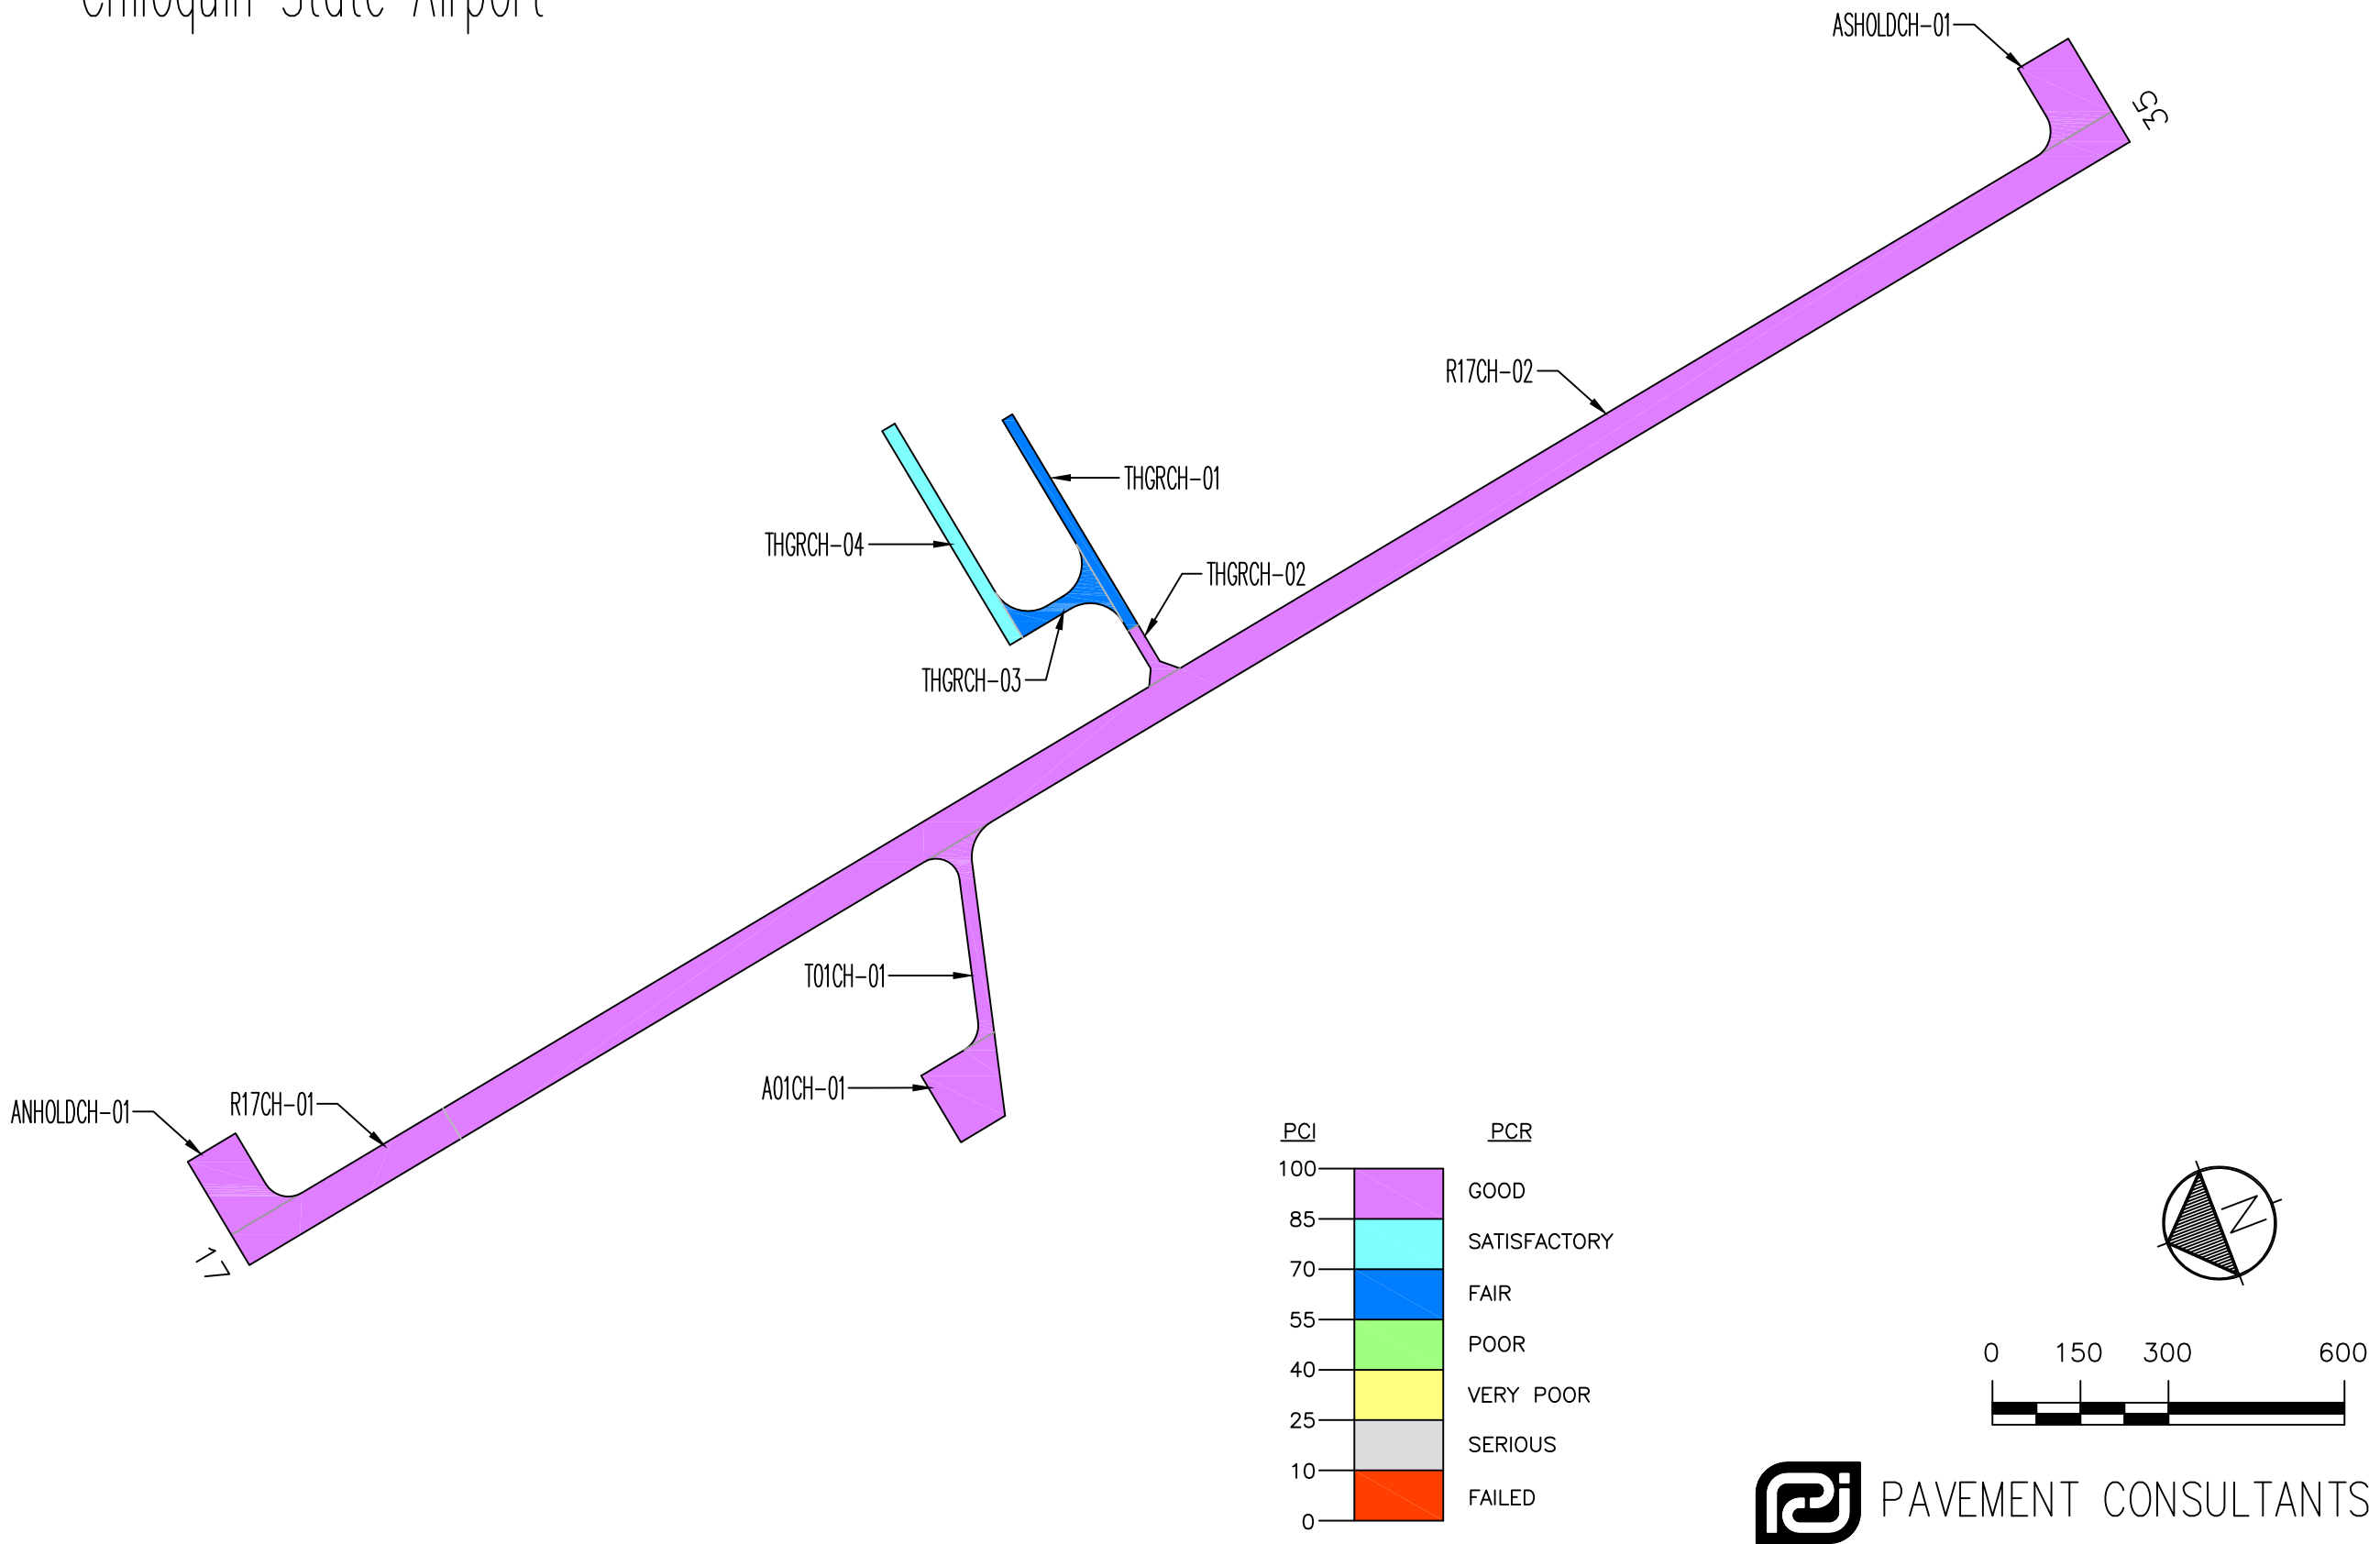
Figure CH-3. Pavement Condition in May 2019.
Chiloquin State Airport

Section PCIs at Chiloquin State Airport range from a low of 569 (a PCR of “Fair”) to a high of 100 (a PCR of “Good”). The area-weighted average PCI for all airport pavements is 88, corresponding to an overall PCR of “Good”. Figure CH-4 shows how much pavement area is associated with each Pavement Condition Rating category and also shows pavement condition distribution from the inspections conducted in 2013 and 2016.

The primary distresses observed during the inspection were: longitudinal and transverse cracking, weathering, and an isolated occurrence of alligator cracking.

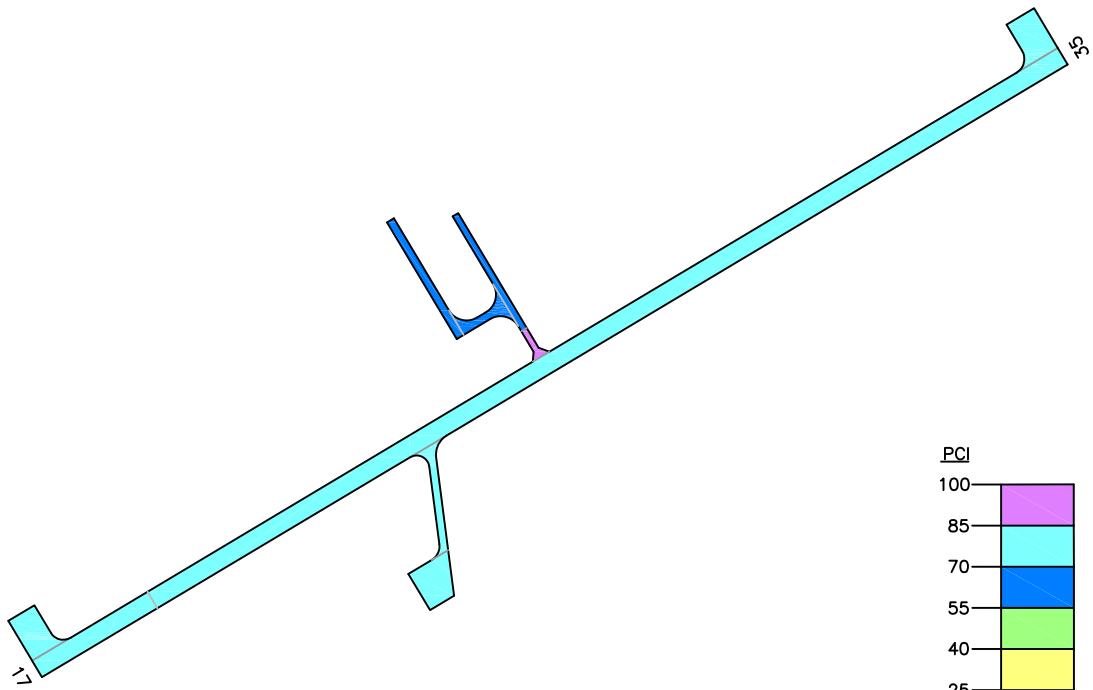
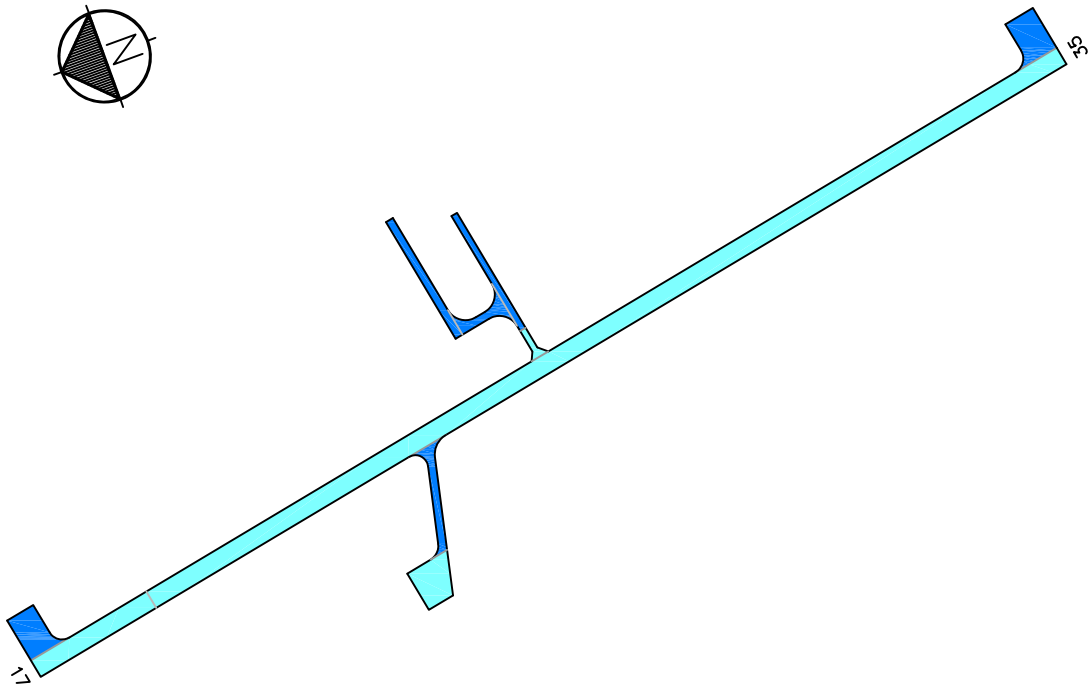
Figure CH-5. Future Pavement Condition.

A graphical representation of the projected PCIs listed in Table 1 is shown in Figure CH-5.
